9 June 2010

### **GROUNDWATER MONITORING AT FORMER FCC SITE, MAPUA – MAY 2010 SAMPLING UPDATE**

GROUNDWATER MONITORING AT MAPUA

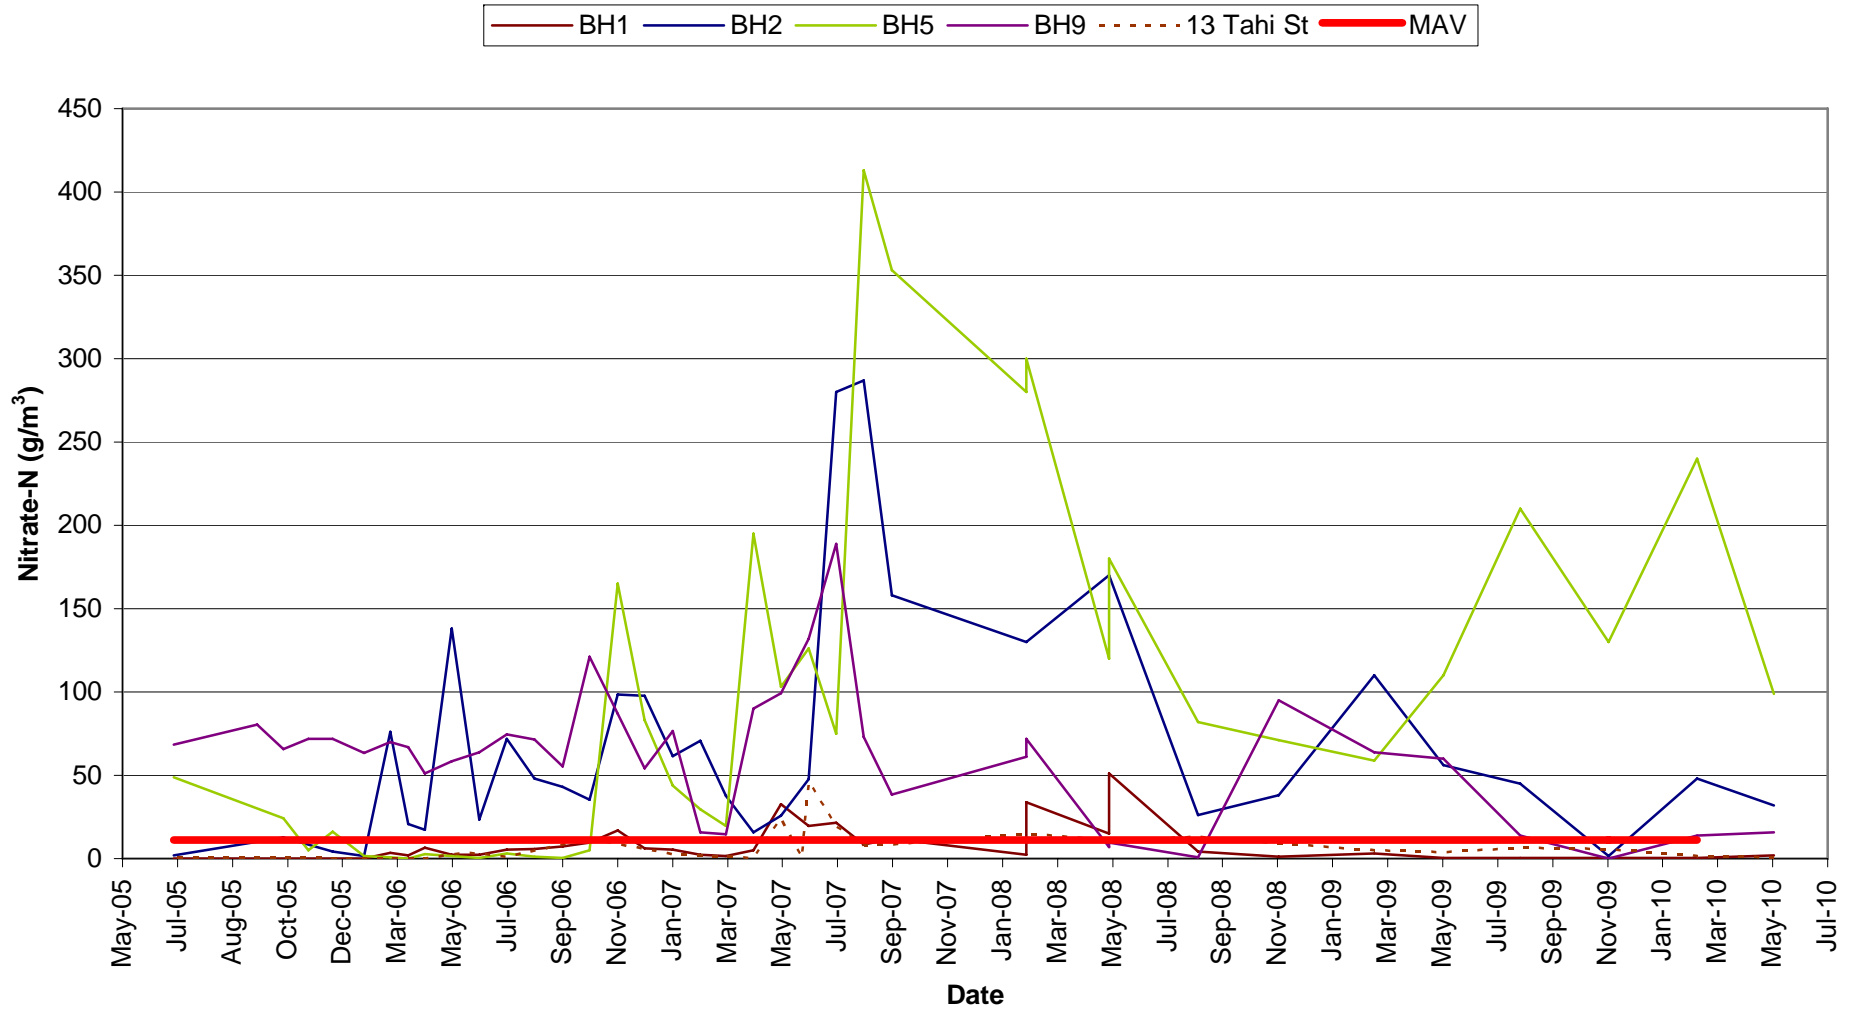
**Figure 2. Nitrate-N**  
**MAV DWSNZ 11.3 NO<sub>3</sub>-N g/m<sup>3</sup>**

- ∴ Figure 2 shows nitrate-nitrogen concentrations. Three boreholes have historically shown elevated concentrations: BH2, BH5 and BH9. Since late 2007, concentrations have decreased significantly in BH2 and BH9, which both had concentrations of less than 2 g/m<sup>3</sup> in November 2009. BH5 continued to show elevated concentrations. Since then, all three of these boreholes have shown an increase in nitrate-nitrogen concentrations, but in the latest sampling round, the concentration has again decreased or been relatively stable, although BH2, BH5 and BH9 all currently have nitrate-N concentrations above the Maximum Acceptable Value in the Drinking Water Standards for New Zealand 2005 (Revised 2008). Figure 2a shows the boreholes that have typically displayed lower nitrate-N concentrations. Both BH1 and 13 Tahi Street remain at stable, low concentrations.

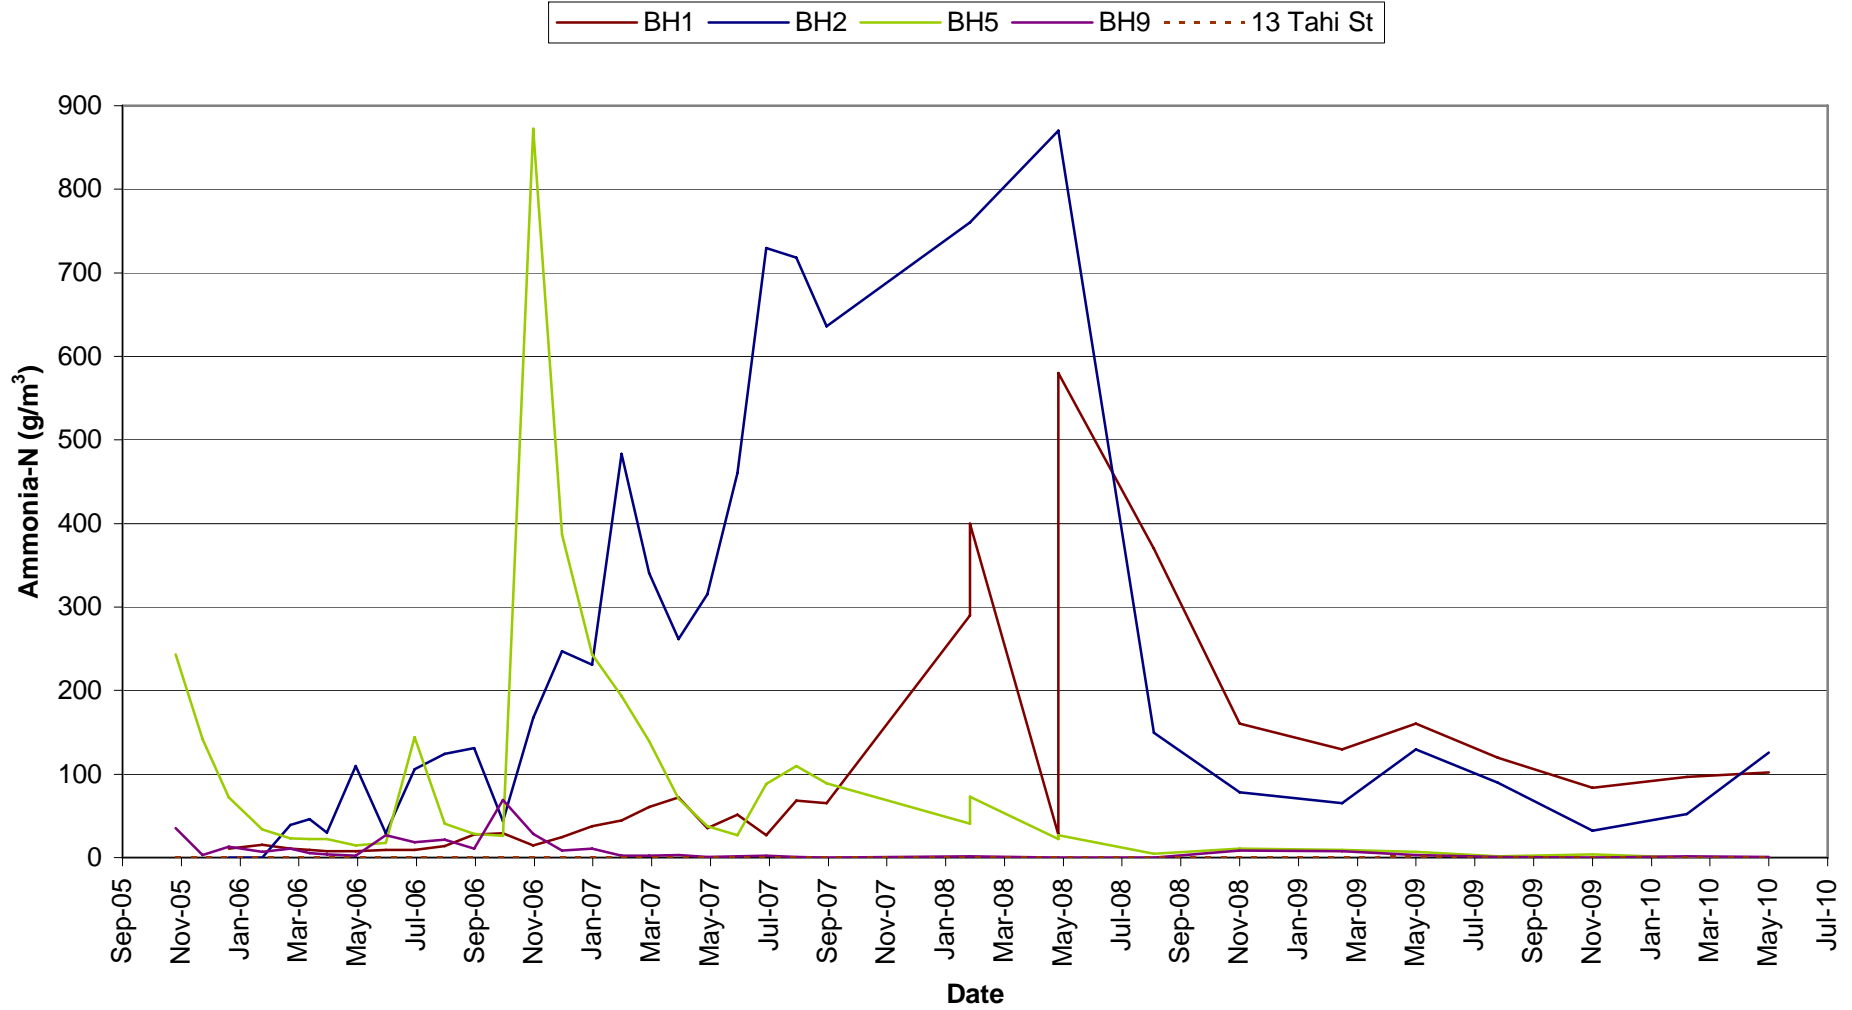
**Figure 3. Ammonia-N**  
**GV Aesthetic DWSNZ 0.30 NH<sub>3</sub>-N g/m<sup>3</sup>; Aquatic Ecosystem Guideline 0.71g/m<sup>3</sup>**

- ∴ Figure 3 shows ammonia-nitrogen concentrations. The bores with elevated concentrations (BH1 and BH2) have shown a very small increase in BH1 in the latest sampling round, and a larger increase in BH2, although well below the historically high concentrations of April 2008. Those bores with lower ammonia-N concentrations (Figure 3a) show stable concentrations in BH5, BH9 and 13 Tahi Street.

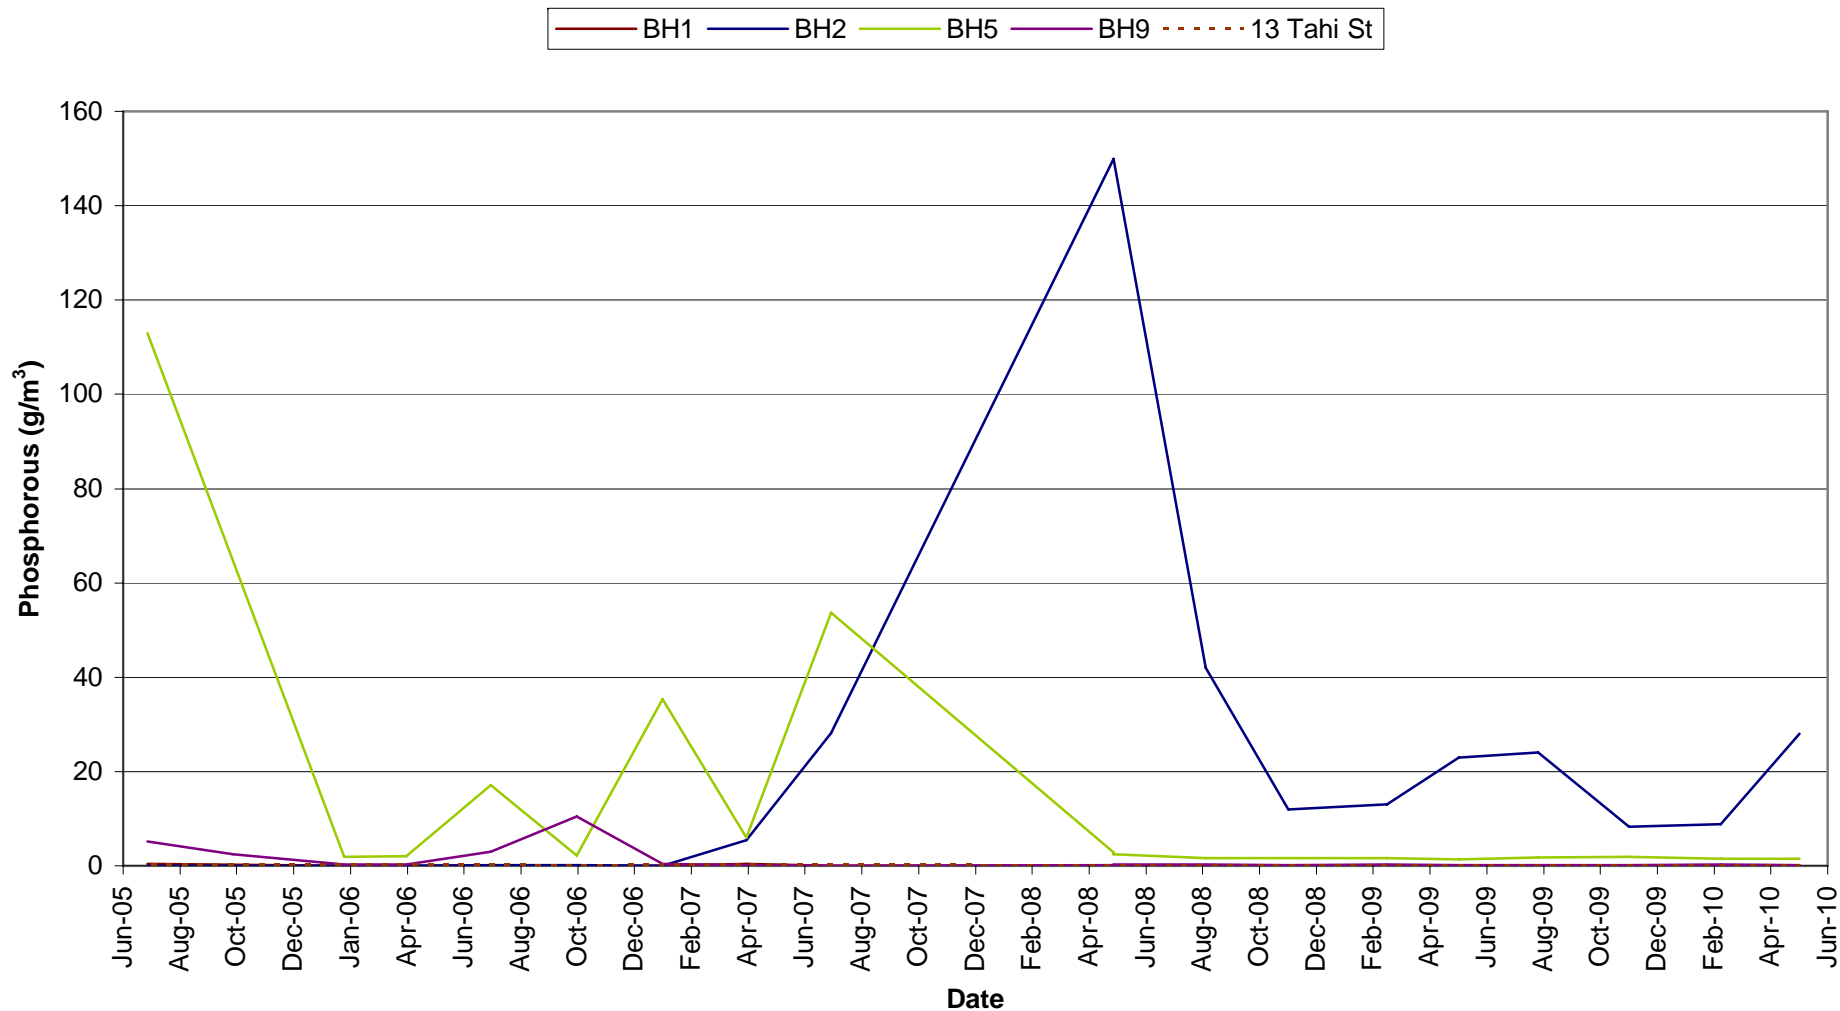
**Figure 4. Phosphorous  
Aquatic Ecosystem Guideline 0.01g/m<sup>3</sup>**

- ∴ Figure 4 shows dissolved reactive phosphorous concentrations, which have increased in BH2, but remained stable in other wells.
- ∴ Figure 5 shows DDX concentrations. The bores with elevated concentrations showed a decrease, apart from 13 Tahi Street, which continues to be non-detectable.

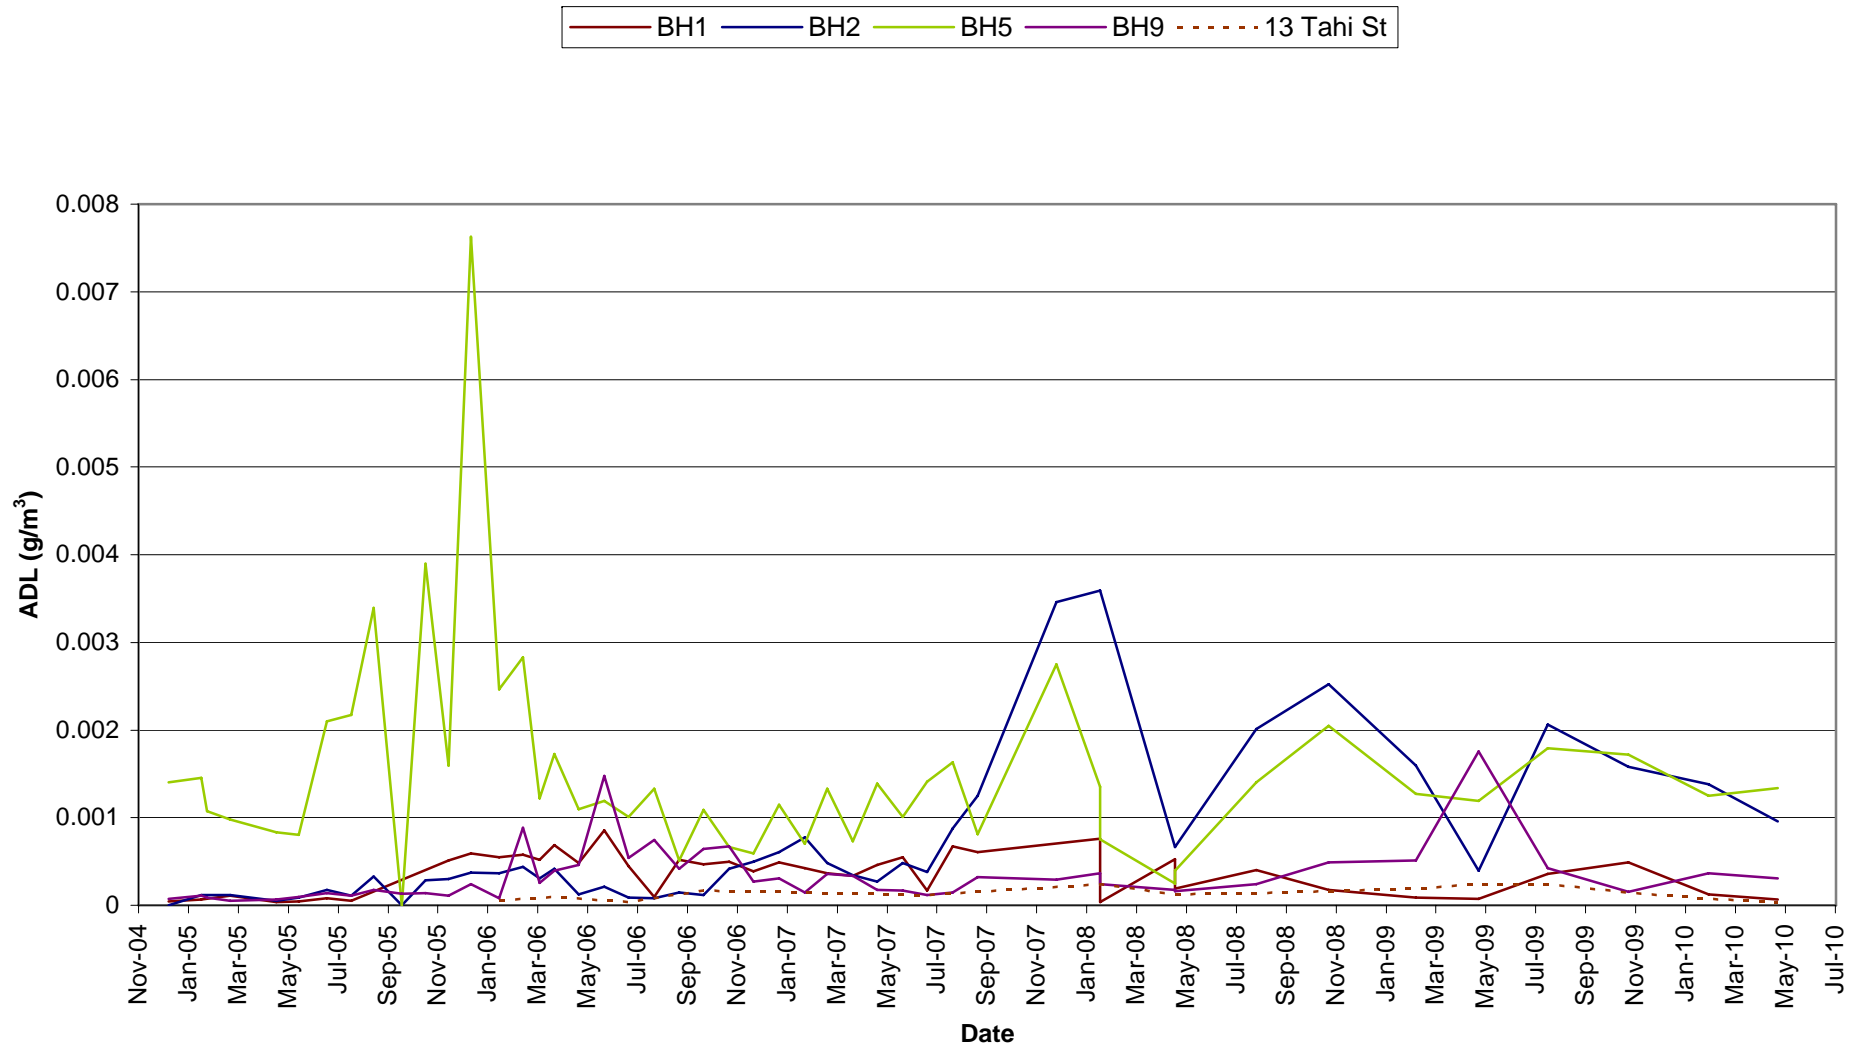
Figure 6. ADL (g/m<sup>3</sup>)

- ∴ Figure 6 shows ADL concentrations. These concentrations continue to show a relatively stable pattern.
- ∴ Figure 7 shows electrical conductivity values, which are a general indicator of all the chemicals dissolved in the water. These show a relatively stable pattern, with the exception of an increase in BH2 and BH9, which both increased.

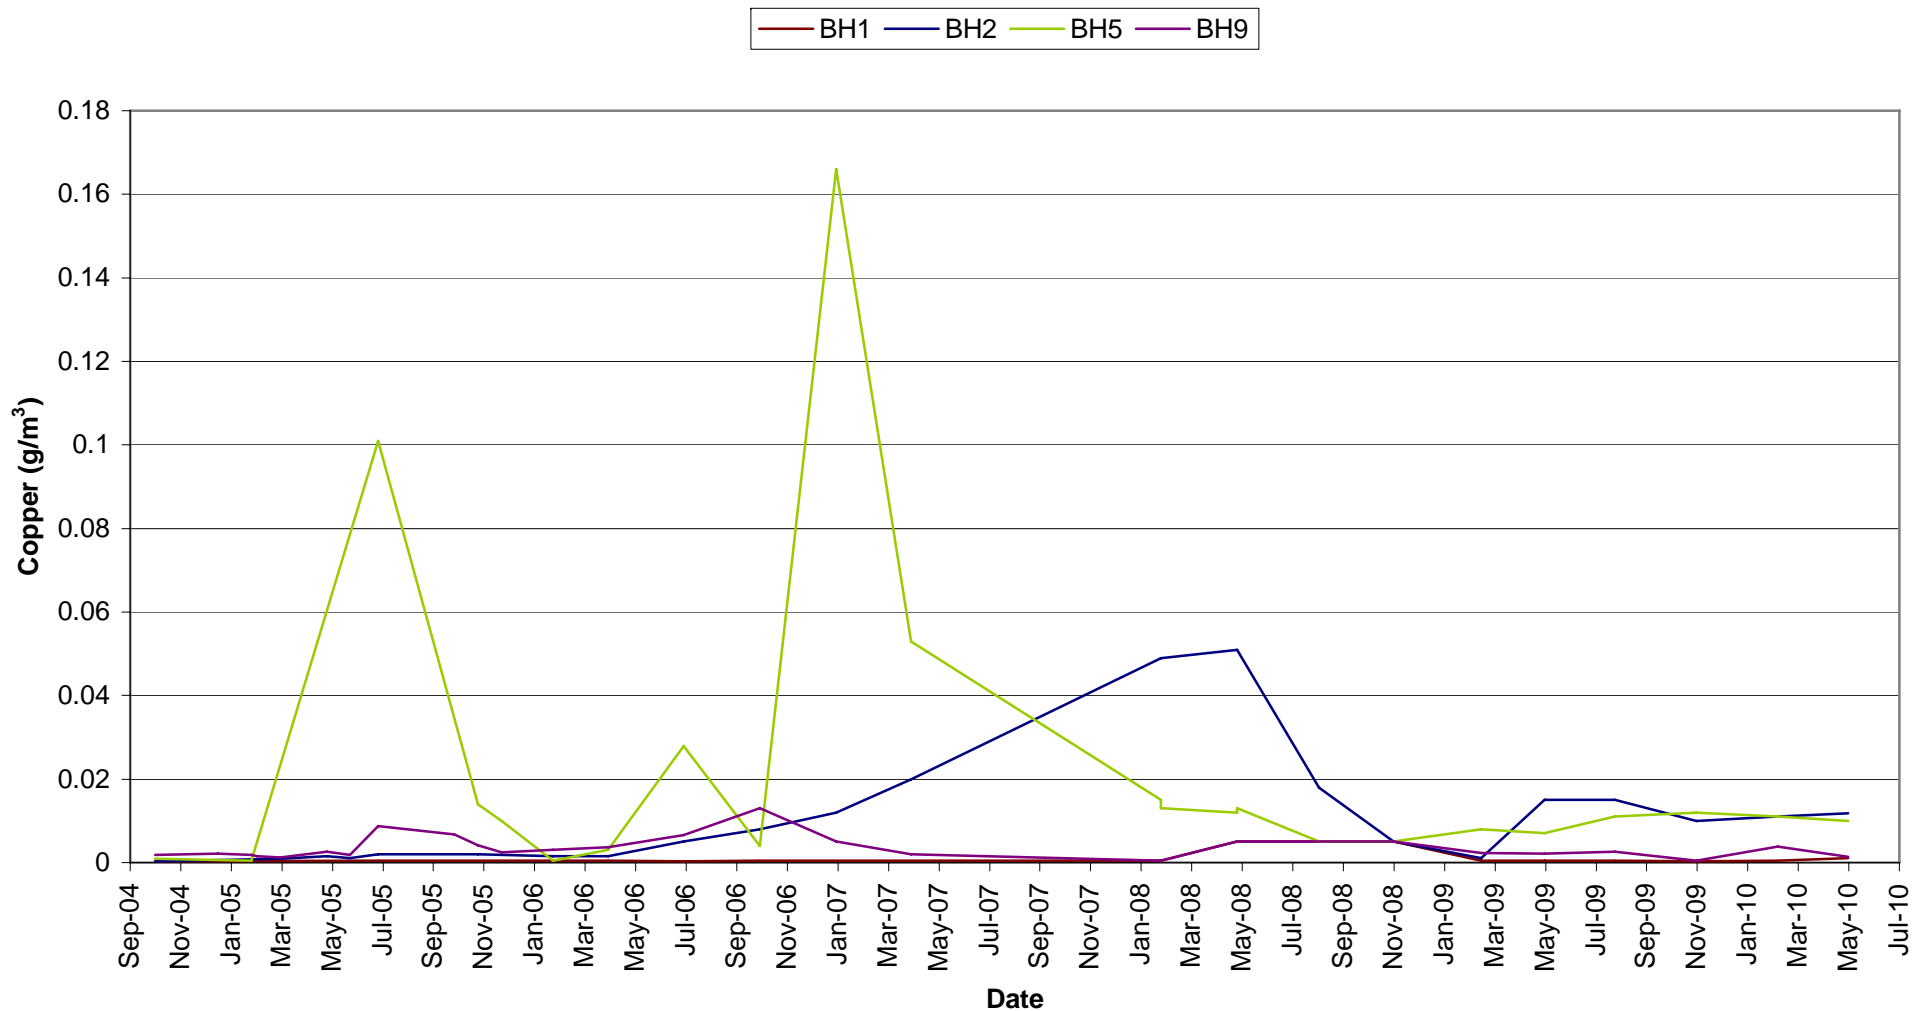
**Figure 8. Copper**  
**MAV DWSNZ 2 g/m<sup>3</sup>, ANZECC Marine Guideline = 0.0013 g/m<sup>3</sup>**

- ∴ Figure 8 shows dissolved copper concentrations. Copper was one of the reagents used in the MCD process. The results show stable concentrations.
- ∴ Iron was utilised in the MCD process, but has only been sampled since January 2008. The results are shown in Figure 9. Detectable concentrations only occur in BH1A, which continues to show quite variable concentrations.

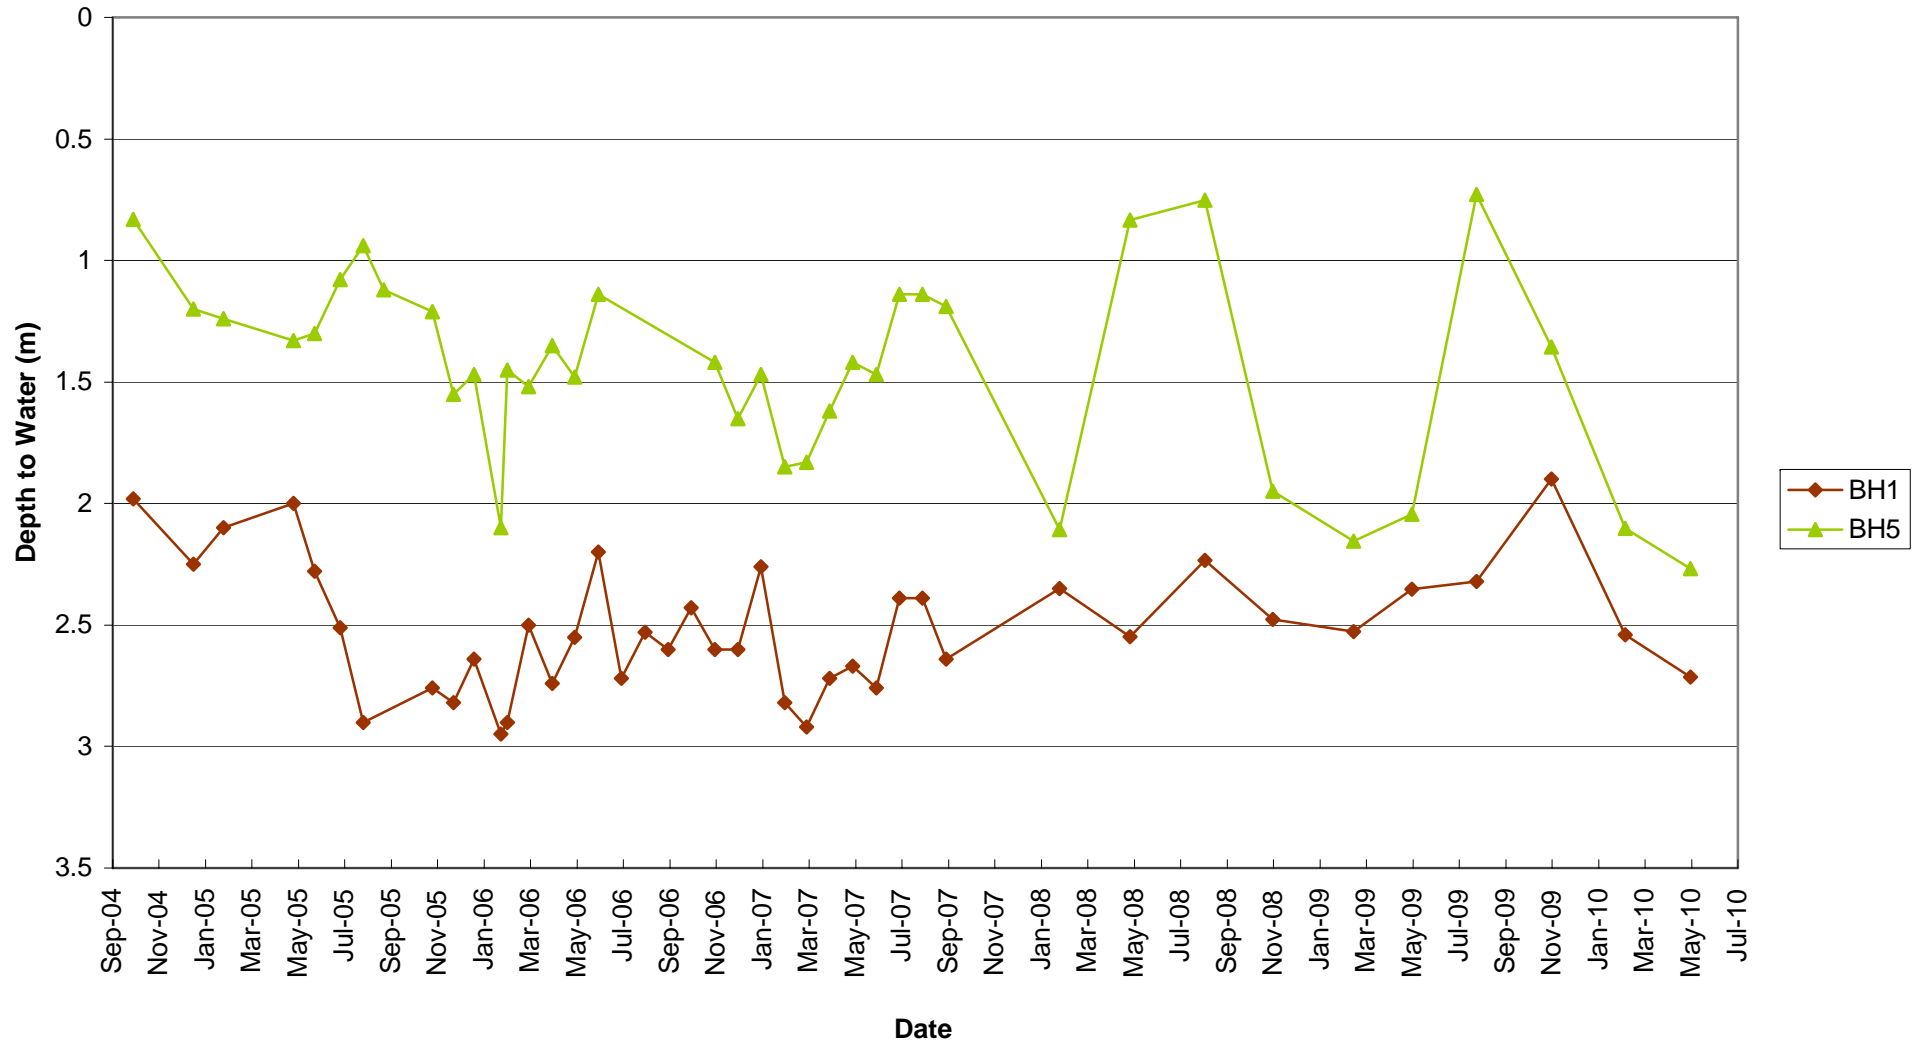
Figure 10. Water Level Plot

The most recent sampling round has occurred during a time of lower summertime water levels, as indicated by the plot in Figure 10. Most chemical concentrations have been generally stable, with the exception of ammonia-N in BH2, DRP in BH2, electrical conductivity in BH2 and BH9 and iron in BH1.

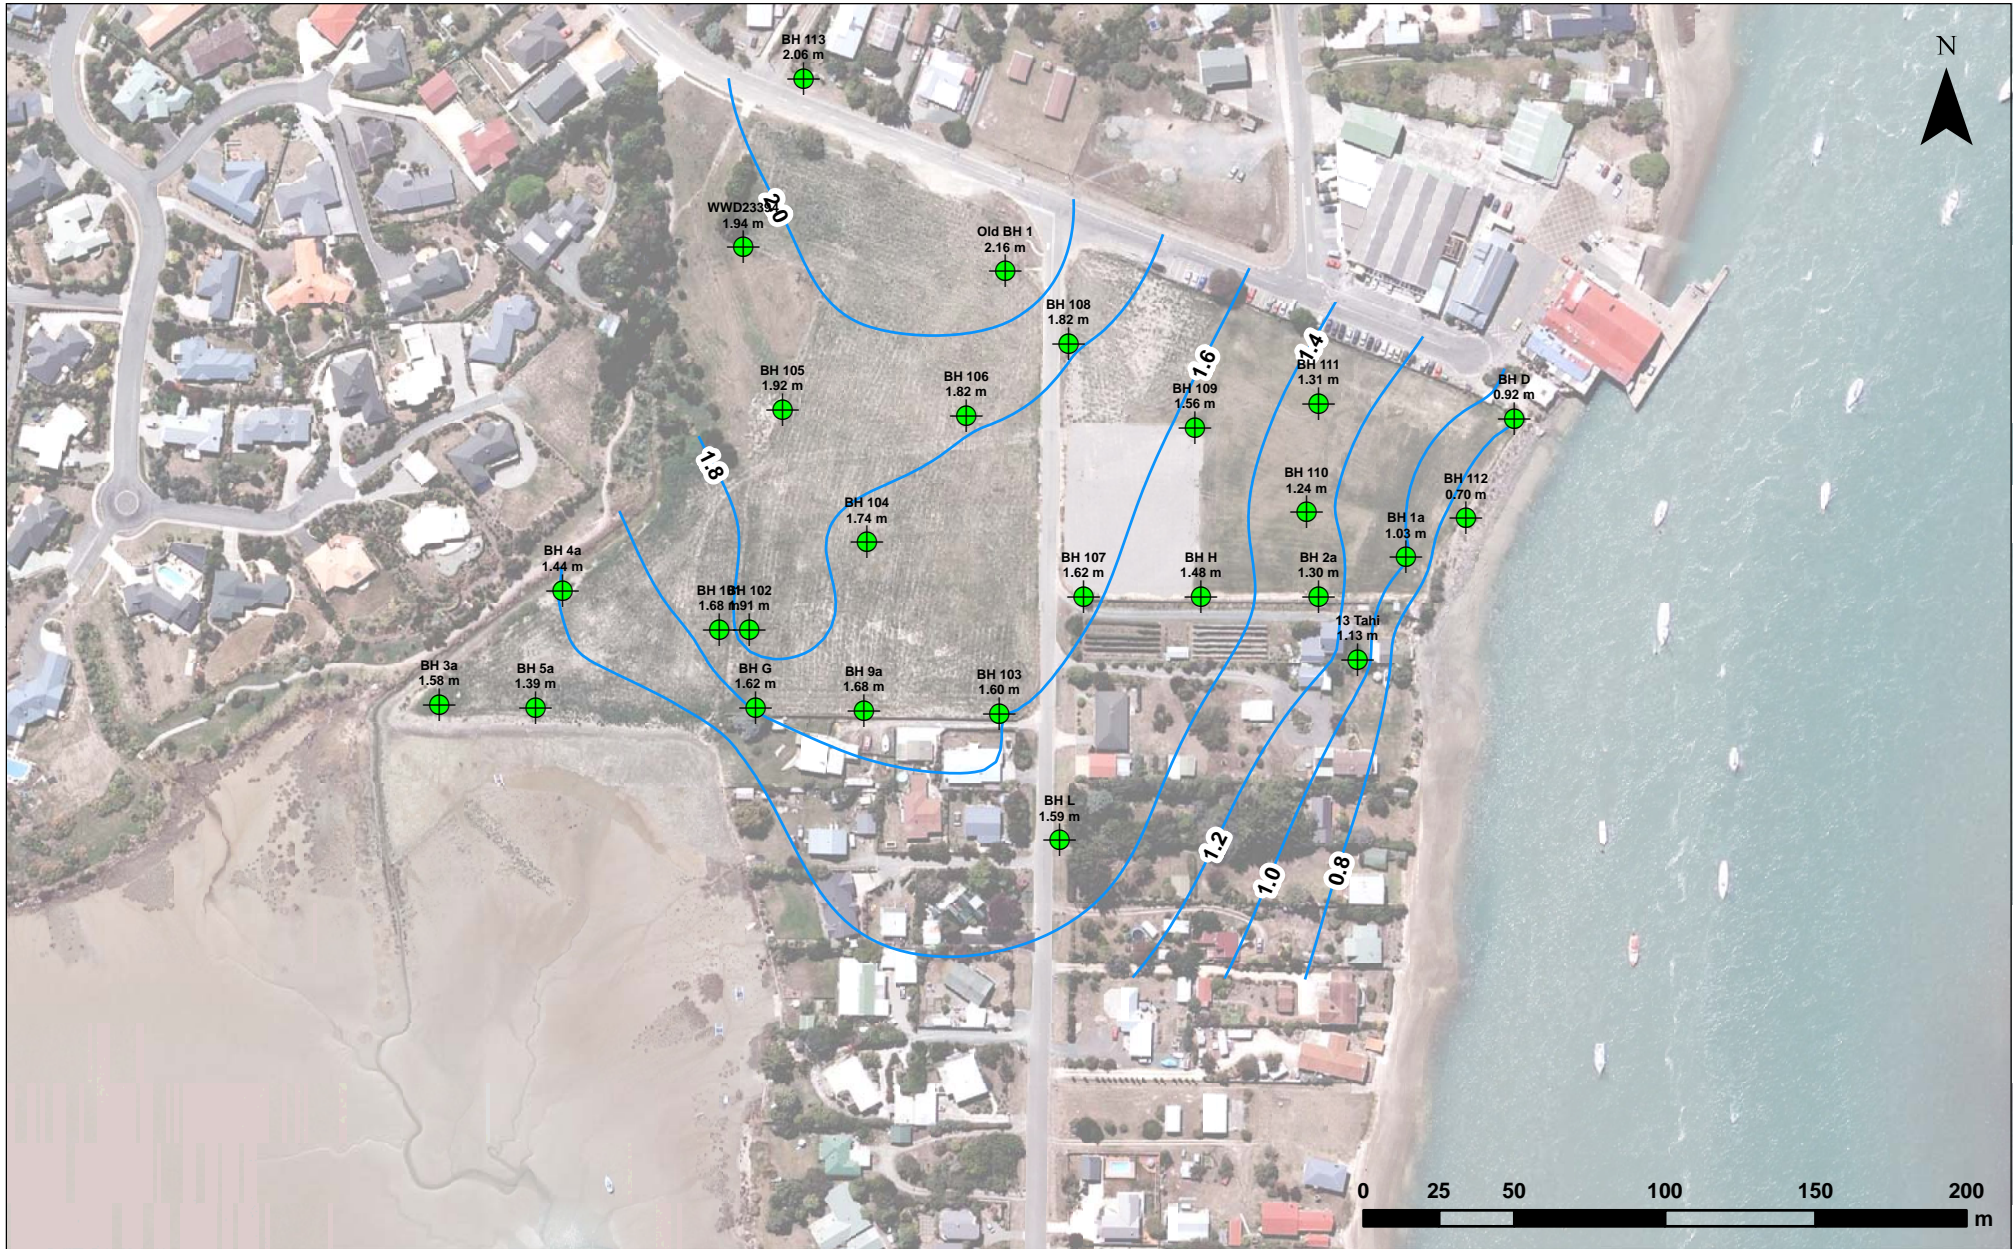
Figure 11 : Groundwater levels and contours on 3 May 2010

The elevation of the groundwater table within the on-site monitoring bores was measured on 3 May 2010, and the resulting contours are plotted in Figure 11. They show that levels are lower than at the time of the last survey in February 2010 resulting in a flatter gradient, but a similar pattern of groundwater flow direction beneath the site, with most of the groundwater discharging either to the Mapua channel to the east, or the Waimea Inlet to the south-west.

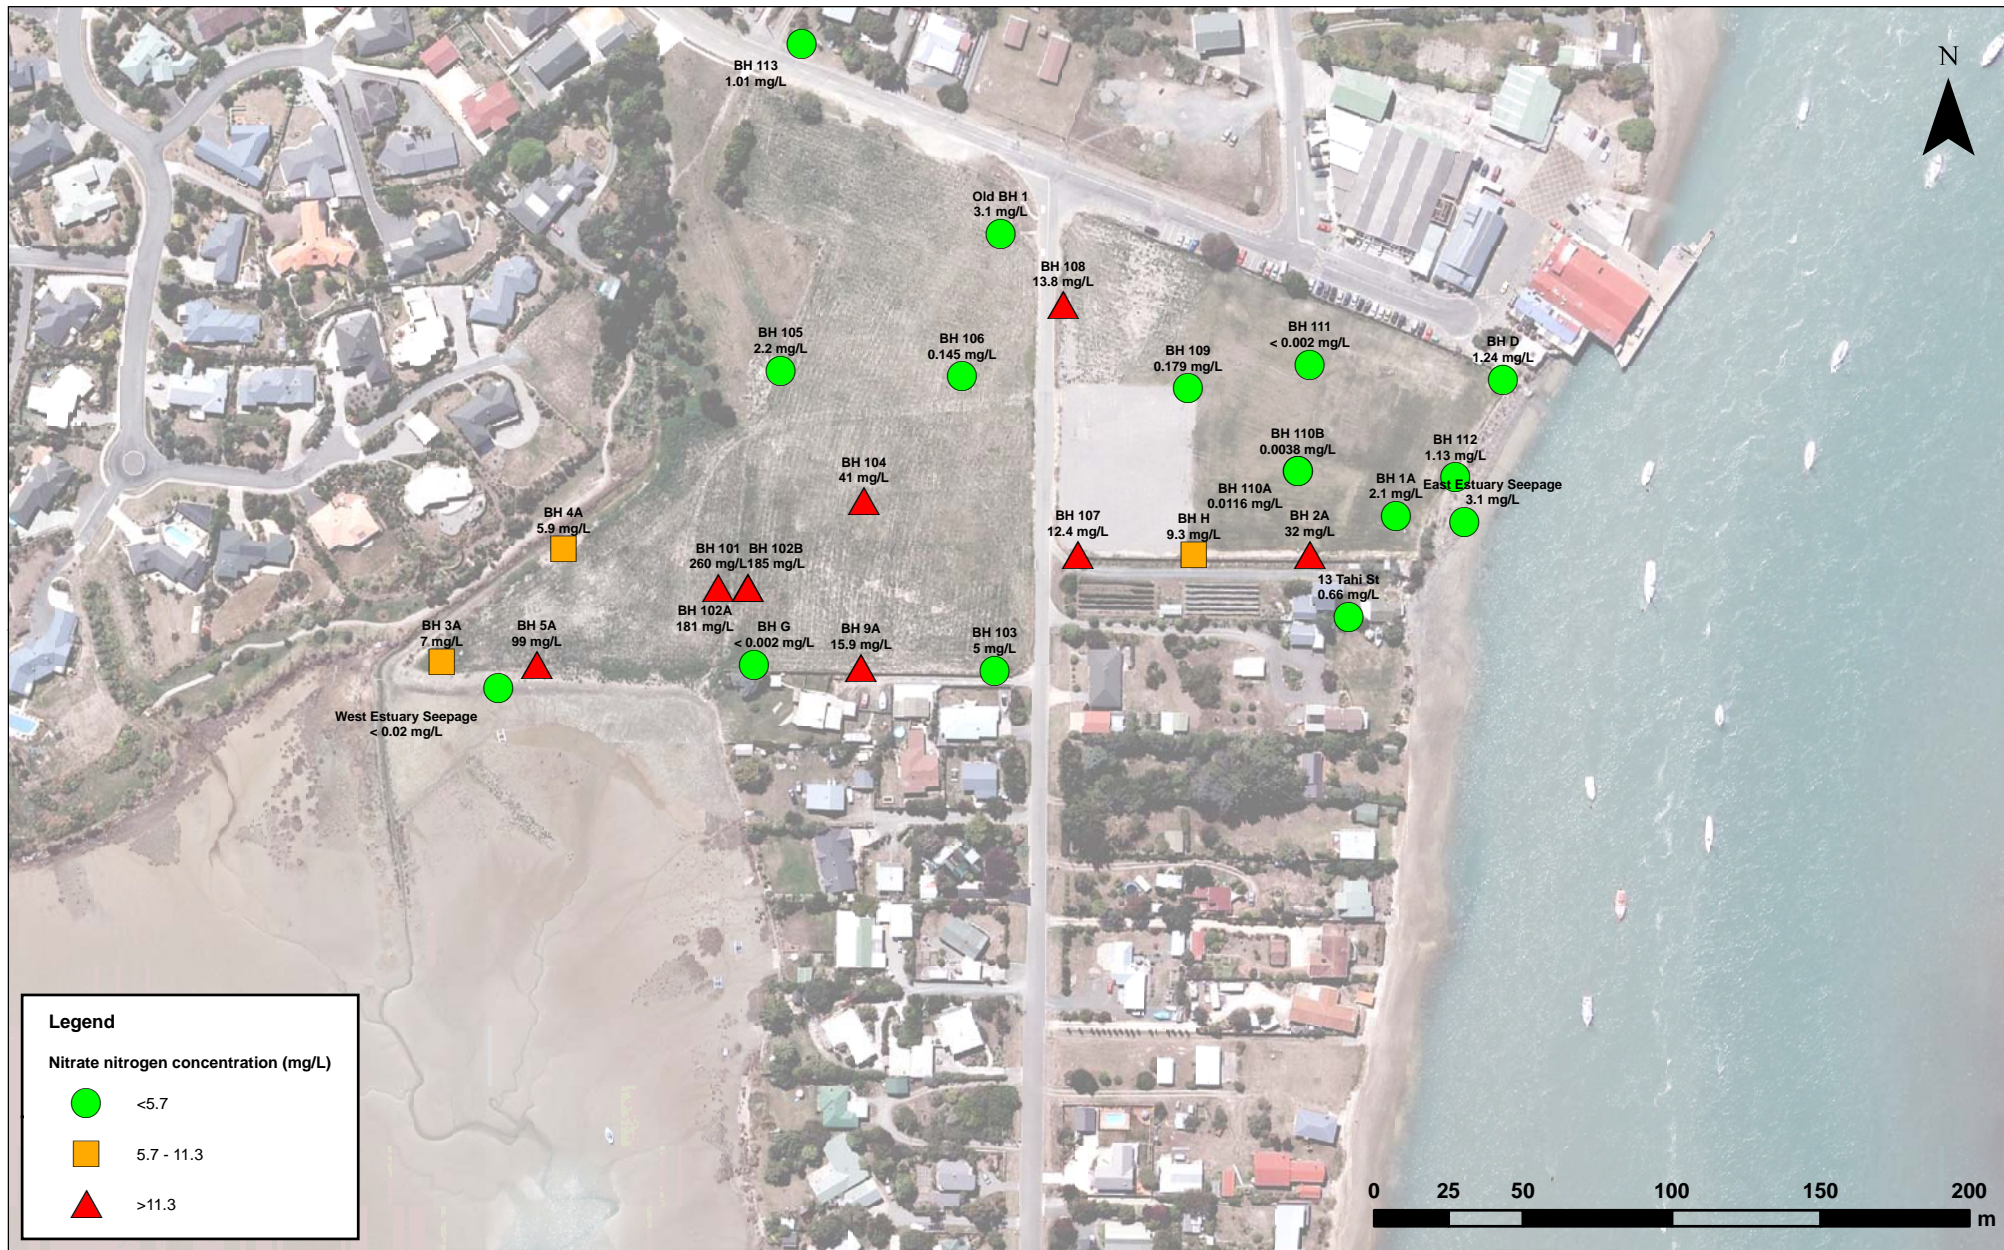
Figure 12 : Nitrate nitrogen concentrations in May 2010

Many of the individual borehole concentrations are lower than the February sampling round, although the general pattern across the site is similar, with low nitrate concentrations generally occurring within the eastern part of the site. More elevated nitrate-nitrogen concentrations occur within the western portion of the site (up to 260 mg/L in BH101, which is significantly less than the 470 mg/L reported in February 2010). This bore is located adjacent to the clay bund around a former landfill area.

Indication of seepage into the Waimea Inlet from nearby boreholes have elevated concentrations (7 mg/L in BH3A and 90 mg/L in BH5A), whereas seepage into the Waimea channel along the eastern side boundary has much lower concentrations (<4 mg/L).

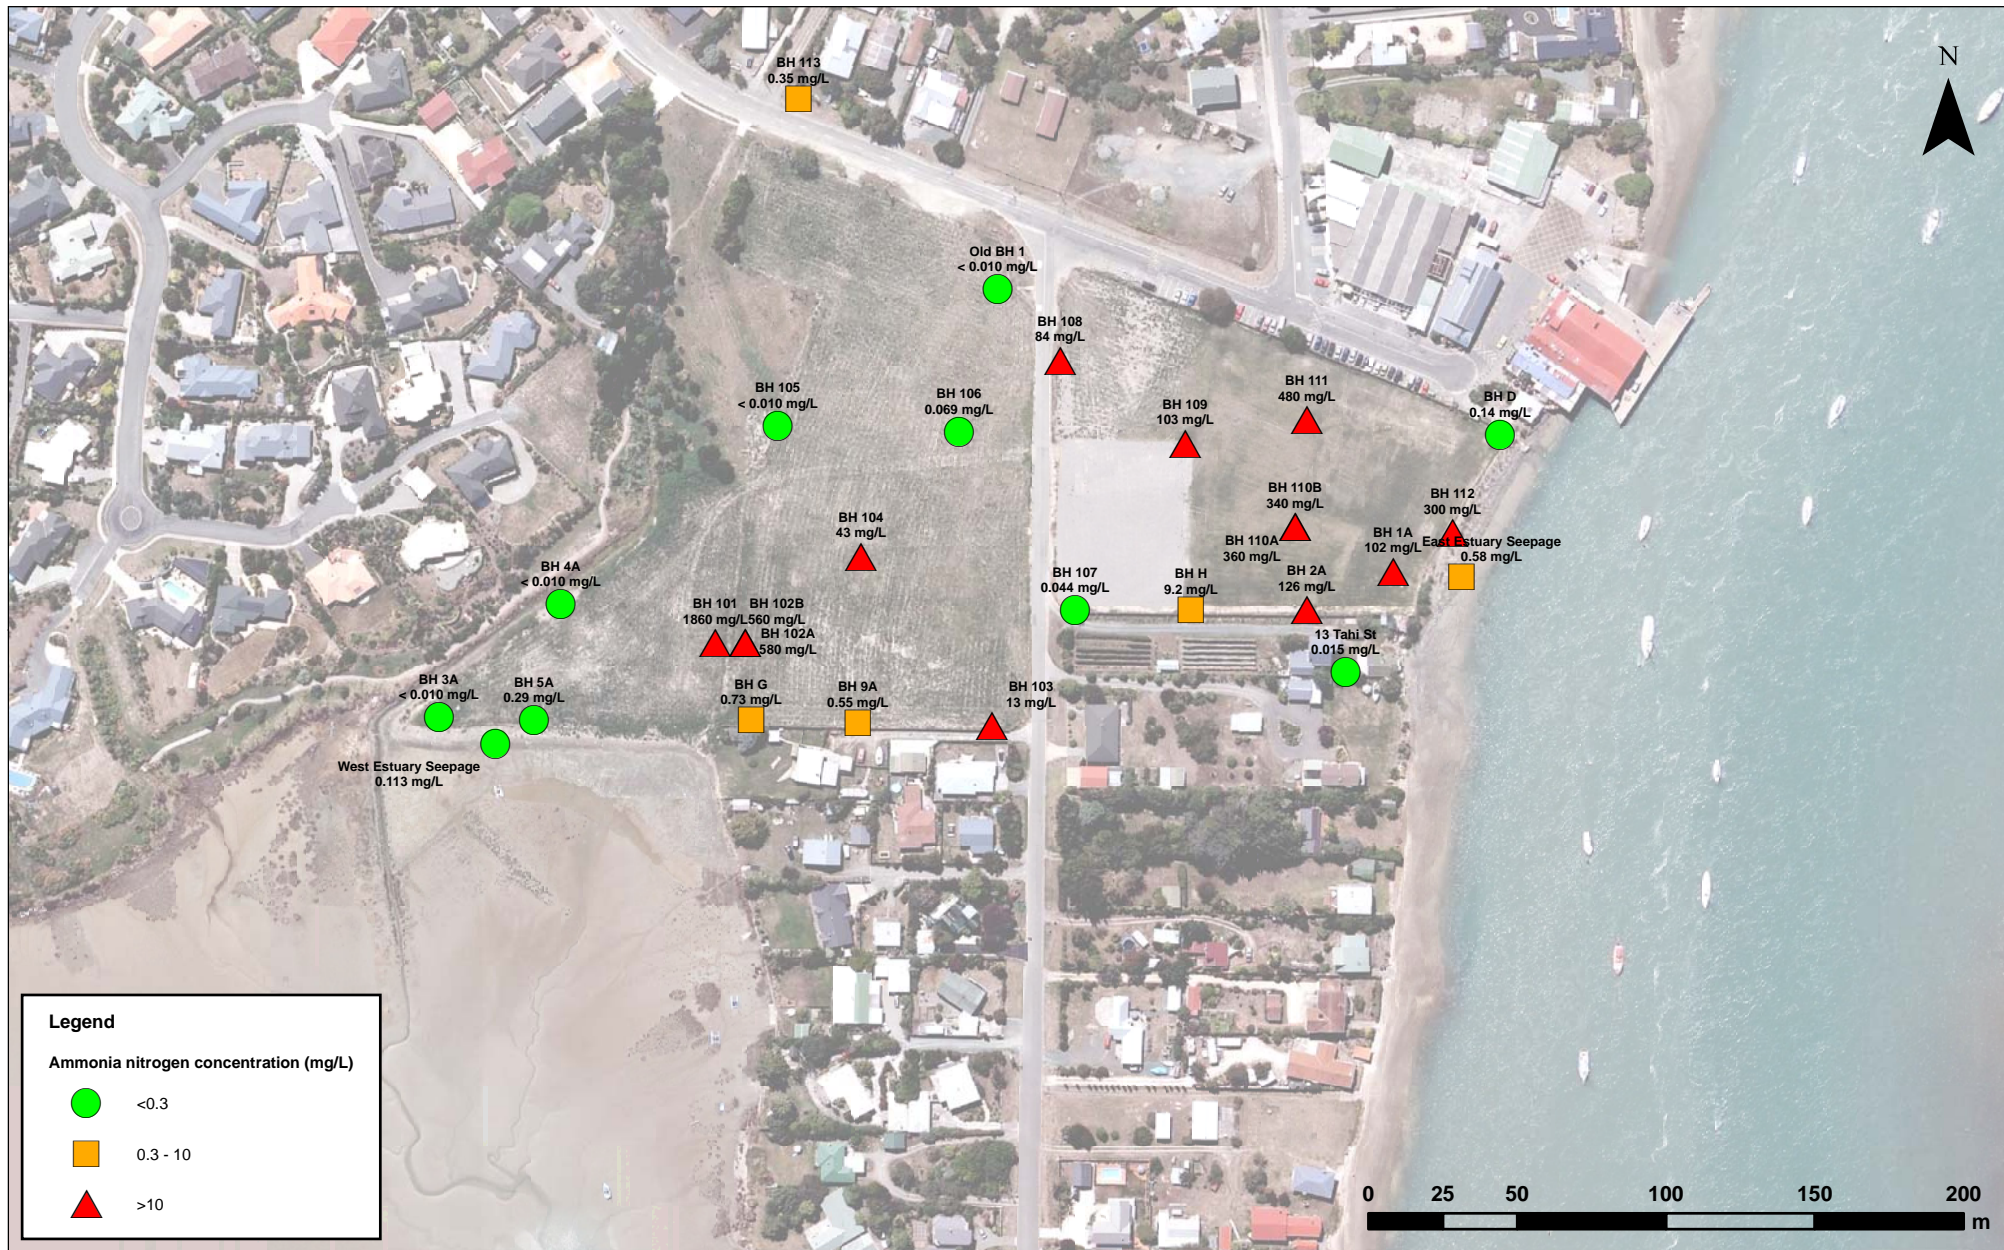
Figure 13 : Ammonia nitrogen concentrations in May 2010

There has been no consistent change since February 2010, with some bores showing increased concentrations and others showing decrease concentrations. The results show elevated concentrations occur in both the east and west of the site, with the highest concentration of 1,860 mg/L occurring at BH101 (down from 2,100 mg/L in February).

The seepage samples indicate elevated ammonia-N concentrations in the east entering the Mapua channel, but much lower concentrations in the west adjacent to the Waimea Inlet.

The ammonia-N concentrations indicate some areas of the site have significantly higher concentrations than the values measured in the regularly monitored bores.

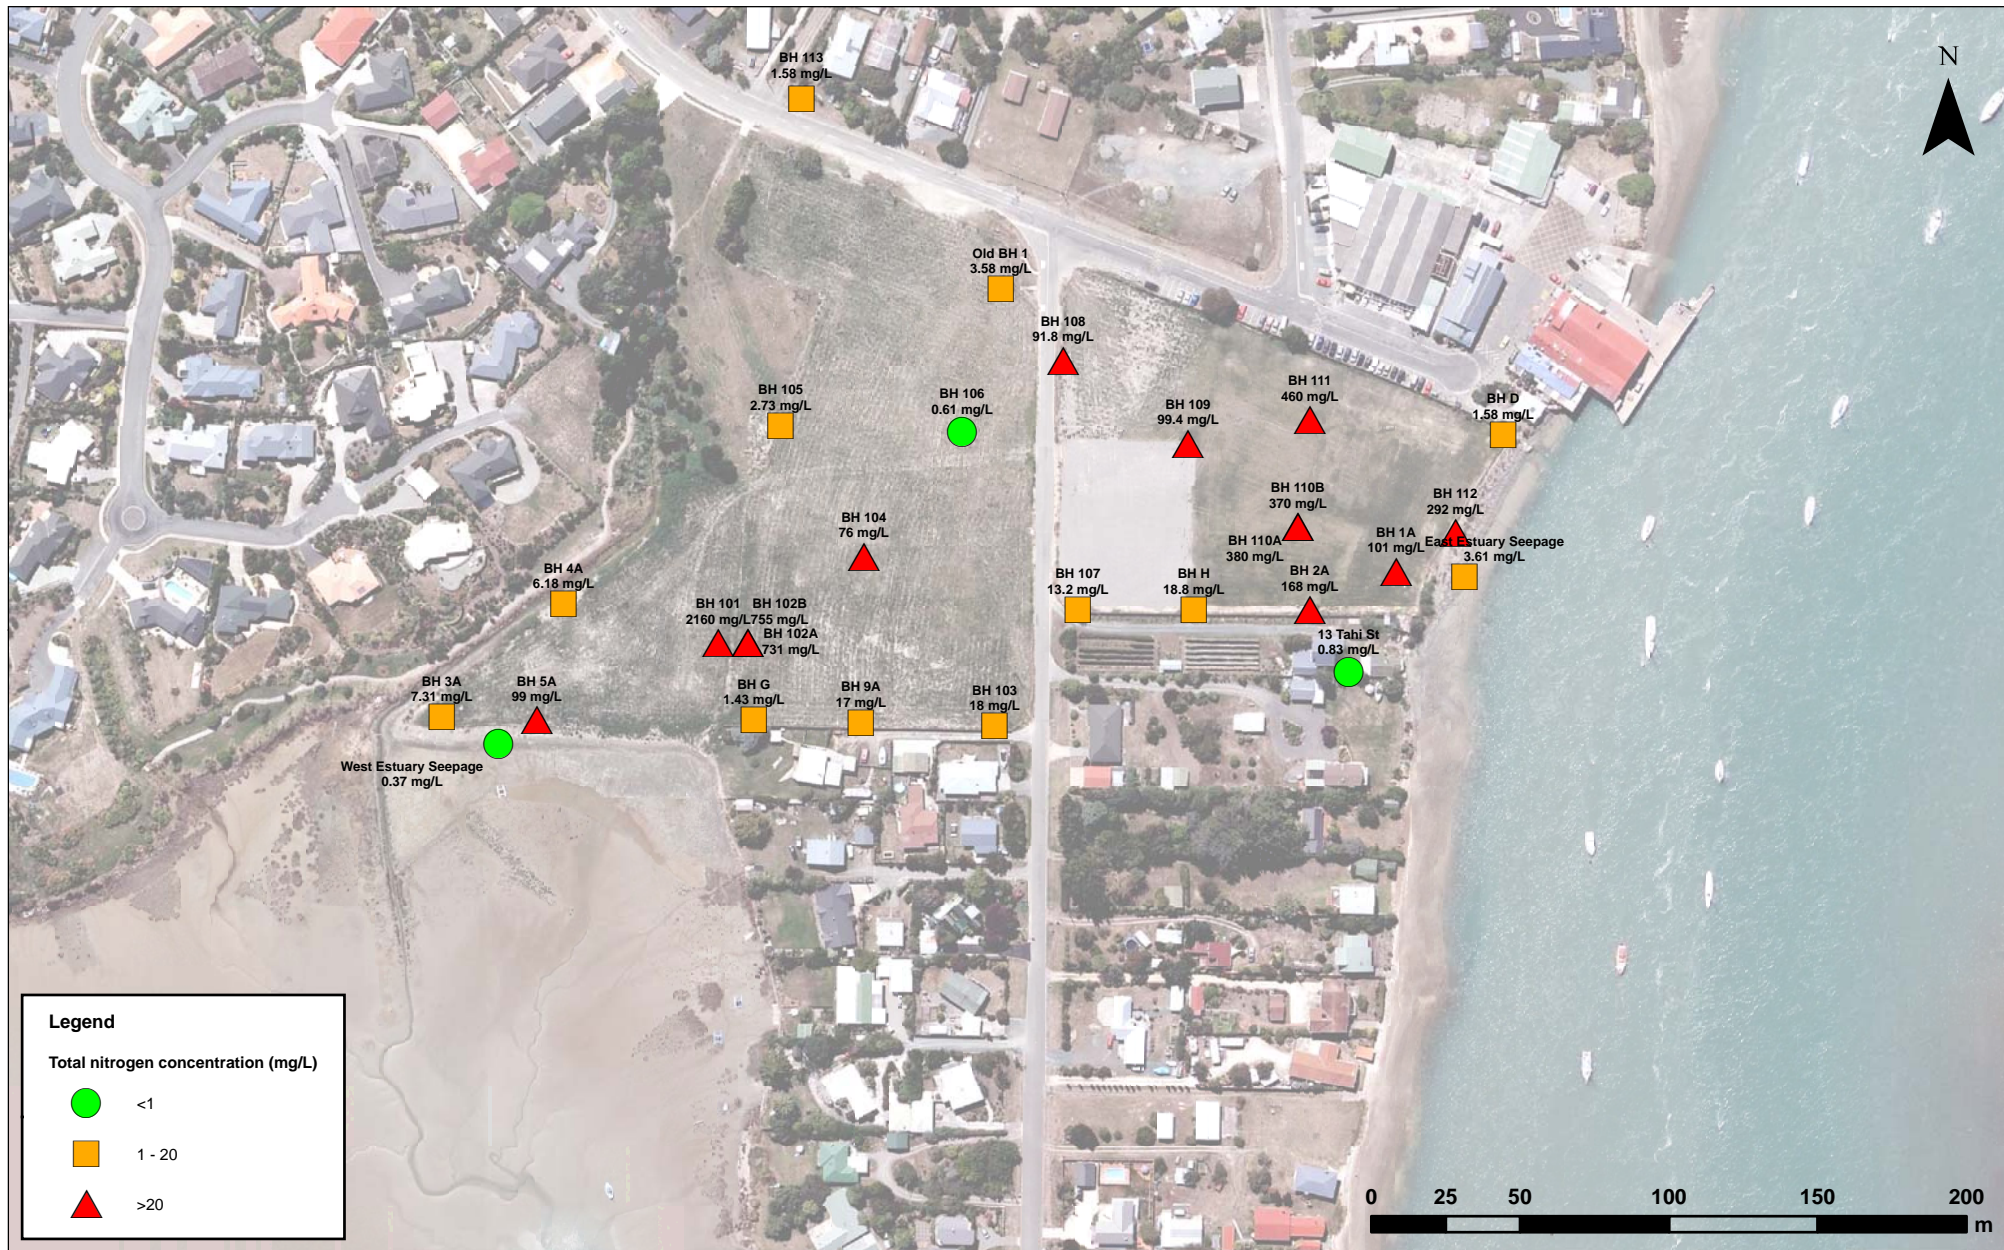
Figure 14 : Total nitrogen concentrations in May 2010

As with the ammonia-nitrogen concentrations, there have been variable changes between the boreholes.

The results indicate that the vast majority of on-site wells have elevated nitrogen concentrations.
