9 June 2010

### **GROUNDWATER MONITORING AT FORMER FCC SITE, MAPUA – MAY 2010 SAMPLING UPDATE**

GROUNDWATER MONITORING AT MAPUA

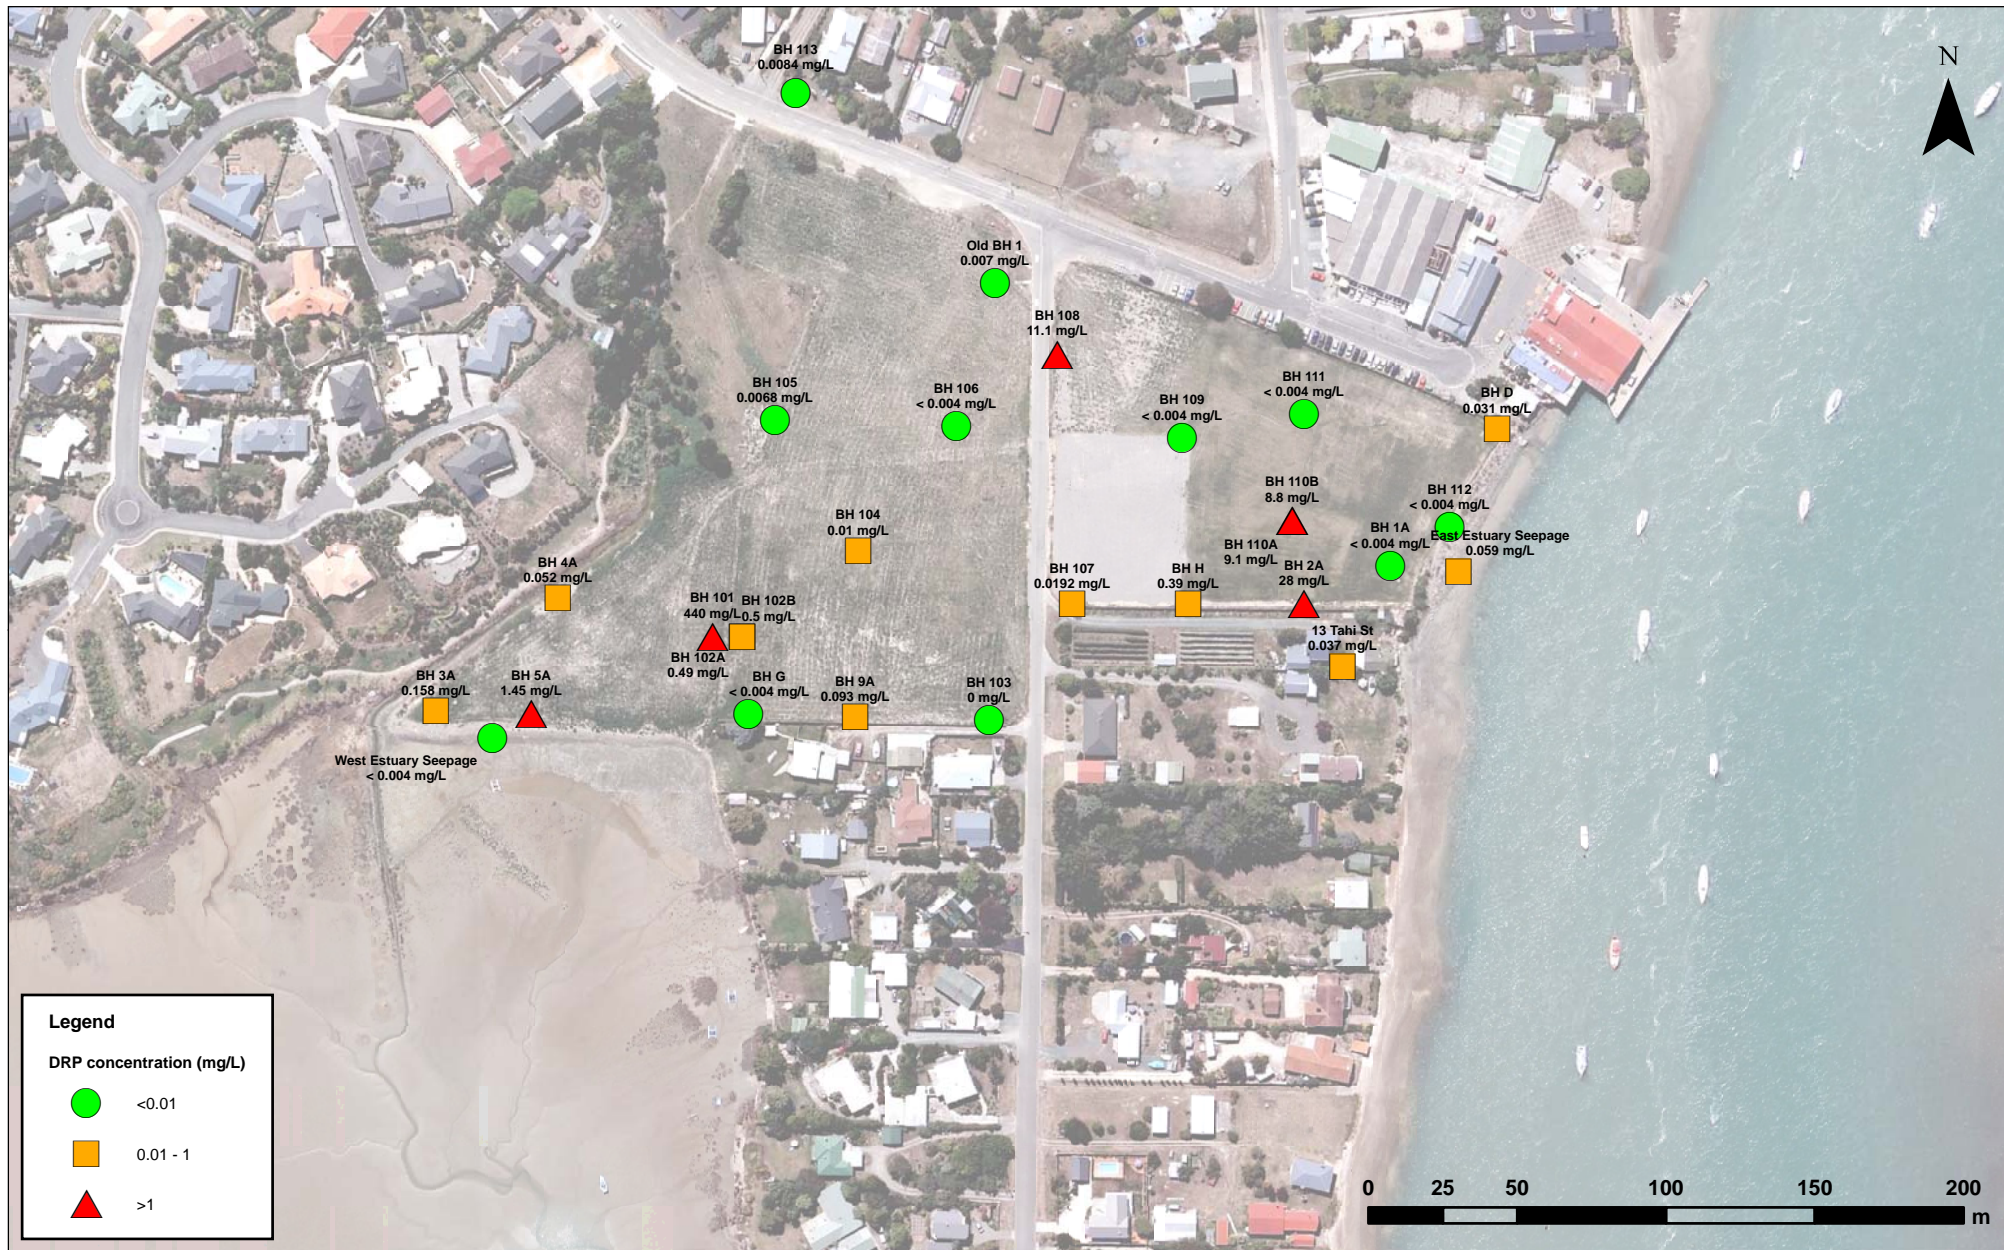
Figure 15 : Dissolved reactive phosphorus concentrations in May 2010

Concentrations have generally been similar to, or lower than, the concentrations in February 2010. Variable concentrations occur across the site, with some low and non-detectable values, and the bores showing localised high concentrations (up to 440 mg/L at BH101).

The eastern seepage sample showed DRP at 0.059 mg/L (above ANZECC guidelines), and the south-western seepage sample had no detectable DRP (<0.004 mg/L), although boreholes adjacent to the Waimea Inlet have variable concentrations up to 1.45 mg/L in BH5A.

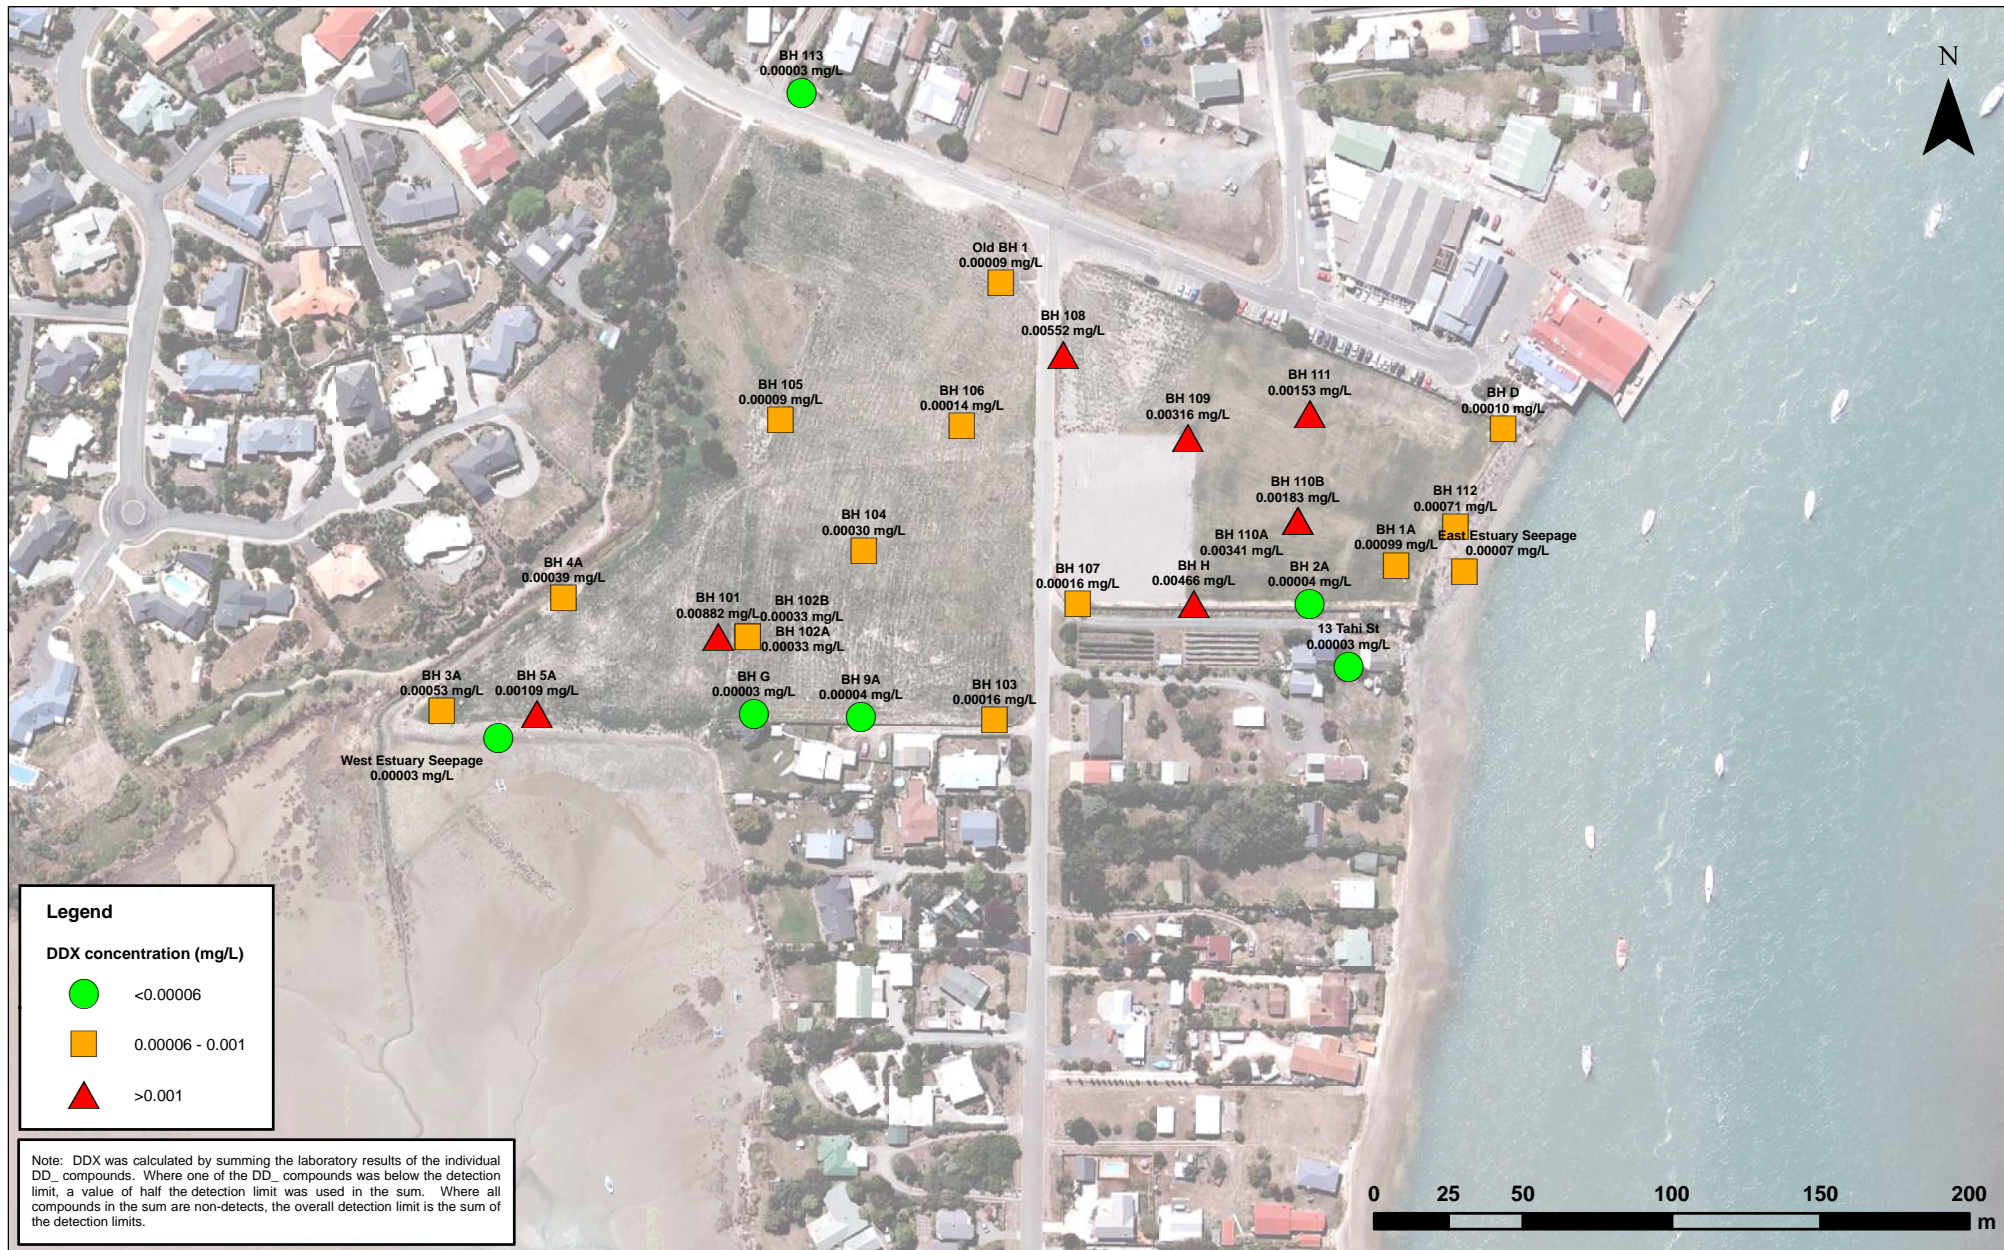
Figure 16 : DDX concentrations in May 2010

There have been some changes in the coding of this figure compared to February, with less red points and less green points, and more in the orange mid-range.

The results show variable DDX concentrations within the site. The variation in concentrations within the site is most likely due to the localised effects of soils with elevated DDX concentrations.

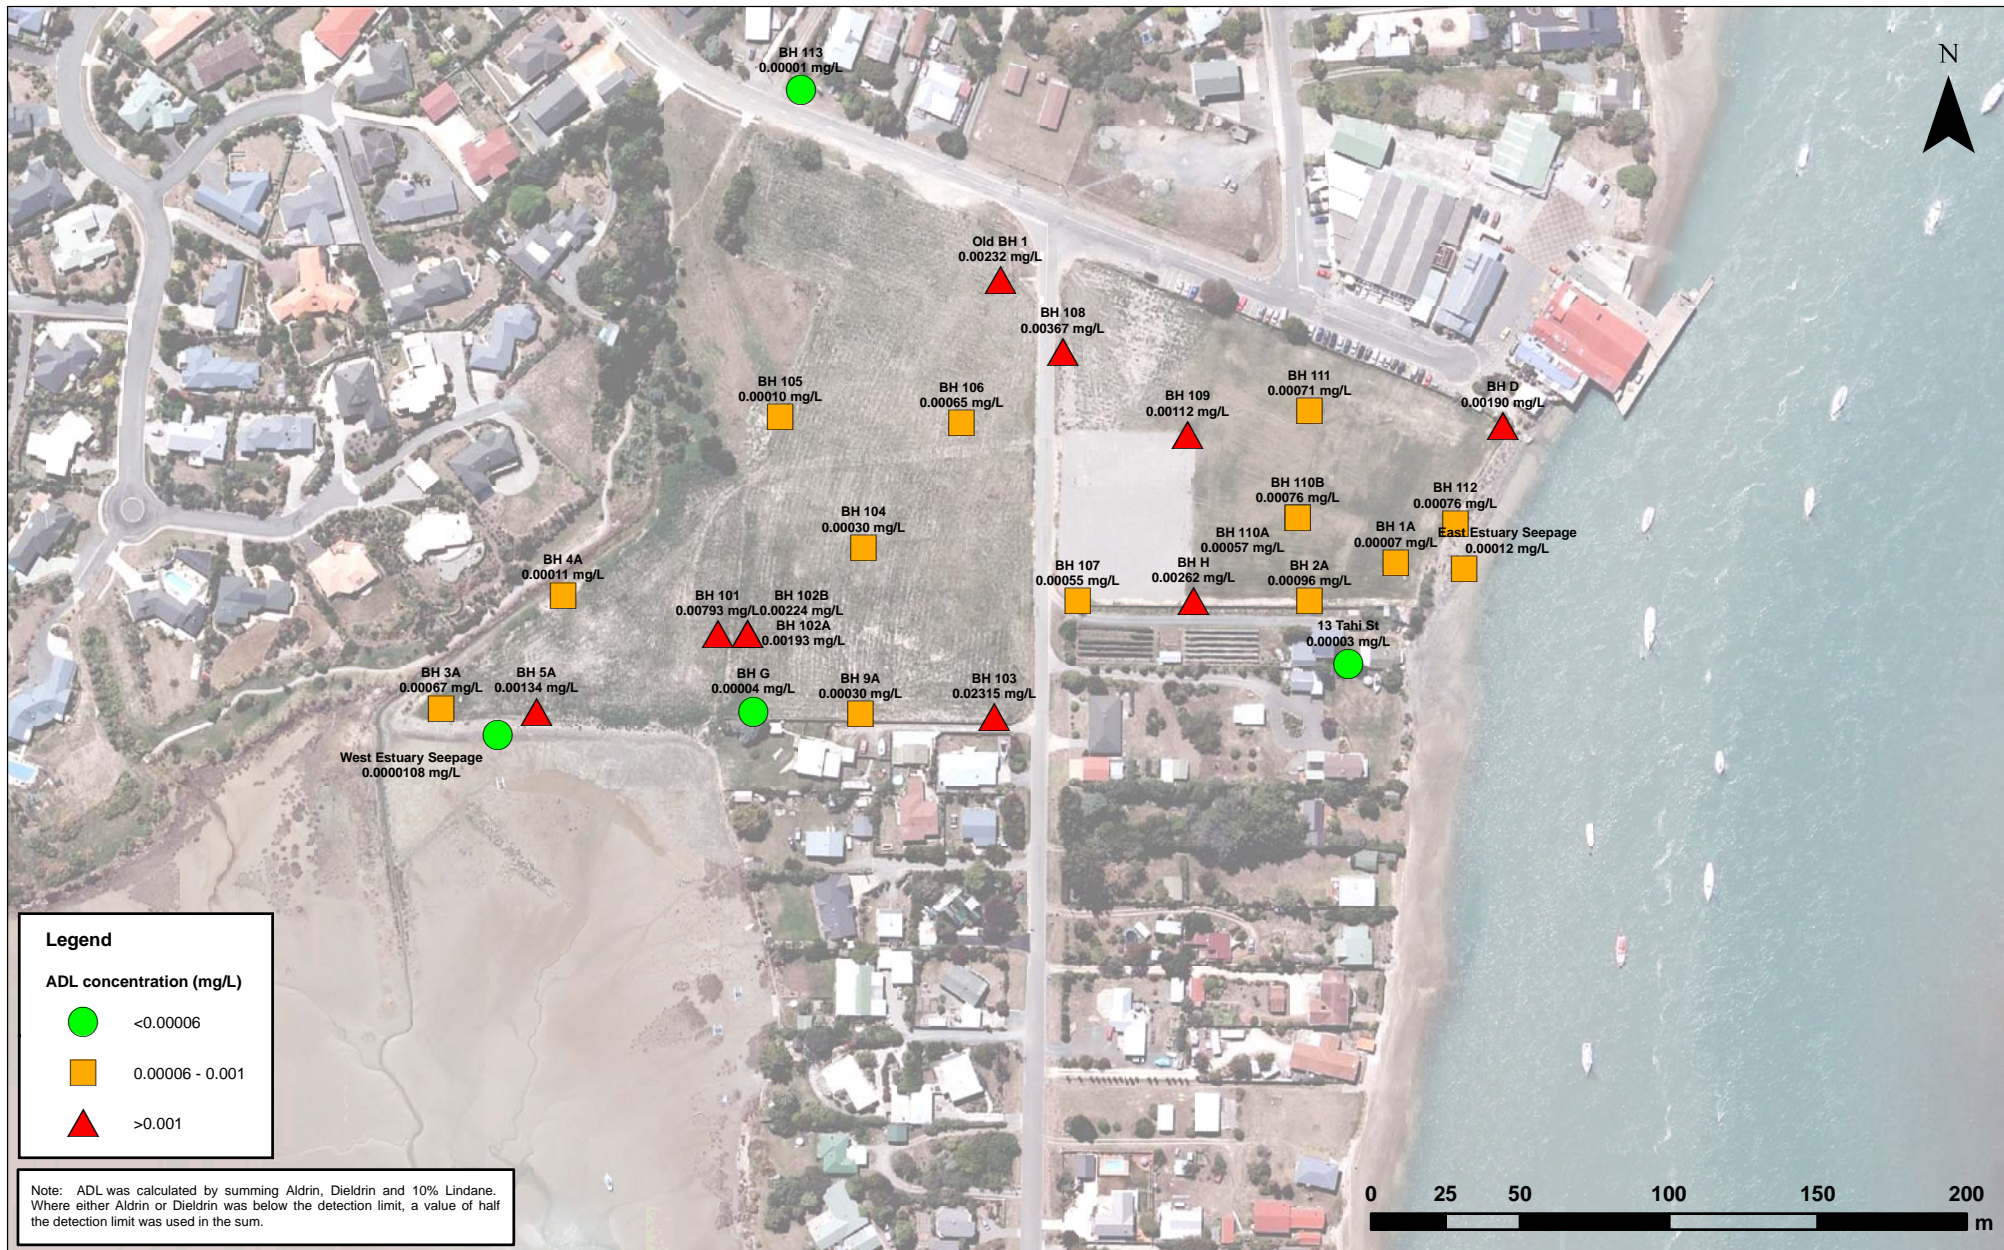
Figure 17 : ADL concentrations in May 2010

As with DDX, the results show variable concentrations within the site, although the pattern from the May sampling round is similar to the February sampling round.

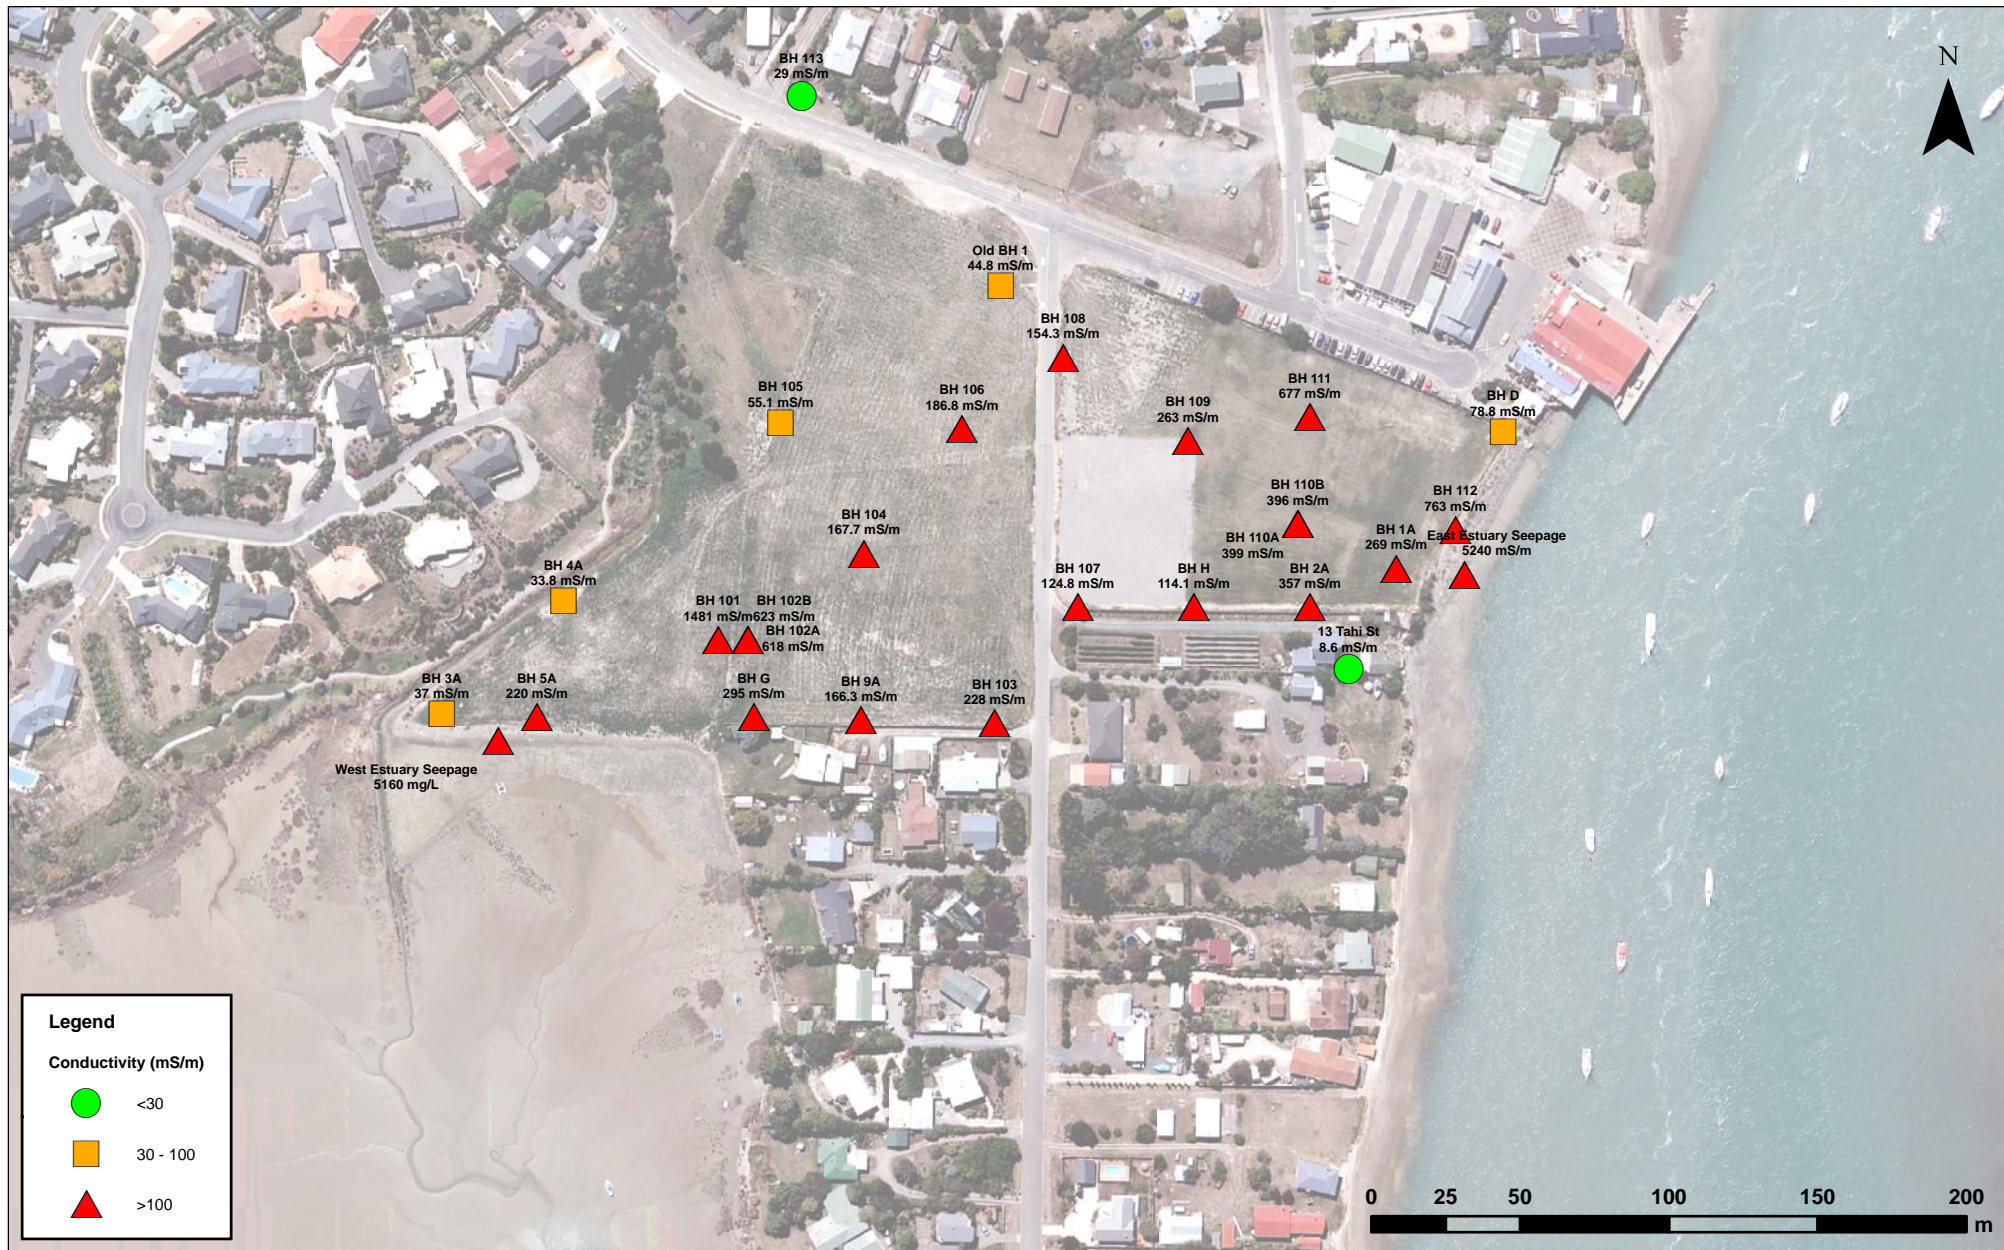
Figure 18 : Conductivity values in May 2010

This plot demonstrates that generally elevated values that occur beneath the site. Higher values have been recorded in the May 2010 round, particularly along the southern boundary of the site adjacent to the Tahī Street properties.

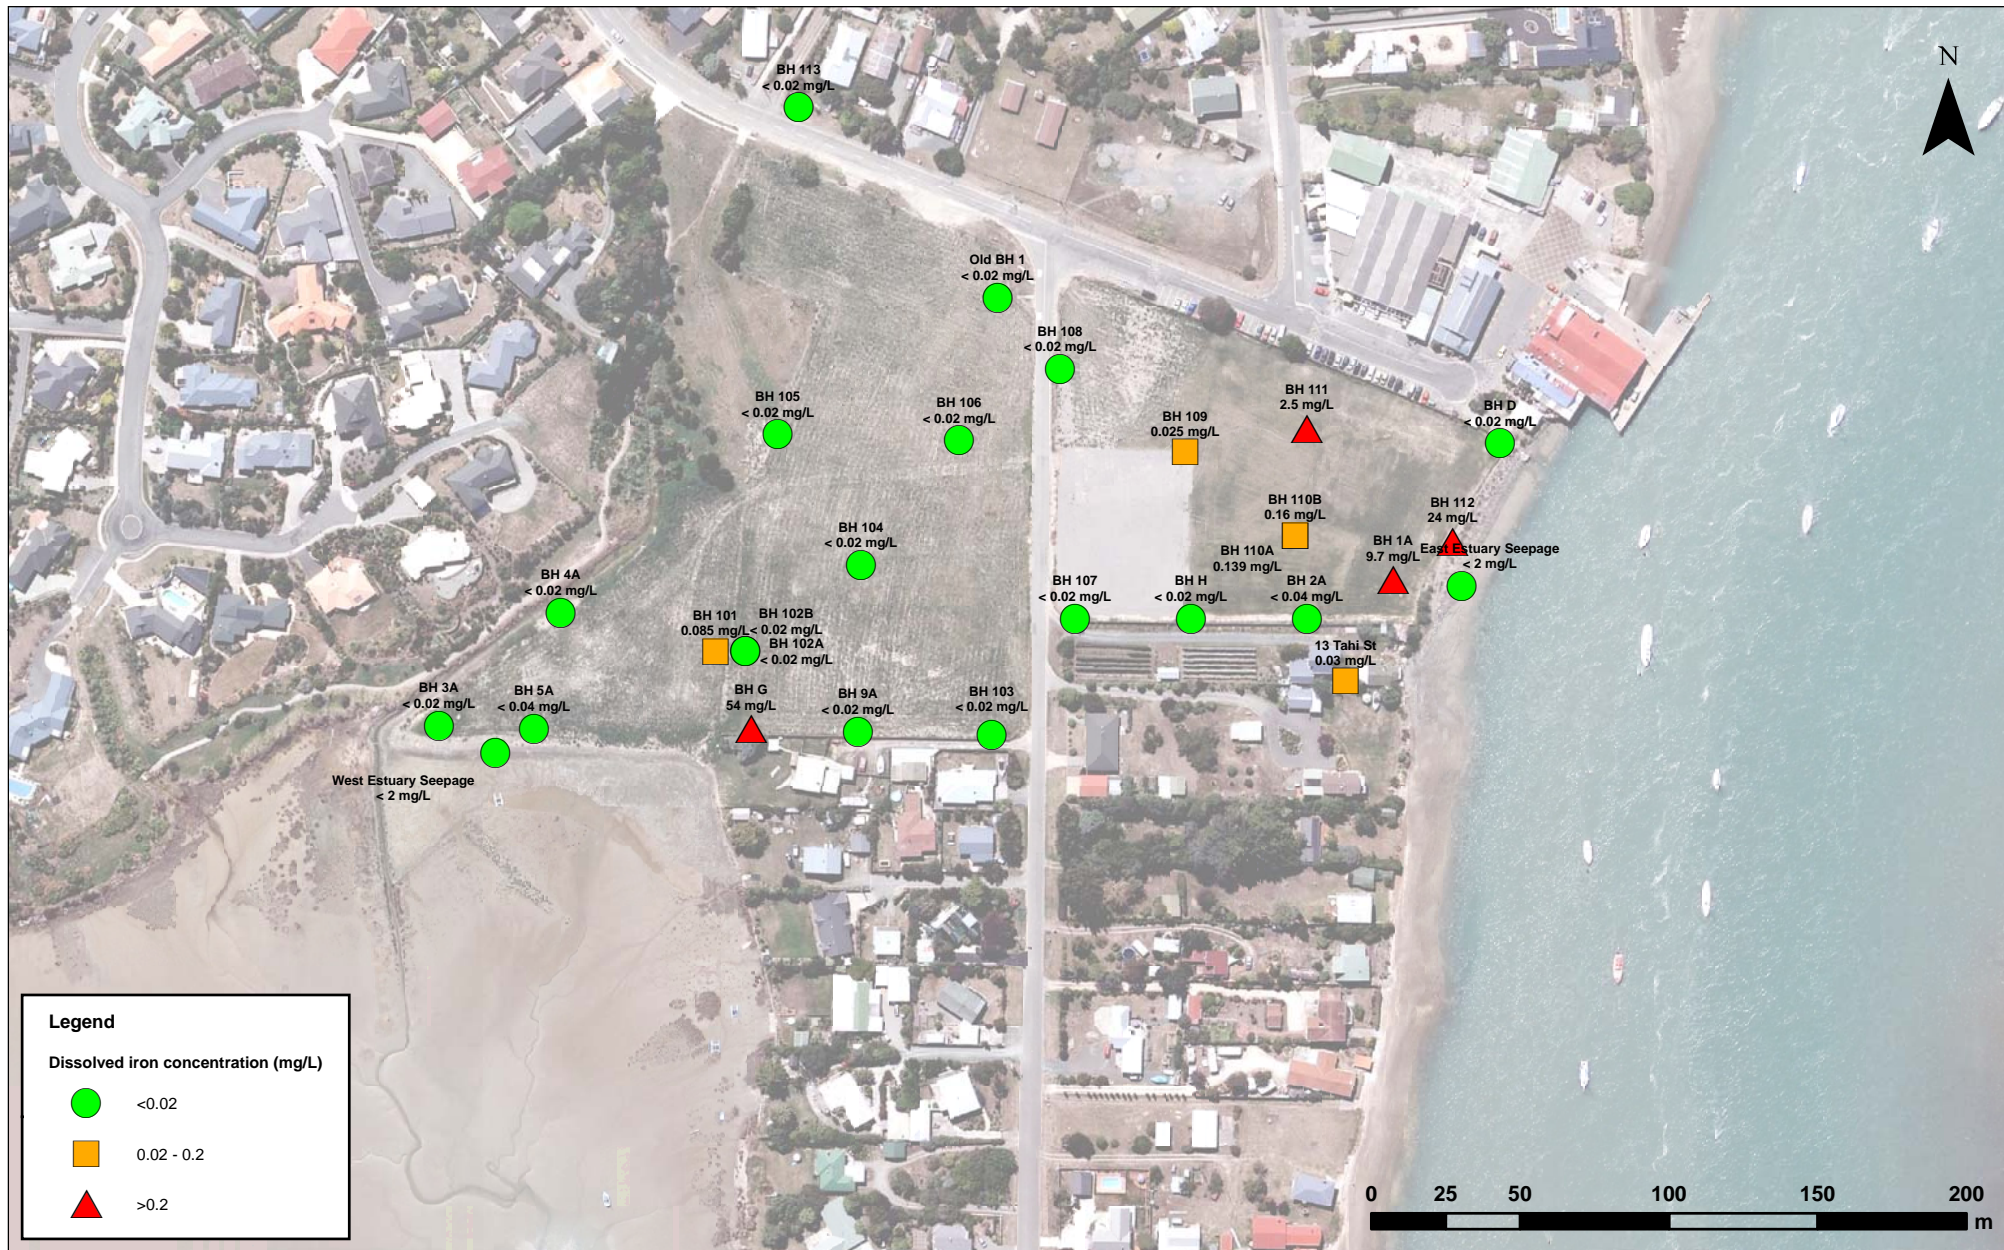
Figure 20 : Dissolved iron concentrations in May 2010

The results show generally low concentration across the site, although four significantly higher values occurred at BHG and at three eastern sites (BH1A, BH111 and BH112).
