Waimea Water Augmentation
Committee

Lee Valley Dam
Detailed Design Geotechnical
Investigation Report

Volume 1

July 2014

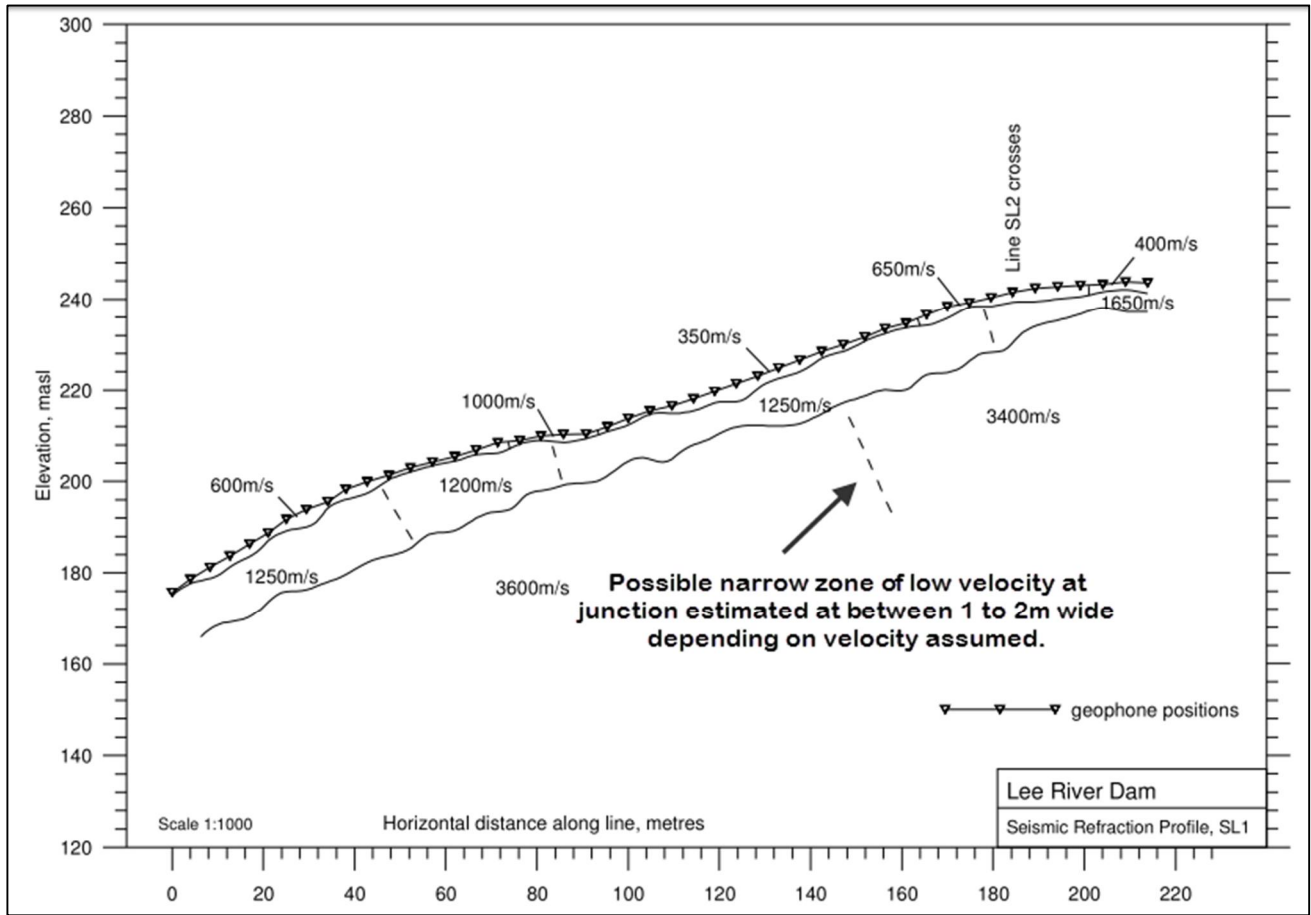
Figure 4: Seismic Line SL 1 (Spillway)

SL 1 located close to the spillway centreline shows a 10 to 20 m thickness of lower velocity rock ranging from 1200 m/s to 1250 m/s which is interpreted as either a dilated and/or weathered rock mass. This is underlain by a higher velocity zone of 3400 m/s on the upper slopes and a 3600 m/s zone on the lower slopes. A 1.5 millisecond time step was observed in the bedrock at the junction between the 3400 m/s and 3600 m/s velocities at about Ch 150 m on the survey line. This could be interpreted as a 2m wide zone with a velocity of 1000 m/s or a 1m wide zone with velocity of 600 m/s.

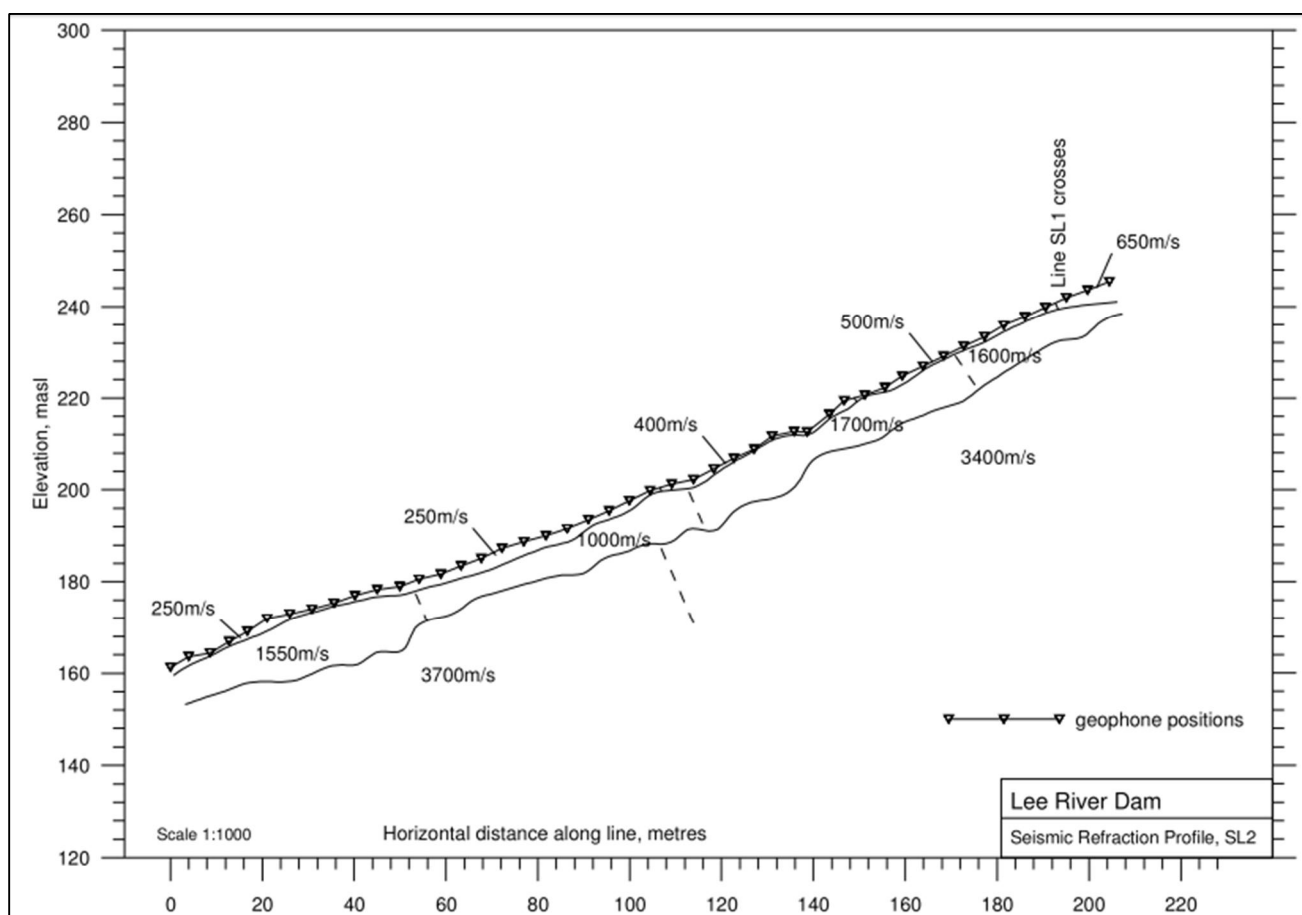
The second line SL 2, located along the left abutment plinth line, shows 8 to 10 m of lower velocity materials overlying bedrock. There is no obvious indication of "terrace gravels" in the seismic data. However, they were identified in the feasibility investigations, to be present near the downslope end of the 1000 m/s zone between Ch 50 m and Ch 90 m on the survey line.

Figure 5: Seismic Line SL2 left abutment plinth line

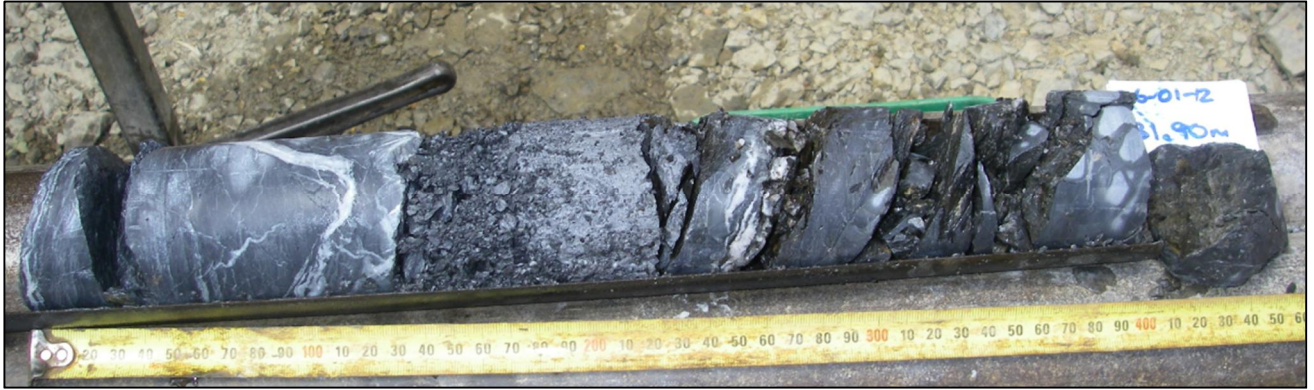
The present phase of drilling investigations was focused on the plinth excavation/plinth line and DH10 drilled as part of this phase intersected a significant sheared zone at 31.6 m which may indicate that one of the zones mapped in outcrop on the right bank of the river crosses the right bank plinth excavation at Chainage 220m. This sheared zone in DH10 comprises 100mm of plastic clayey gouge with angular rock fragments throughout. This is typical of crushed zones in greywacke terrain; the gouge is usually well graded with a low clay content, which gives rise to a low plasticity. The amount of clay present in the gouge zones increases towards the most recently active planes of shearing. The gravel content usually consists of angular, interlocking blocks of mudstone/siltstone. Photographs of this sheared zone is presented in figures 11 and 12.

Figure 11: DH10 sheared zone at 31.6 m as recovered.

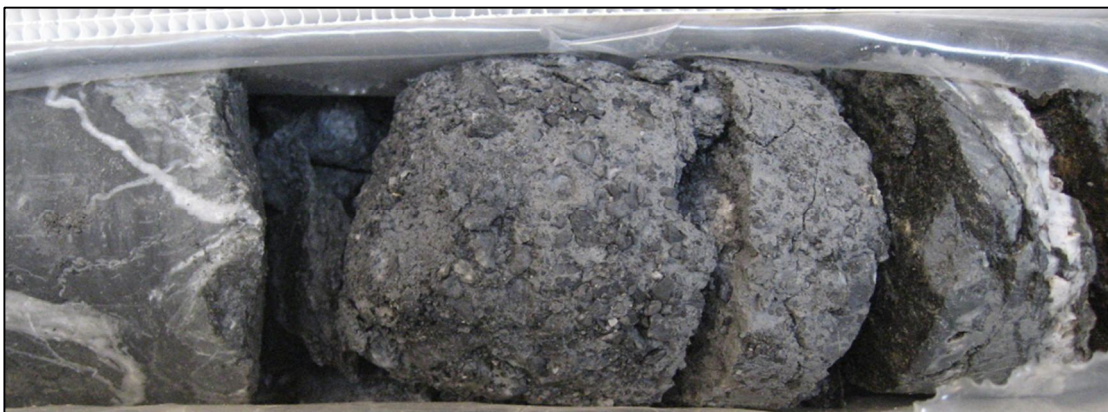
Figure 12: DH10 Shear zone with plastic clayey gouge and rock fragments at 31.6m

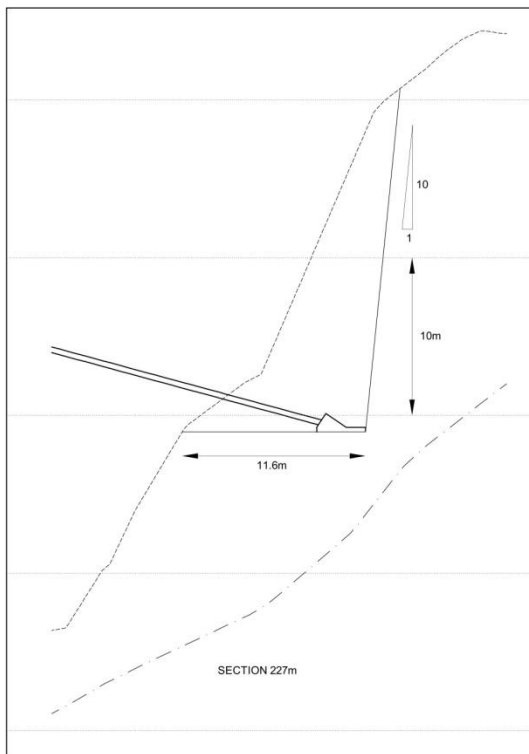
Figure 28: Plinth cut at Station 227 (right abutment)

The analyses indicate that a face pressure of 2.4 tonnes/sq m is required for wedge A and 1.0 tonnes/sq m for wedge B to achieve a static FOS = 1.5. However, face mapping will be required as the plinth excavation is progressively undertaken and support requirements will need to be designed for the specific defects encountered.

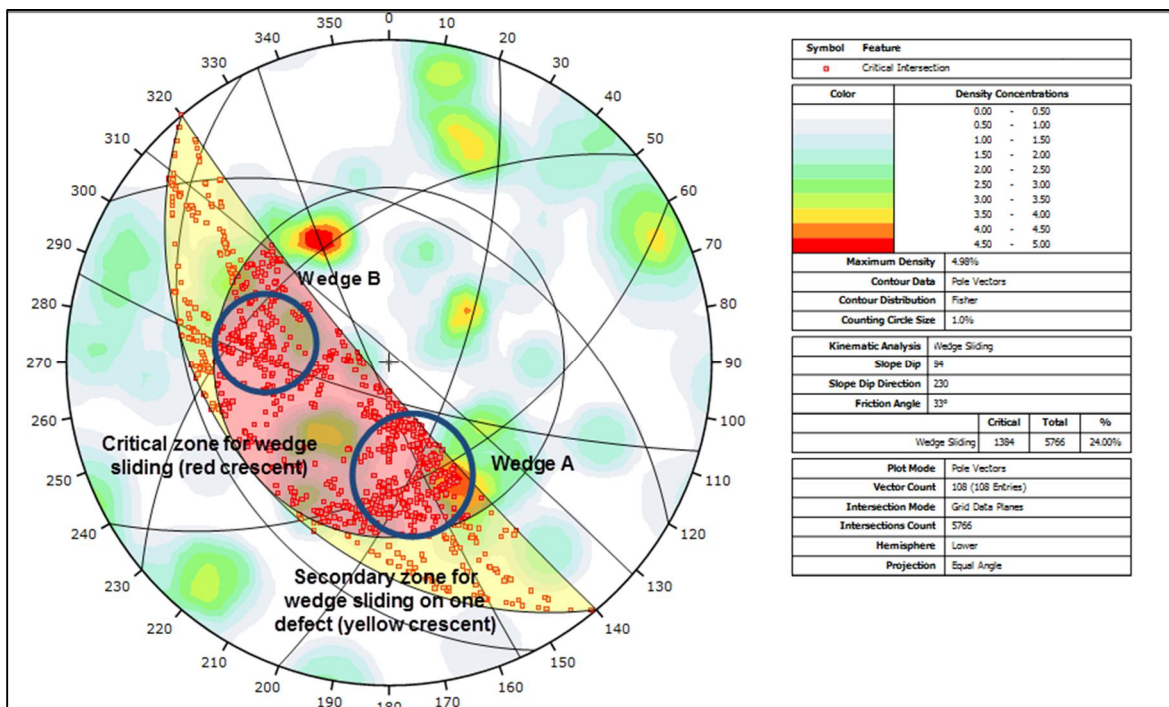
Figure 29: Stereonet of right abutment defect data showing potential wedges at intersections of major defect sets at section 227 of the plinth excavation.

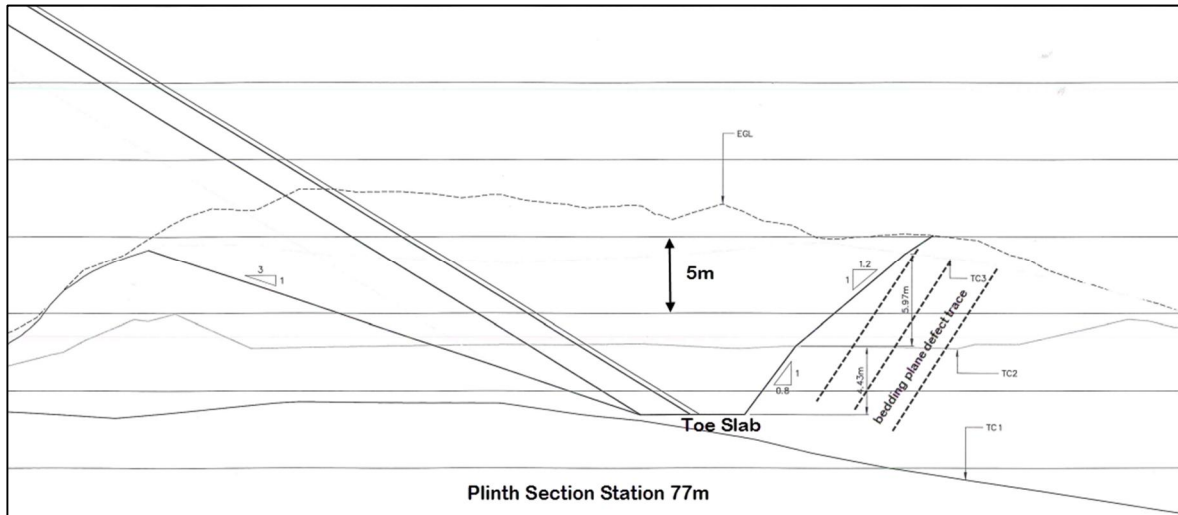
The design for cut slopes for the left abutment plinth excavation is shown in Figure 30 for Station 77 where the cut is highest. The upstream face of the plinth excavation will be cut at 1V:0.8H (51°) for the lower 4.5m with the balance to ground surface cut at 1V:1.2H (40°). The trace of bedding plane defects is sub parallel to the cut batter and local drapes of wire netting may be required to contain loose blocks of rock.

Figure 30: Plinth cut at Station 77.

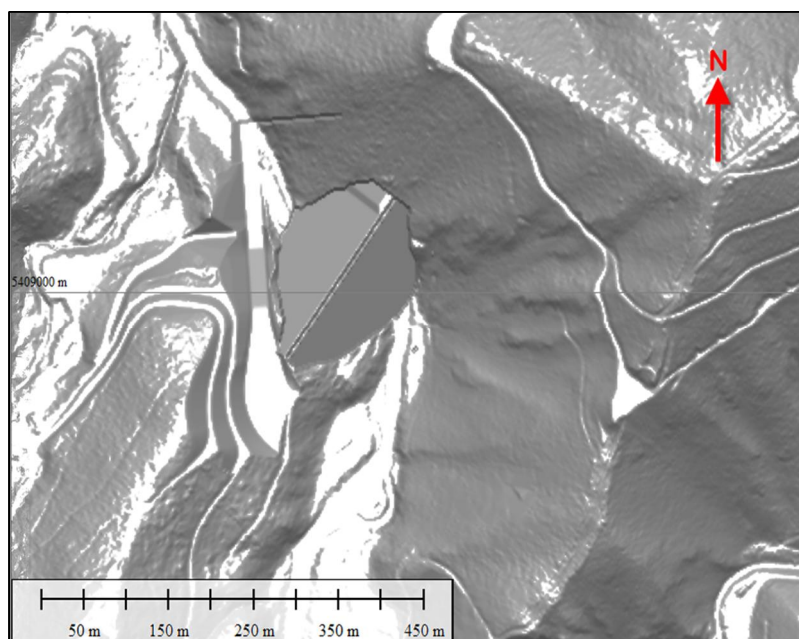
The slopes above the right abutment are moderately steep at 40° with bedrock exposed in ribs and scree in chutes between the ribs. The top of the ridge is 150m above reservoir level. The slopes have been recently clear felled of exotic (pine) trees and may be replanted in the near future. While steep there are no indications of deep seated instability (see Figure 31). However, TP7 excavated at the toe of the slope encountered a 7 m thickness of scree overlying disturbed/displaced bedrock. At an overall slope angle of 40° debris will be more inclined to slide/roll than bounce down the slopes while clear of vegetation.

Figure 31: Final slope shape model following dam construction showing shallow instability features upstream of the right abutment.

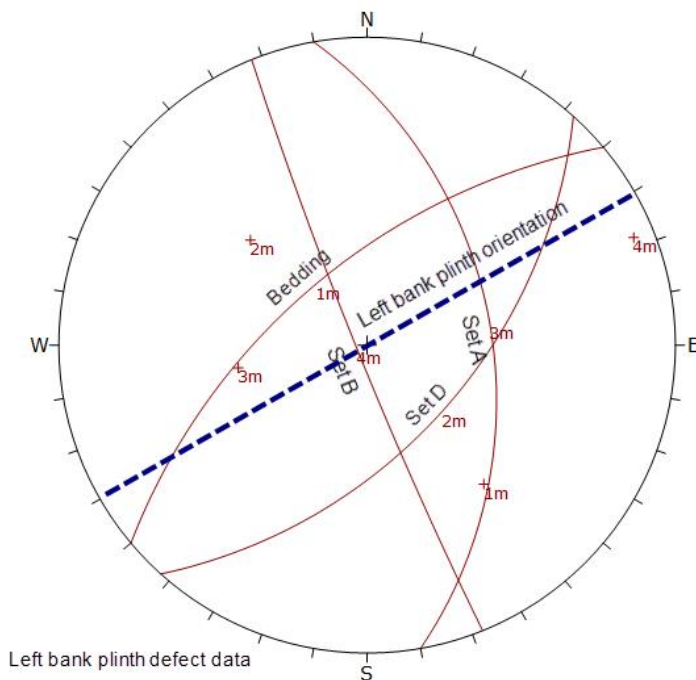
The main defect sets that may control water leakage on the left abutment are bedding partings (and associated crushed zones) dipping $60^\circ \rightarrow 320^\circ$ and joints conjugated to bedding $55^\circ \rightarrow 135^\circ$ and normal to bedding $42^\circ \rightarrow 070^\circ$ as shown on the stereonet below (Figure 32). The more significant joint set is judged to be the $42^\circ \rightarrow 070^\circ$ set oriented at right angles to the plinth excavation. It should be noted that the dips and dip directions provided are mean values and variations are likely to occur on site. Drill holes DH12A and DH13A were oriented to pass through this defect set at more or less at right angles. Thus the Lugeon numbers from testing in these drill holes reflects the water leakage potential along this defect set.

Figure 32: The mean orientations of the main defect sets on the left abutment plinth

Based on this information it is recommended that the grout holes have a similar orientation to DH's 12A & 13A, which is at moderate angles to the southwest.
