**BEFORE AN INDEPENDENT HEARINGS COMMISSIONER
AT NELSON**

**STATEMENT OF EVIDENCE OF IAIN CAMPBELL ON BEHALF OF VALLEY RESIDENTS AGAINST
GRAVEL EXTRACTION (PRODUCTIVE SOILS)**

Dr Iain Campbell
Land & Soil Consultancy Services
46 Somerset Terrace, Stoke
Nelson
June 2017

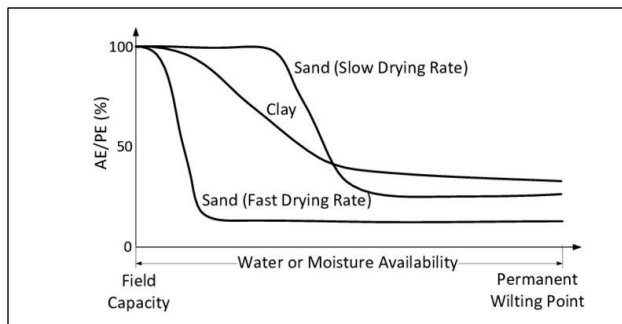
62. There is an extensive world-wide scientific literature relating to the reinstatement of disturbed land and compaction is seen as a universal problem. Soil materials with clayey textures are especially vulnerable to compaction because it is very difficult to achieve a moisture content that is low enough to avoid compaction when the soil is compressed during backfilling. The figure below illustrates a drying curve for a clay textured soil, with less than 35% moisture content becoming difficult to achieve (a moisture content of 15% is acceptable for earth bricks made from clay).

(Source: Canadian Geotechnical Journal 1997 34: 144-155)

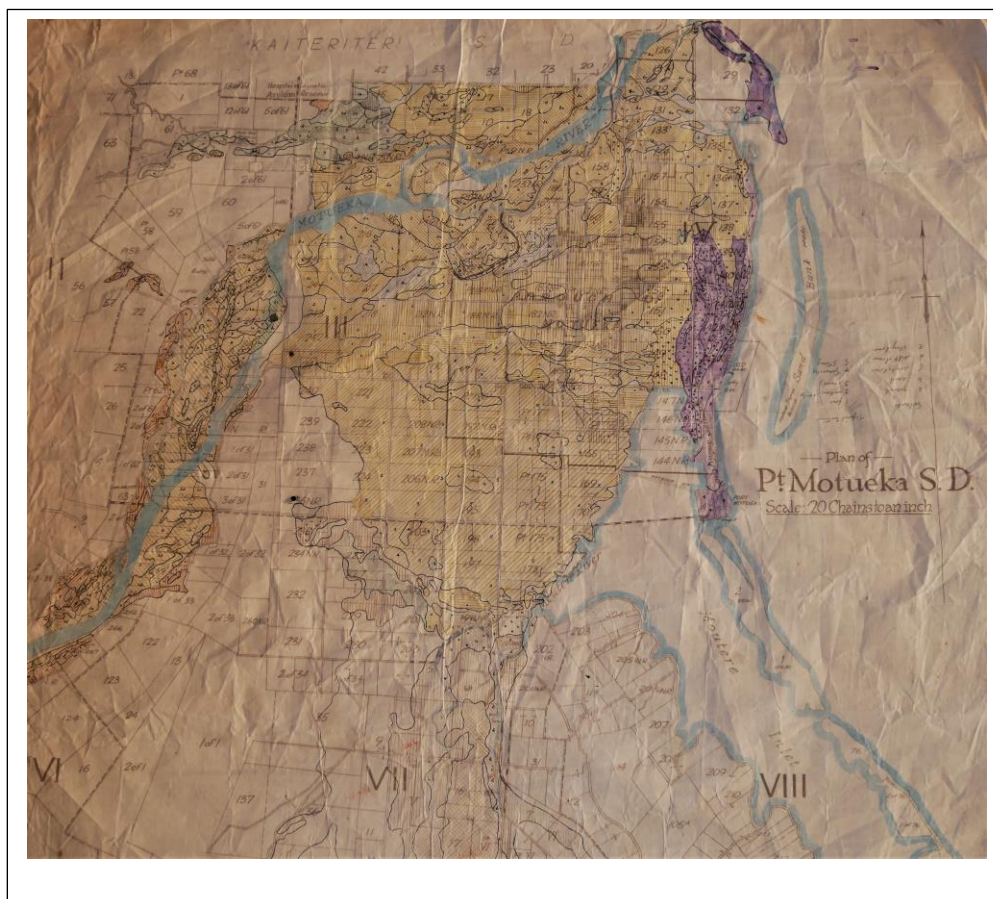
Figure 1. The unpublished original soil map of part of the Motueka Plain area is a compilation from the field work that was undertaken by the Cawthron Institute in the 1950's.

The published map (Chittenden, Dodson & Hodgson Soil Bureau Bulletin 30, 1966) that shows the Riwaka soils on the Motueka Plain was derived from this early compilation sheet.

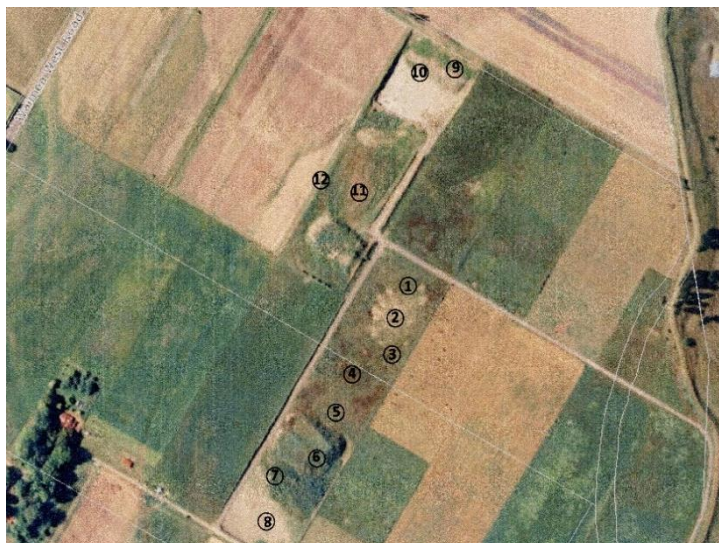
Figure 1 location of sample sites

possible with the existing conditions. At each pit (sites 1-10) a sample of the subsurface materials (12 samples) and restored soil from 2 sites (2 samples) were collected for chemical analyses.

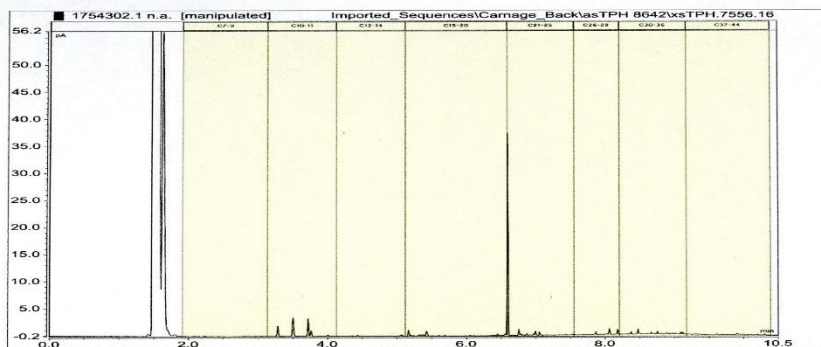
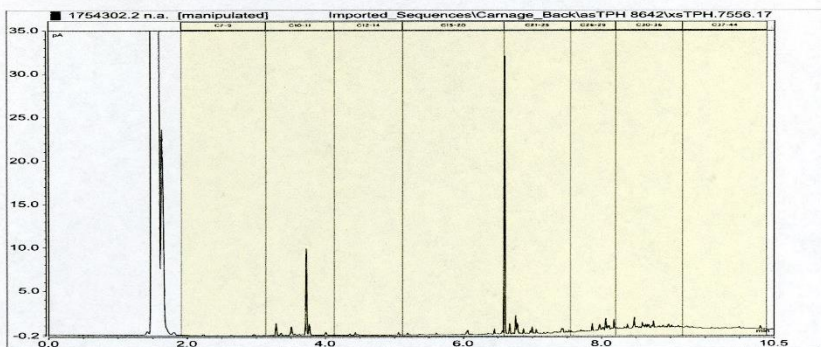
1754302.1
 SG 1 Random Fill 21-Mar-2017
 Client Chromatogram for TPH by FID

1754302.2
 SG 2 Random Fill 21-Mar-2017
 Client Chromatogram for TPH by FID

1754302.4
 SG 4 Random Fill 21-Mar-2017
 Client Chromatogram for TPH by FID

Carbon particulates were observed in the matrix of sample 1754302.1 and .2 and this has absorbed some of the System Monitoring Compounds in the PAH, e.g. the recovery of Anthracene-d10 was 7% and 32% respectively. Therefore the results presented for these analytes may not represent the actual concentration in the sample.

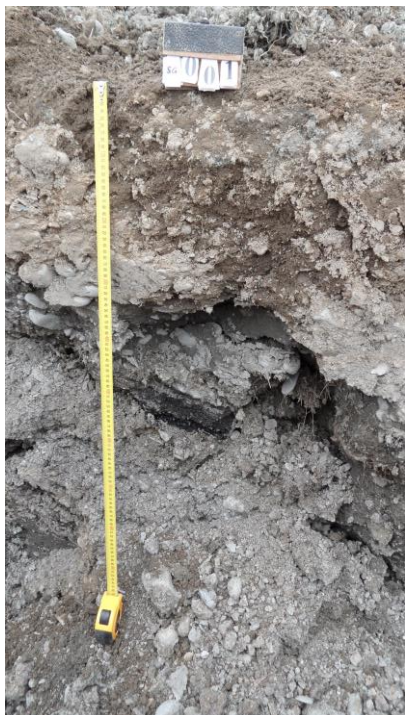
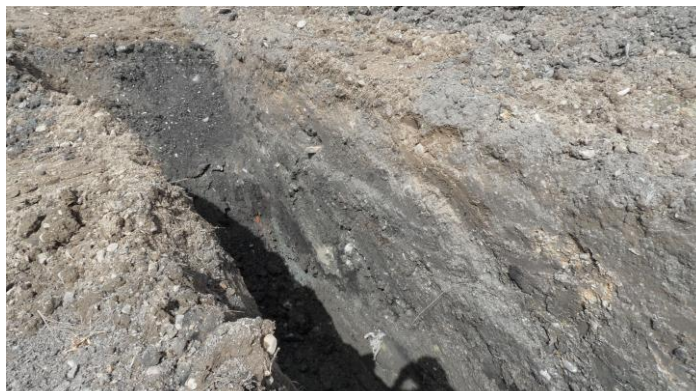
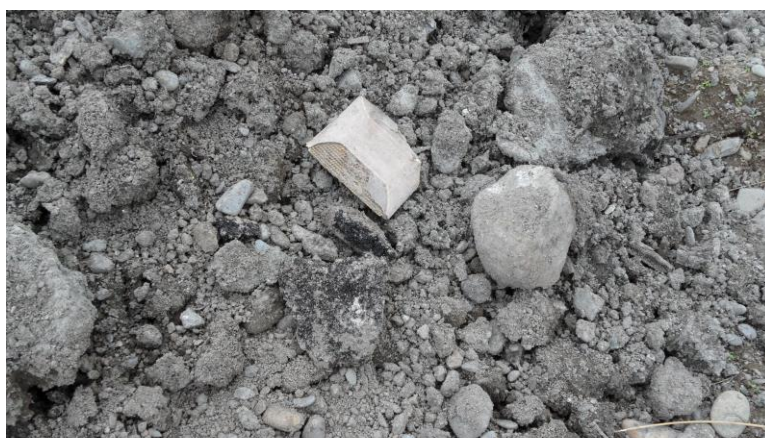
Figure 1 A

- 2) Foreign substances are widespread and of a similar nature to those seen in the pit sites. The presence of some fused, vesicular glassy material suggests an origin from a high temperature process and some baked earth material and charred wood is indicative of burning processes. The presence of asphalt (figures 1A, 19) suggests an origin from road materials.

Pit 1. top left, soil profile;
top right, trench cross section;
right, asphalt waste material.

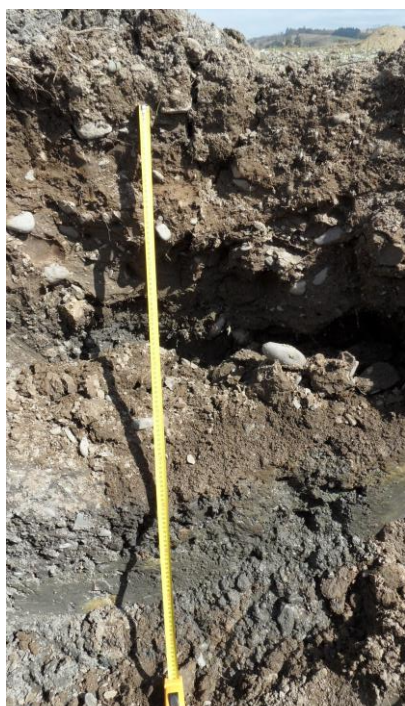
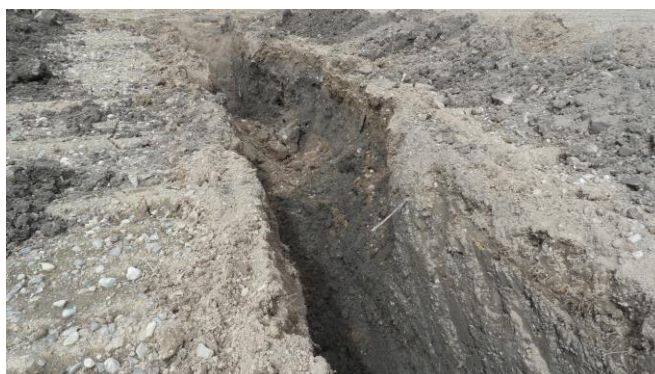
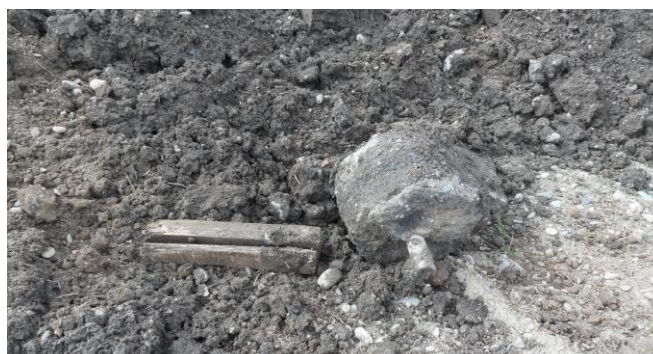
Figure 2A

Pit 2. above left, soil profile;
above right, trench cross section;
right, waste materials.

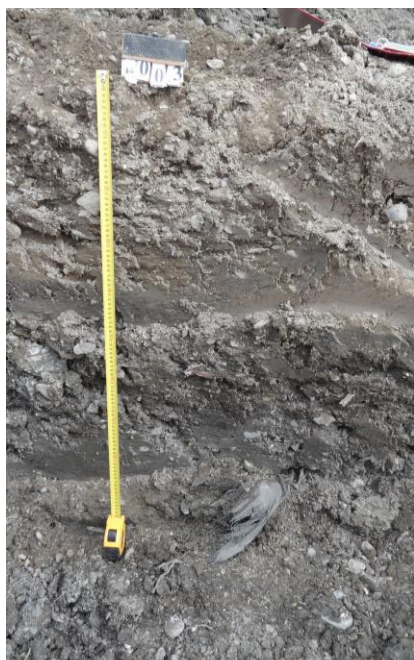
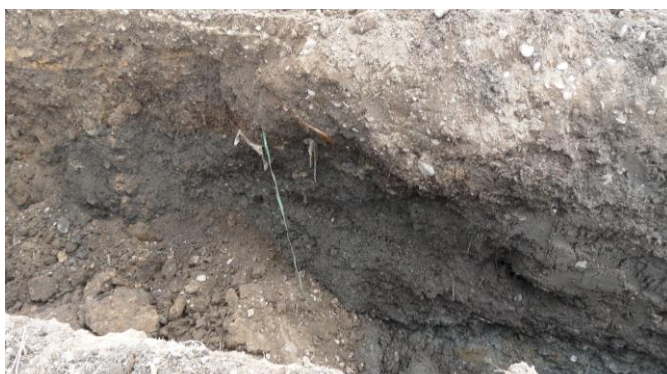
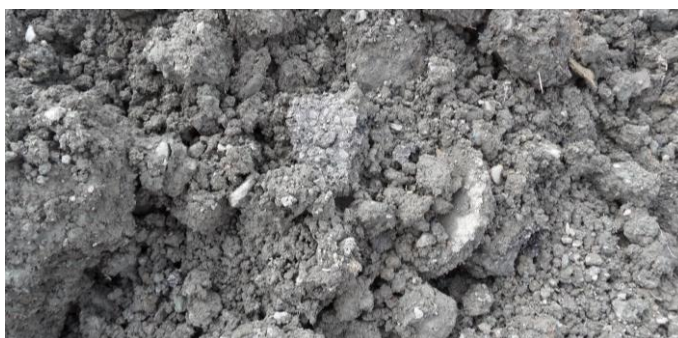
Figure 3A

Pit 3. Top left, soil profile; top right, trench cross section; right, waste material.

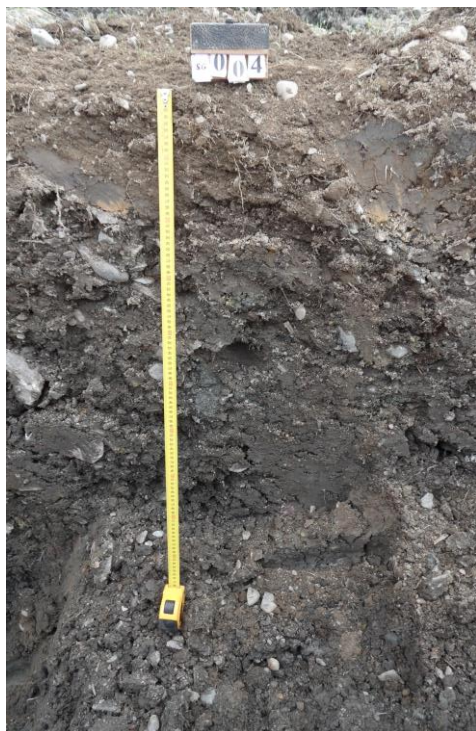
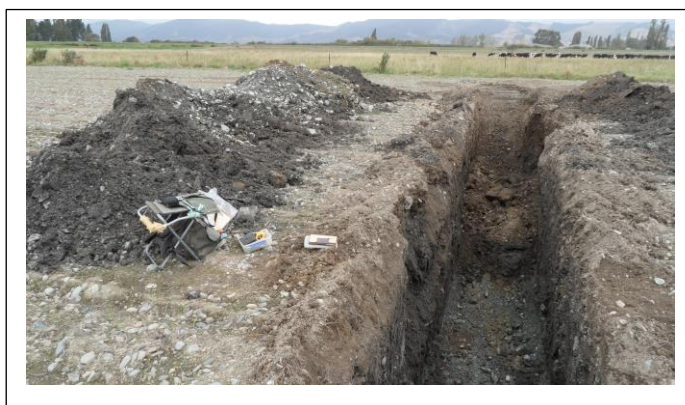
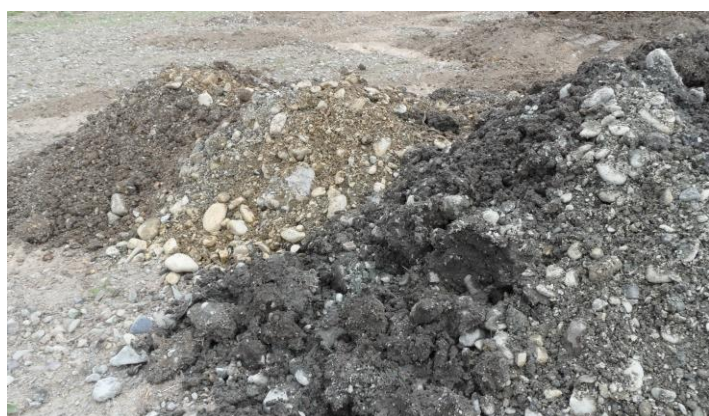
Figure 4A

Pit 4. Above left, soil profile; above right, trench cross section; right, black material including asphalt and charcoal.

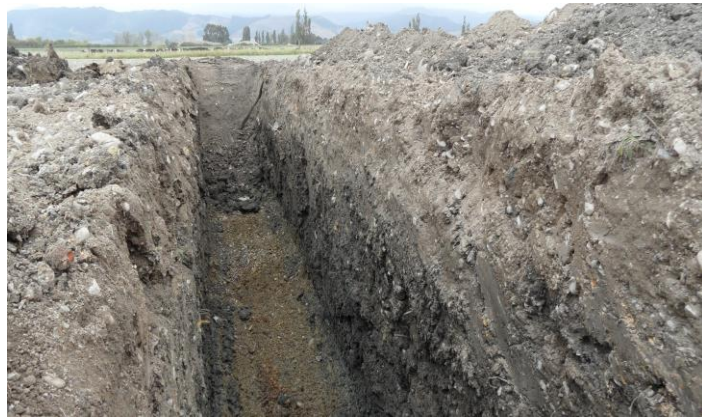
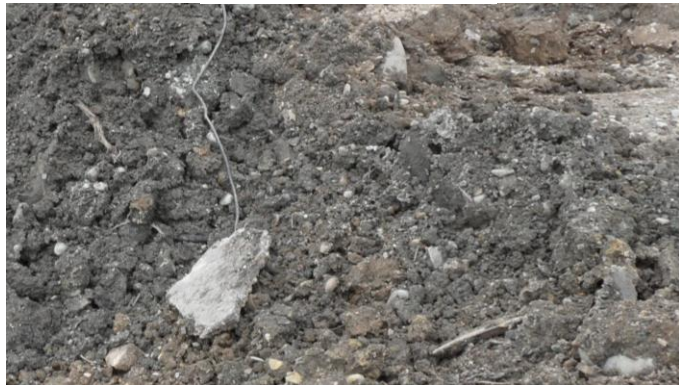
Figure 5A

Pit 5. Top left, soil profile
top right, trench cross section;
right, waste materials.

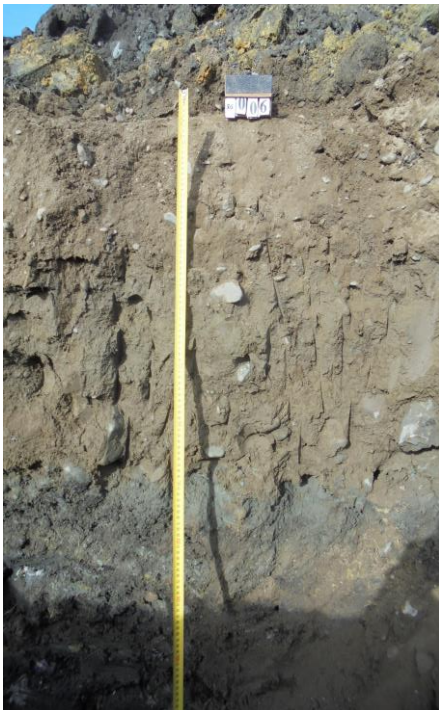
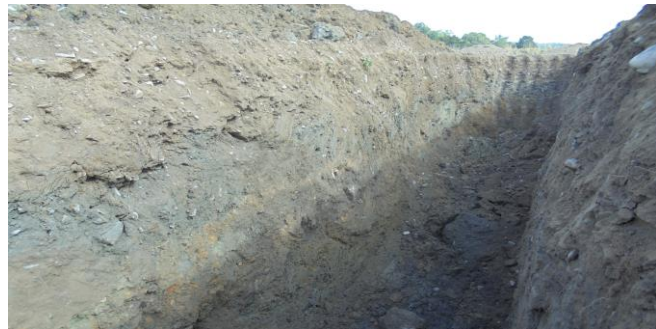
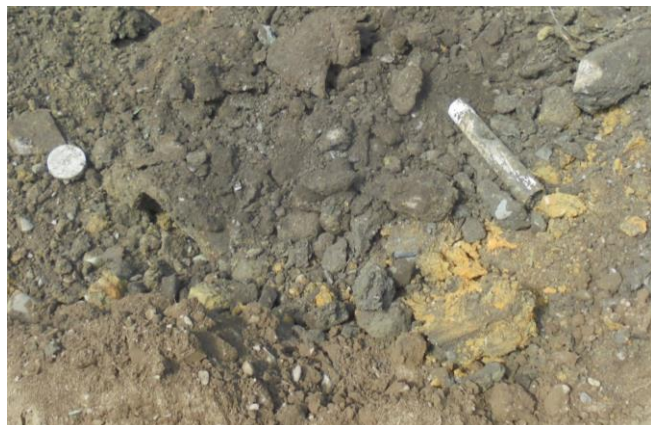
Figure 6A

Pit 6, above left, soil profile;
above right, trench cross section;
right, concrete & plastic waste
materials.

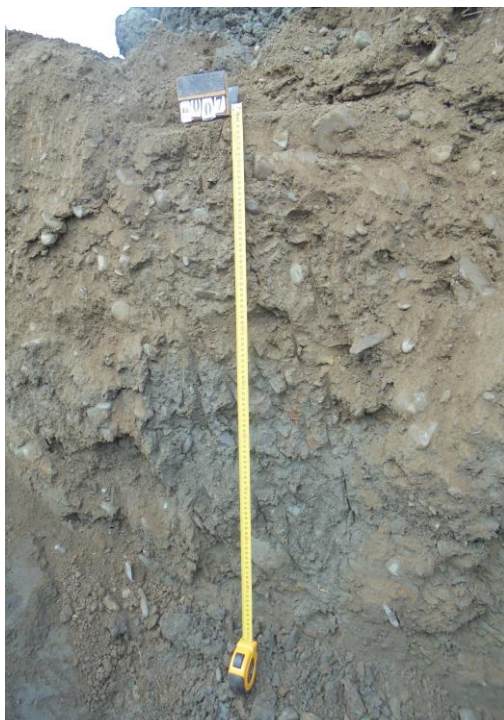
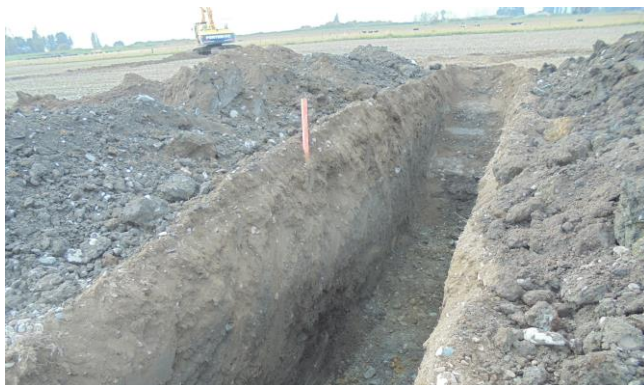
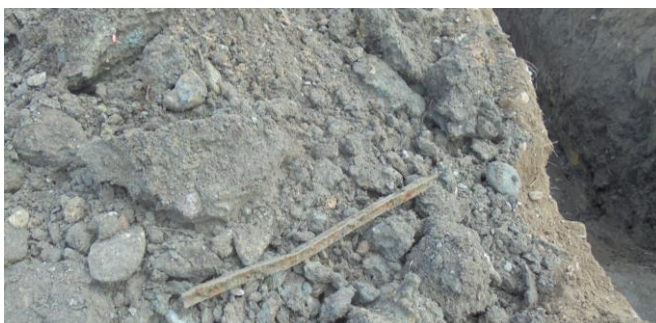
Figure 7 A

Pit 7. top left, soil profile
top right, trench cross section
right, metal and concrete waste materials

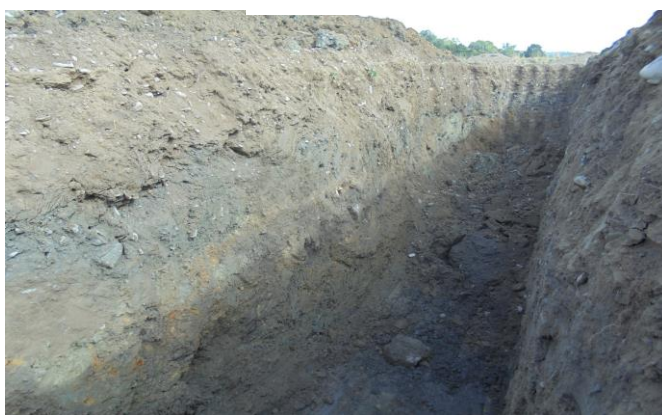
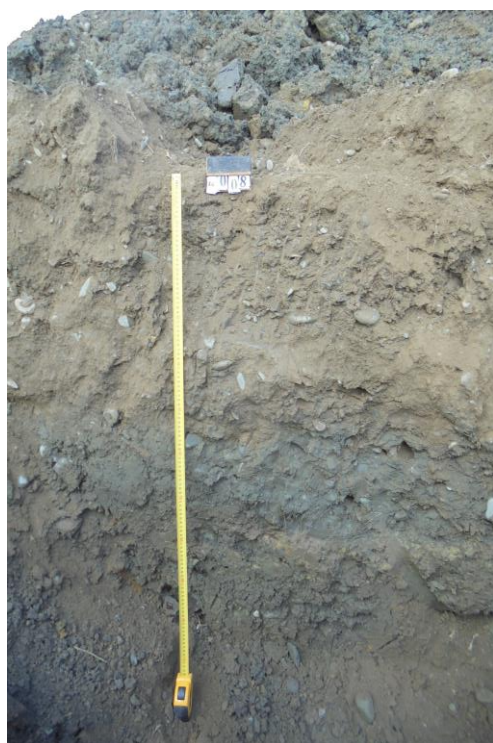
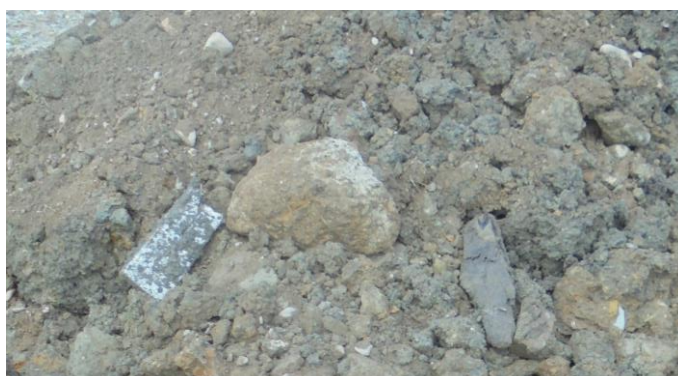
Figure 8B

Pit 8. above left, soil profile
above right, trench cross section
right, plastic, concrete & asphalt waste

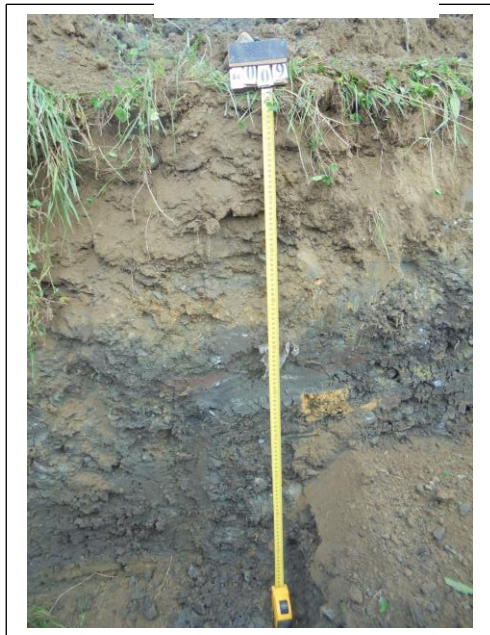
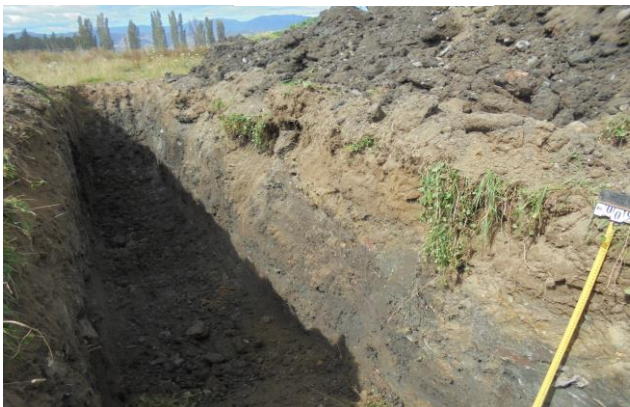
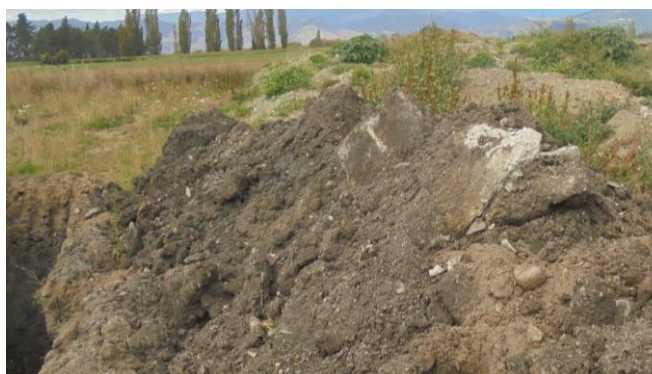
Figure 9A

Pit 9. top left soil profile,
top right, trench cross section
right, concrete waste material

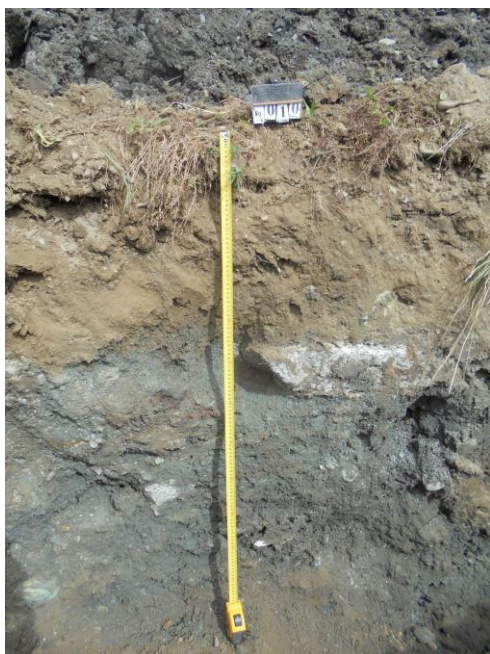
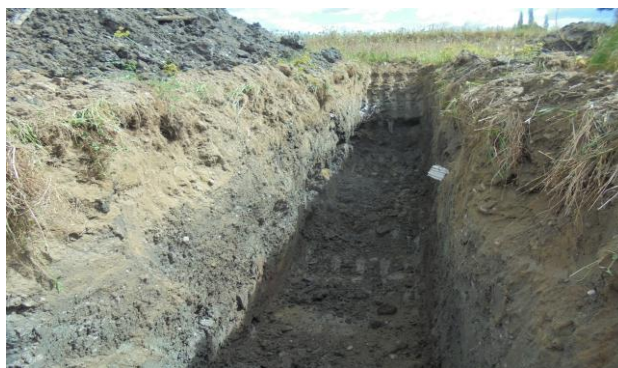
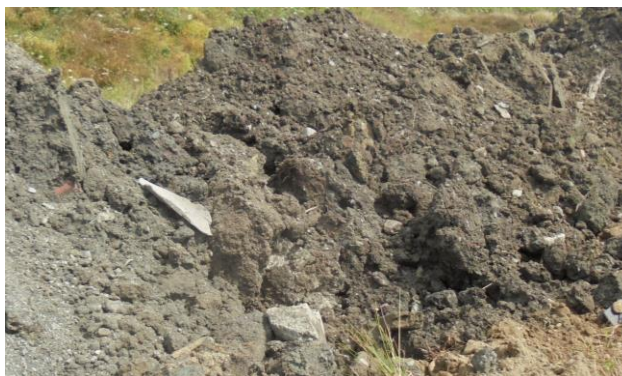
Figure 10A

Pit 10. above left soil profile,
above right, trench cross section,
right plastic, brick, concrete & wood
waste material.

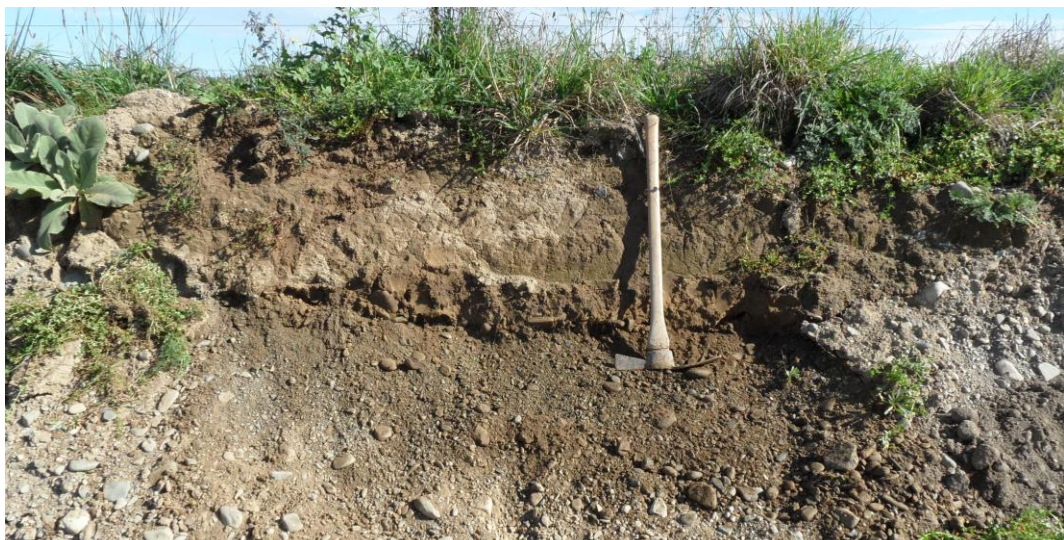
Figure 12. Undisturbed original soil

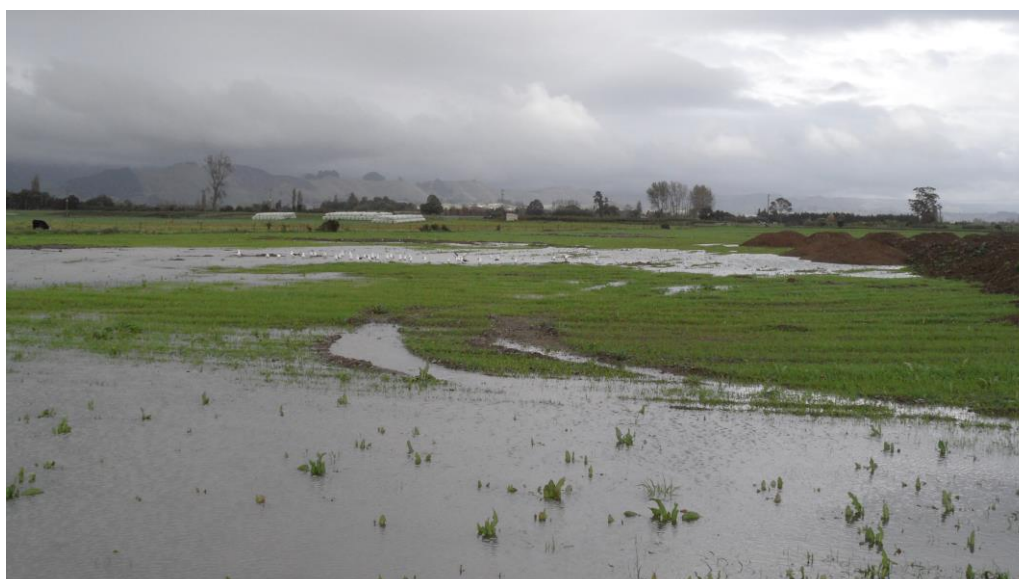
Each of the pits had a surface layer of replaced soil which was without any soil structure, was predominantly light olive brown coloured (2.5Y 5/4) and which varied in thickness from 20 to 70cm but with an average thickness of 39cm. This surface layer lacked an identifiable A horizon (topsoil*) and the stone content was in excess of 35% (gravimetric) and within the *very stony class* of soils. In deeper parts of the surface layer (e.g. Pits 6, 8), the replaced material is very dense and compacted. The upper 20cm of the surface layer is fragmented due to recent tillage. No foreign materials were observed within the surface layer of original soil. Permeability was measured at >300mm per hour (very rapid) and the soil was noted to be saturated after rainfalls, with extensive surface water

Figure 13. Water ponding on restored land.

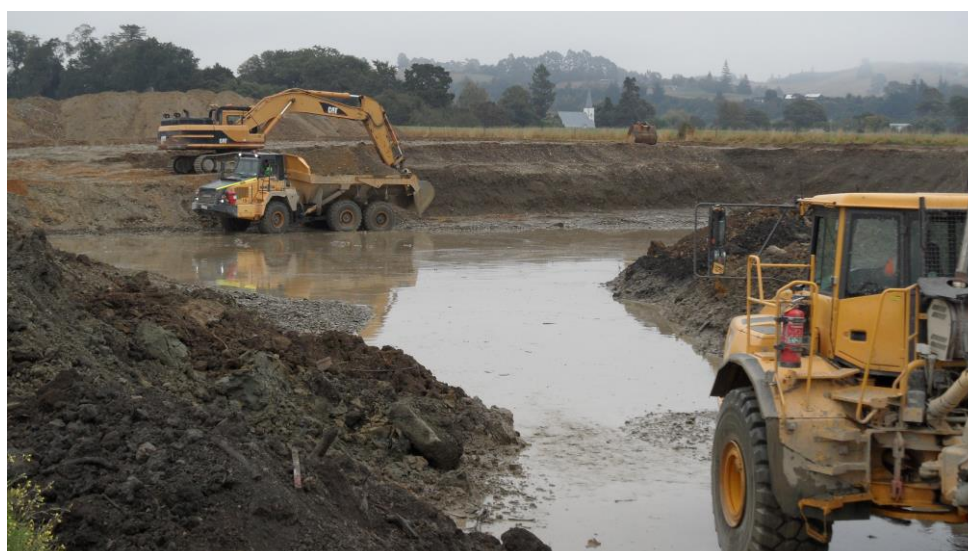
Staplegrove Farm in the Waimea West district Nelson, has been a site for gravel extraction since the 1980's. At the time of examination, gravel was being extracted to a depth of approximately 4m below the existing ground surface (Figure 14) with a thickness of about 3.5m of earth materials back filled. At a request from *Downer* (e-mail 27/2/2017), an examination of the soils and soil materials was undertaken for the purpose of preparing a report to ascertain if conditions of the Resource Consent issued by The Planning Tribunal Hearing 10/2/1992 were being fulfilled. The examination focussed on the conditions of the resource consent given as per the brief below. Other conditions of the Resource Consent are not addressed in this report.

Figure 14. Excavation and backfilling.

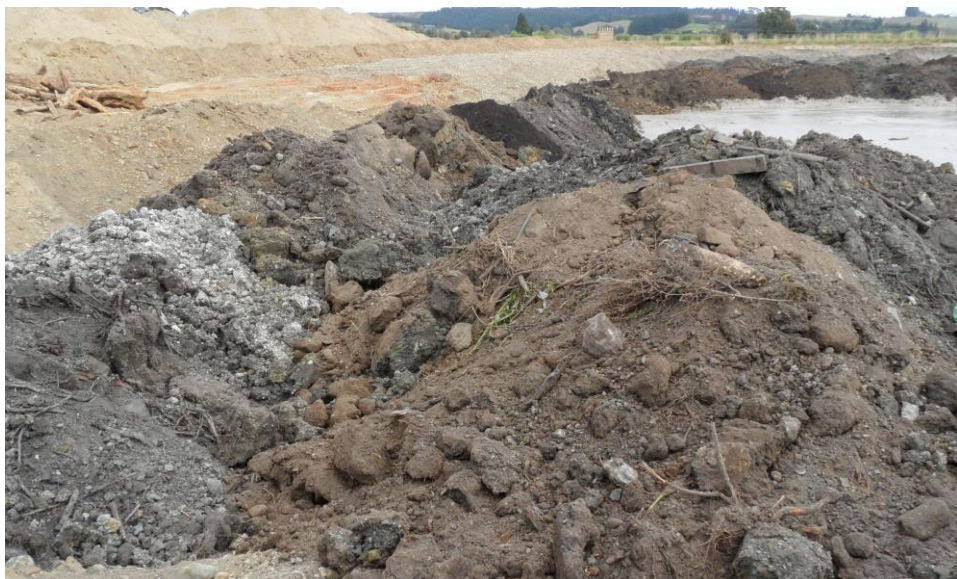
The area in which earth materials were being dumped at the time of the inspection was examined since this is the fill for the current phase of gravel extraction and the base for the soil when restoration is completed. The nature of the materials being disposed of is shown in Figures 14-20 and some of the materials that were noted are given in Table 1.

- 1) There are a wide variety of earth materials being disposed of, much with no clear origin. A typical excavation for a Nelson house site or subdivision would produce clean overburden, usually brown in colour, but there appears to be little of this type of earth matter present. Some very light coloured material appears to be 'chalky.' Some of the very dark or black material may be 'ashy' as charcoal was noted to be present and burning was observed to be taking place at the Downer site in Bartlett Road. The texture of the materials range from clay to gravelly. Dark coloured material does not resemble normal topsoil. Because of the diversity of earth materials, available plant nutrients will be variable but probably mostly low.

Figure 15. Backfill showing the variety of materials being deposited.

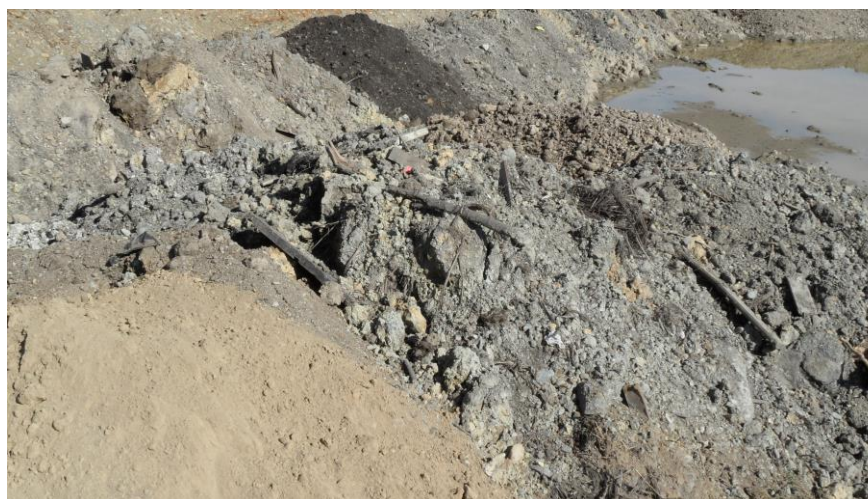
Figure 16. Backfill showing materials being deposited.

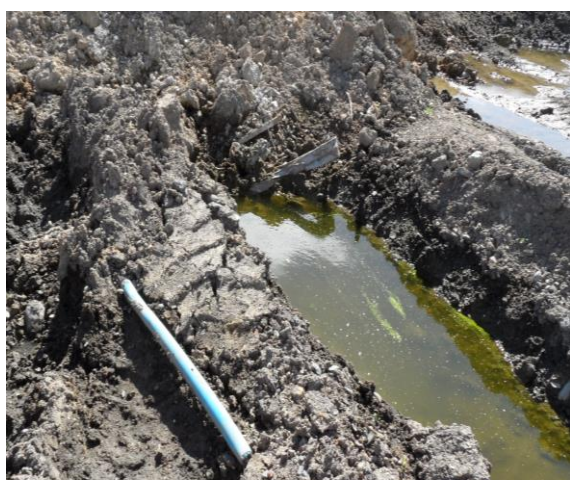
Figure 17. Foreign material.

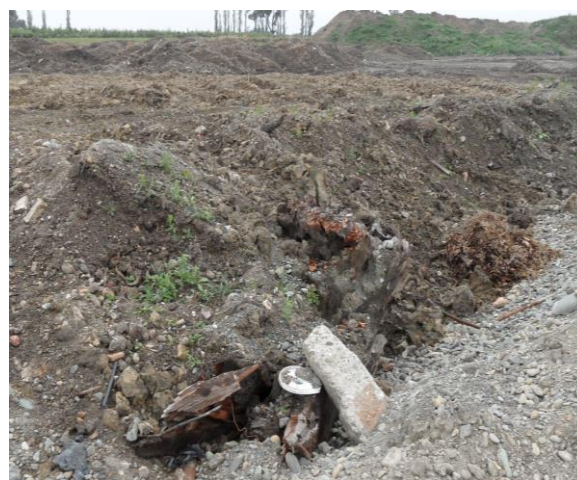
Figure 18. Foreign material.

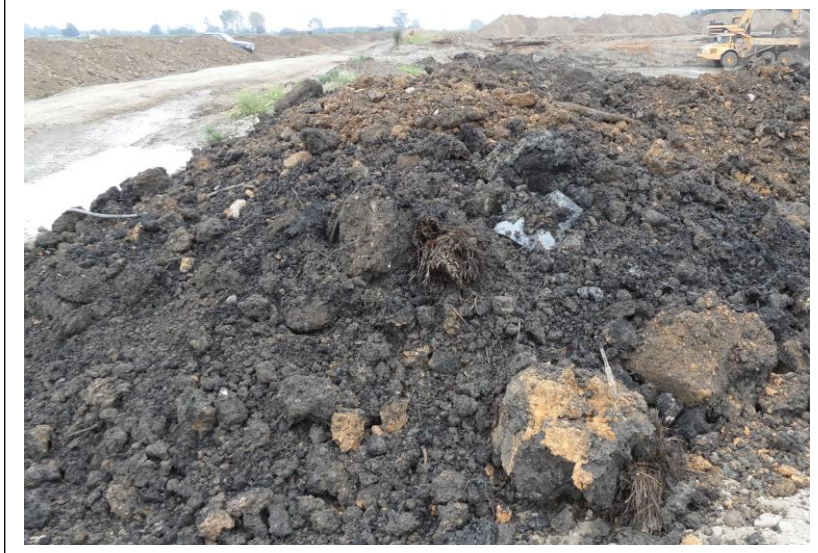
Figure 19. Foreign material, asphalt

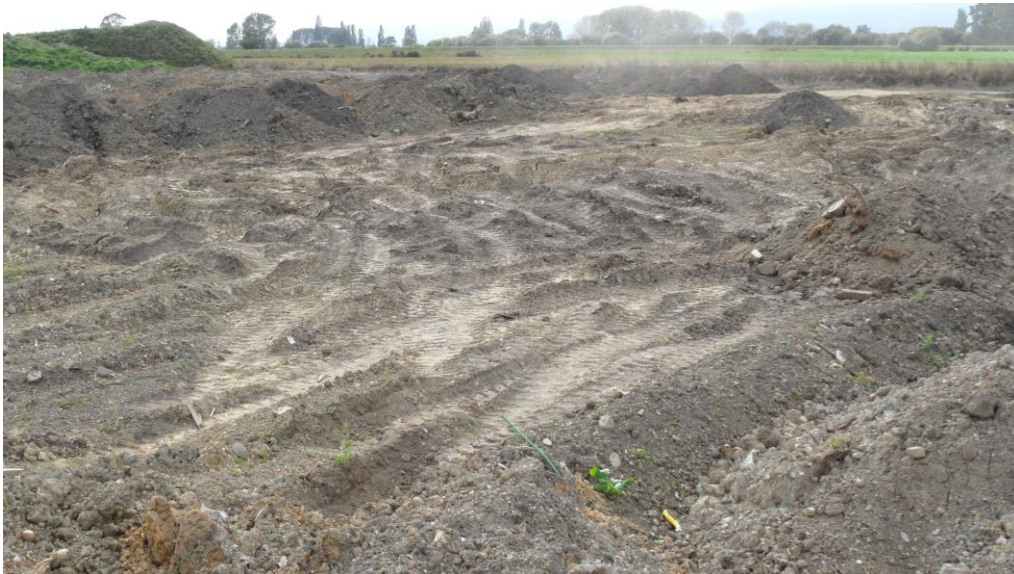
- 3) The compaction and consequent increase in soil density provides poor physical conditions for root penetration, soil moisture storage and soil drainage and has lowered the soil production potential.

Figure 20. Earth spreading and compaction.

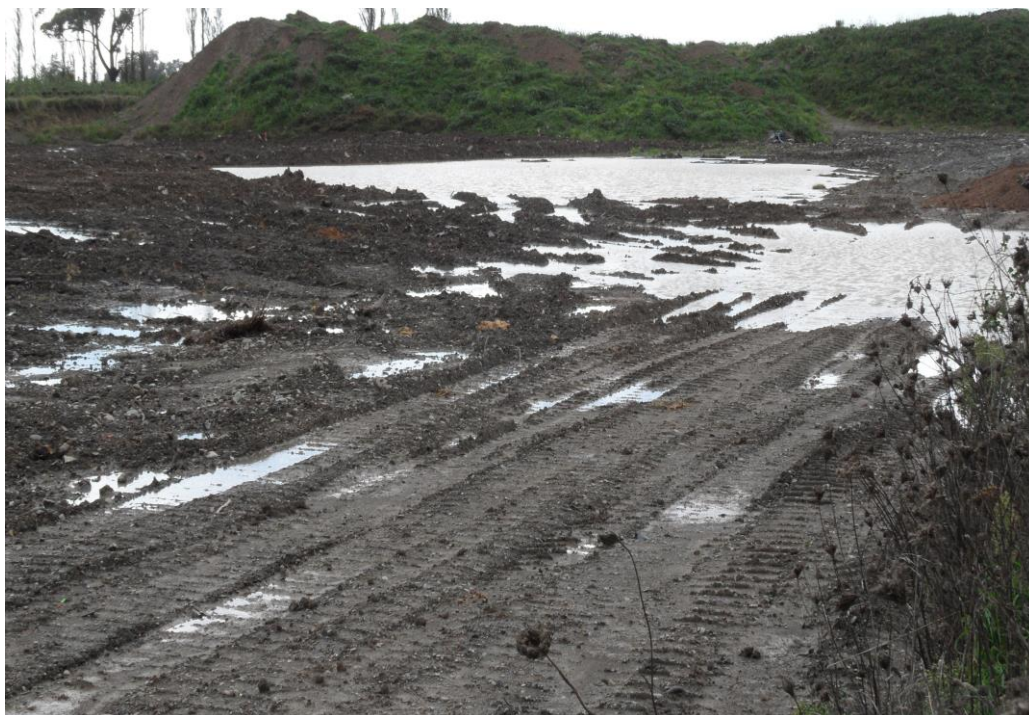
- 5) What was a well-drained soil has now been replaced with earth material that has inferior physical and drainage properties and which impact on land management and potential crop use.

Figure 21. Spreading compaction and drainage impairment.
