**BEFORE AN INDEPENDENT HEARINGS COMMISSIONER  
AT NELSON**

**COUNCIL REF: RM200488,  
RM200489 AND RM220578**

**STATEMENT OF EVIDENCE OF PETER JOHN TAIA ON BEHALF OF VALLEY RESIDENTS AGAINST  
GRAVEL EXTRACTION (LANDSCAPE PLANTING / MITIGATION)**

Dated: 11 November 2022

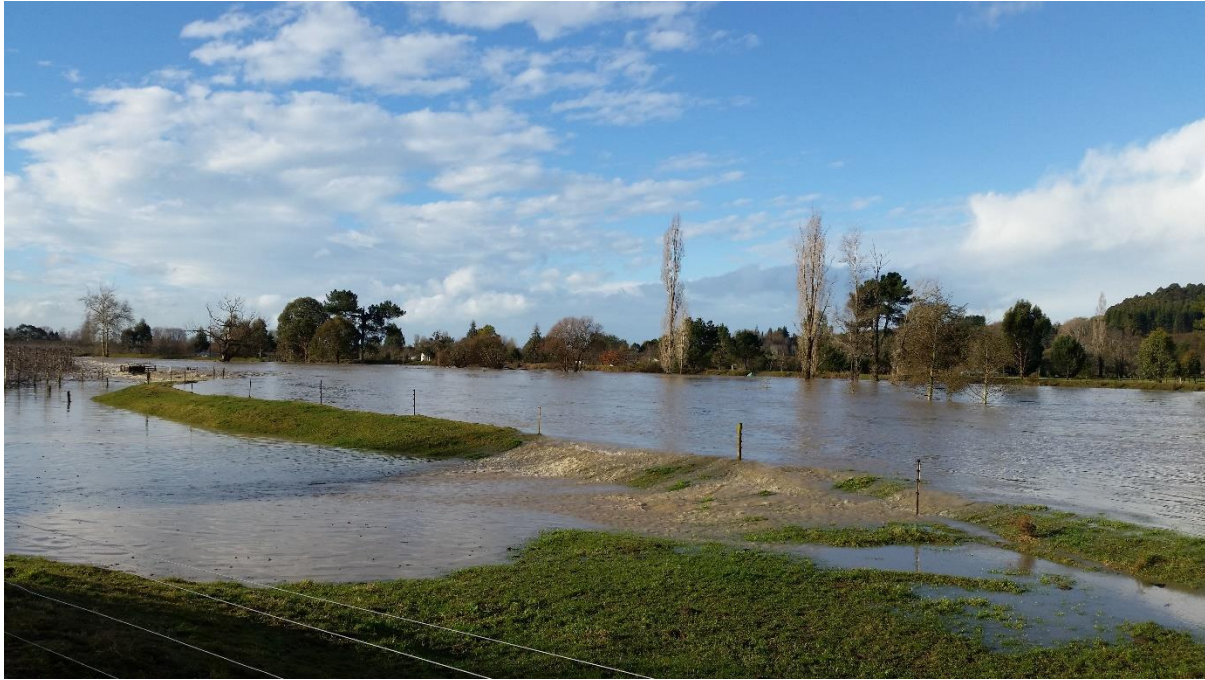
17 July 2021 - Stage 1 site in peak flood.

26. The evidence provided above of almost yearly channel flooding events and the associated water flow velocity in the channel, such as July 2021 where the whole of stage 1 was 1-2 meters deep, will inevitably result in significant to almost total failure of any planting undertaken in the floodplain.
27. In my view the function of the flood plain is to take water away from the land which reduces the damage of inundation. The floodplain is not a suitable medium by its nature for the establishment of a mitigation planting.

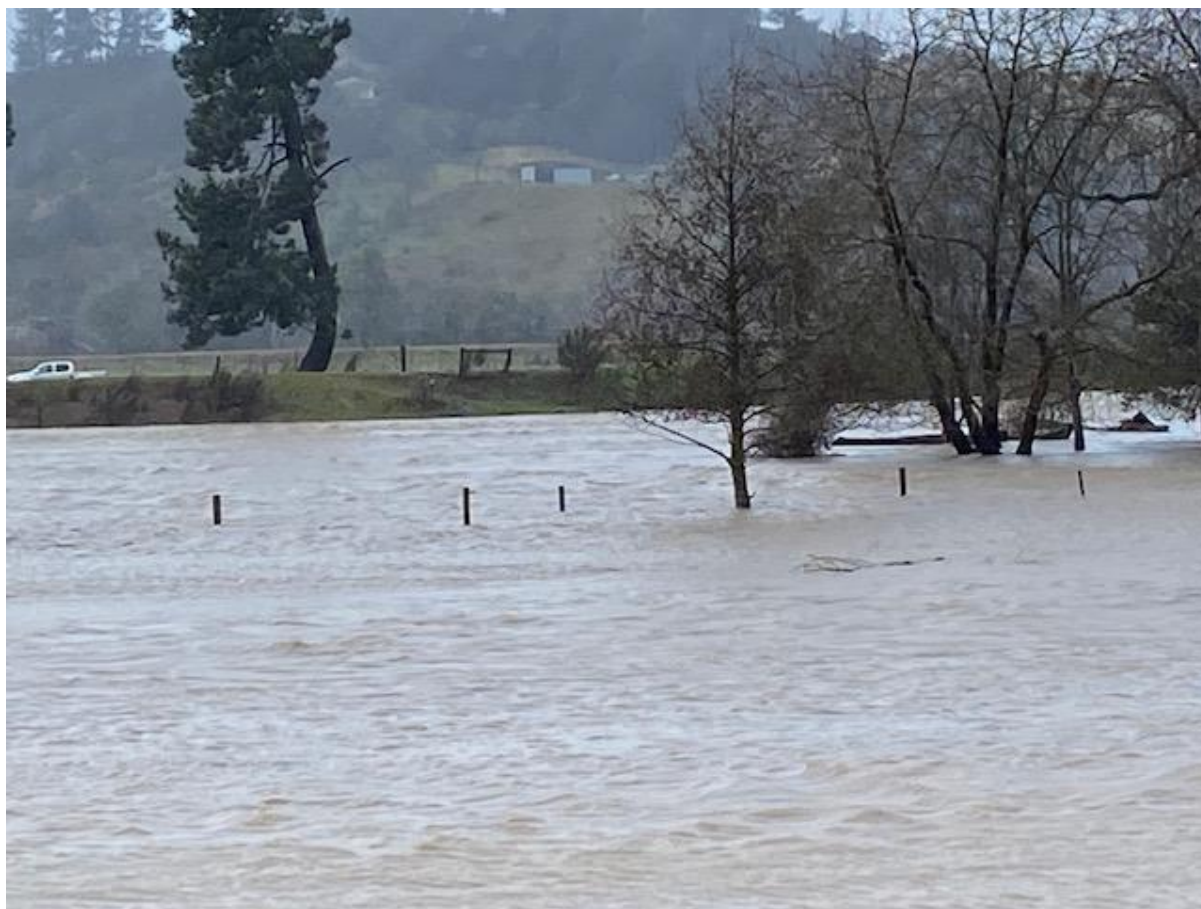
17 July 2021 - Stage 1 Close up view during peak flood.

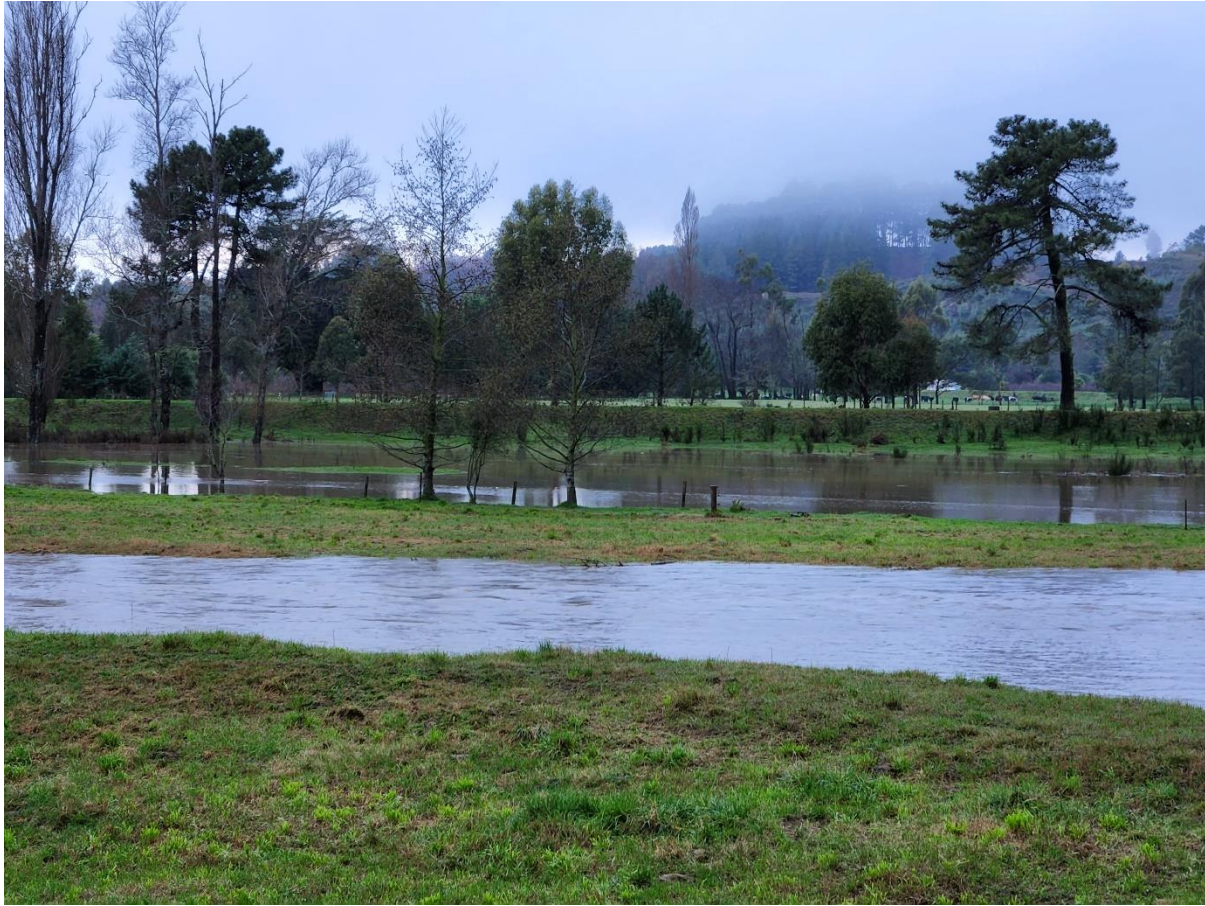
12 July 2022 - Stage 1 site in flood.

- (j) 2022 One flood including July 2022
23. Based on the frequency of flooding events in the back channel, this area can be expected to be inundated an estimated 10 times in the next 10 years, making establishment of the mitigation planting unlikely in the suggested 6-year period.
