**IN THE MATTER** Of an application by CJ Industries Ltd for  
land use consent RM200488 for gravel  
extraction and associated site rehabilitation  
and amenity planting, for land use consent  
RM200489 to establish and use vehicle access  
on an unformed legal road and erect  
associated signage, and for a discharge permit  
to discharge clean fill to land RM220578

**REPLY EVIDENCE OF ELIZABETH JANE GAVIN ON BEHALF OF CJ  
INDUSTRIES**

**LANDSCAPE**

# CJ INDUSTRIES GRAPHIC ATTACHMENT A

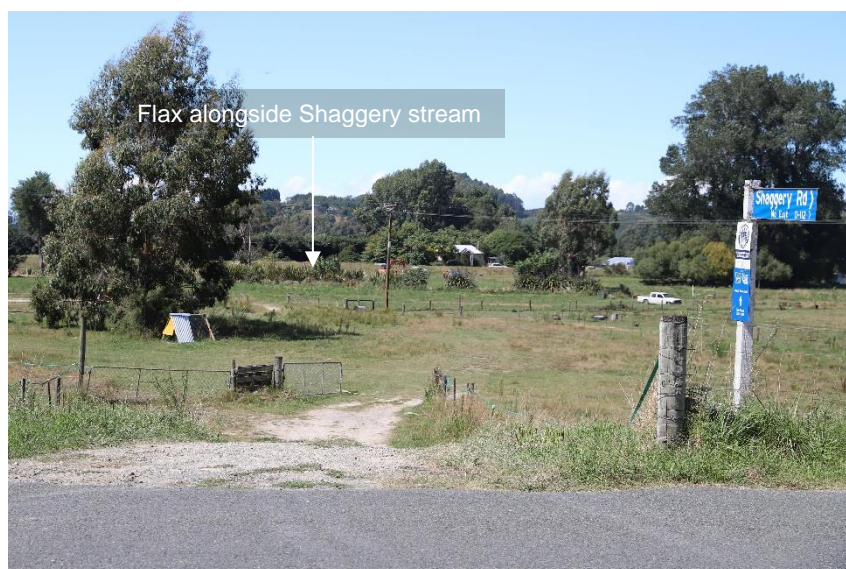
**Figure 1:** The Stream path of Shaggery Stream can be seen mid distant lined with Flax. Flax plants are also growing on the “dry” side of the stopbank around the dwelling at 134 Peach Island Road.

5.10 I note that the tributary stream (Shaggery Stream), downstream from the site has flax growing alongside it as seen in the photo below:

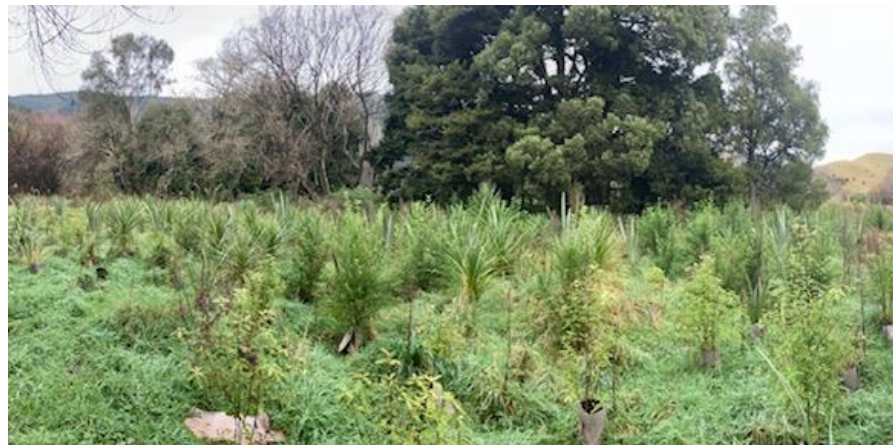
**Figure 2:** Planting 50m north of the figure 1 area one year younger - after 2 years growth.

5.14 The above photos illustrate how within 2-3 years there can be good growth and habitat developing, achieving the height and density consistent with the images shown by Mr Payne in his evidence. In terms of plant guards, I have found that in some cases in high flow areas adjacent to the River, the guards can be removed by the force of the water. This is less likely to occur in areas back from the high energy flow, where the issue is more water inundation.

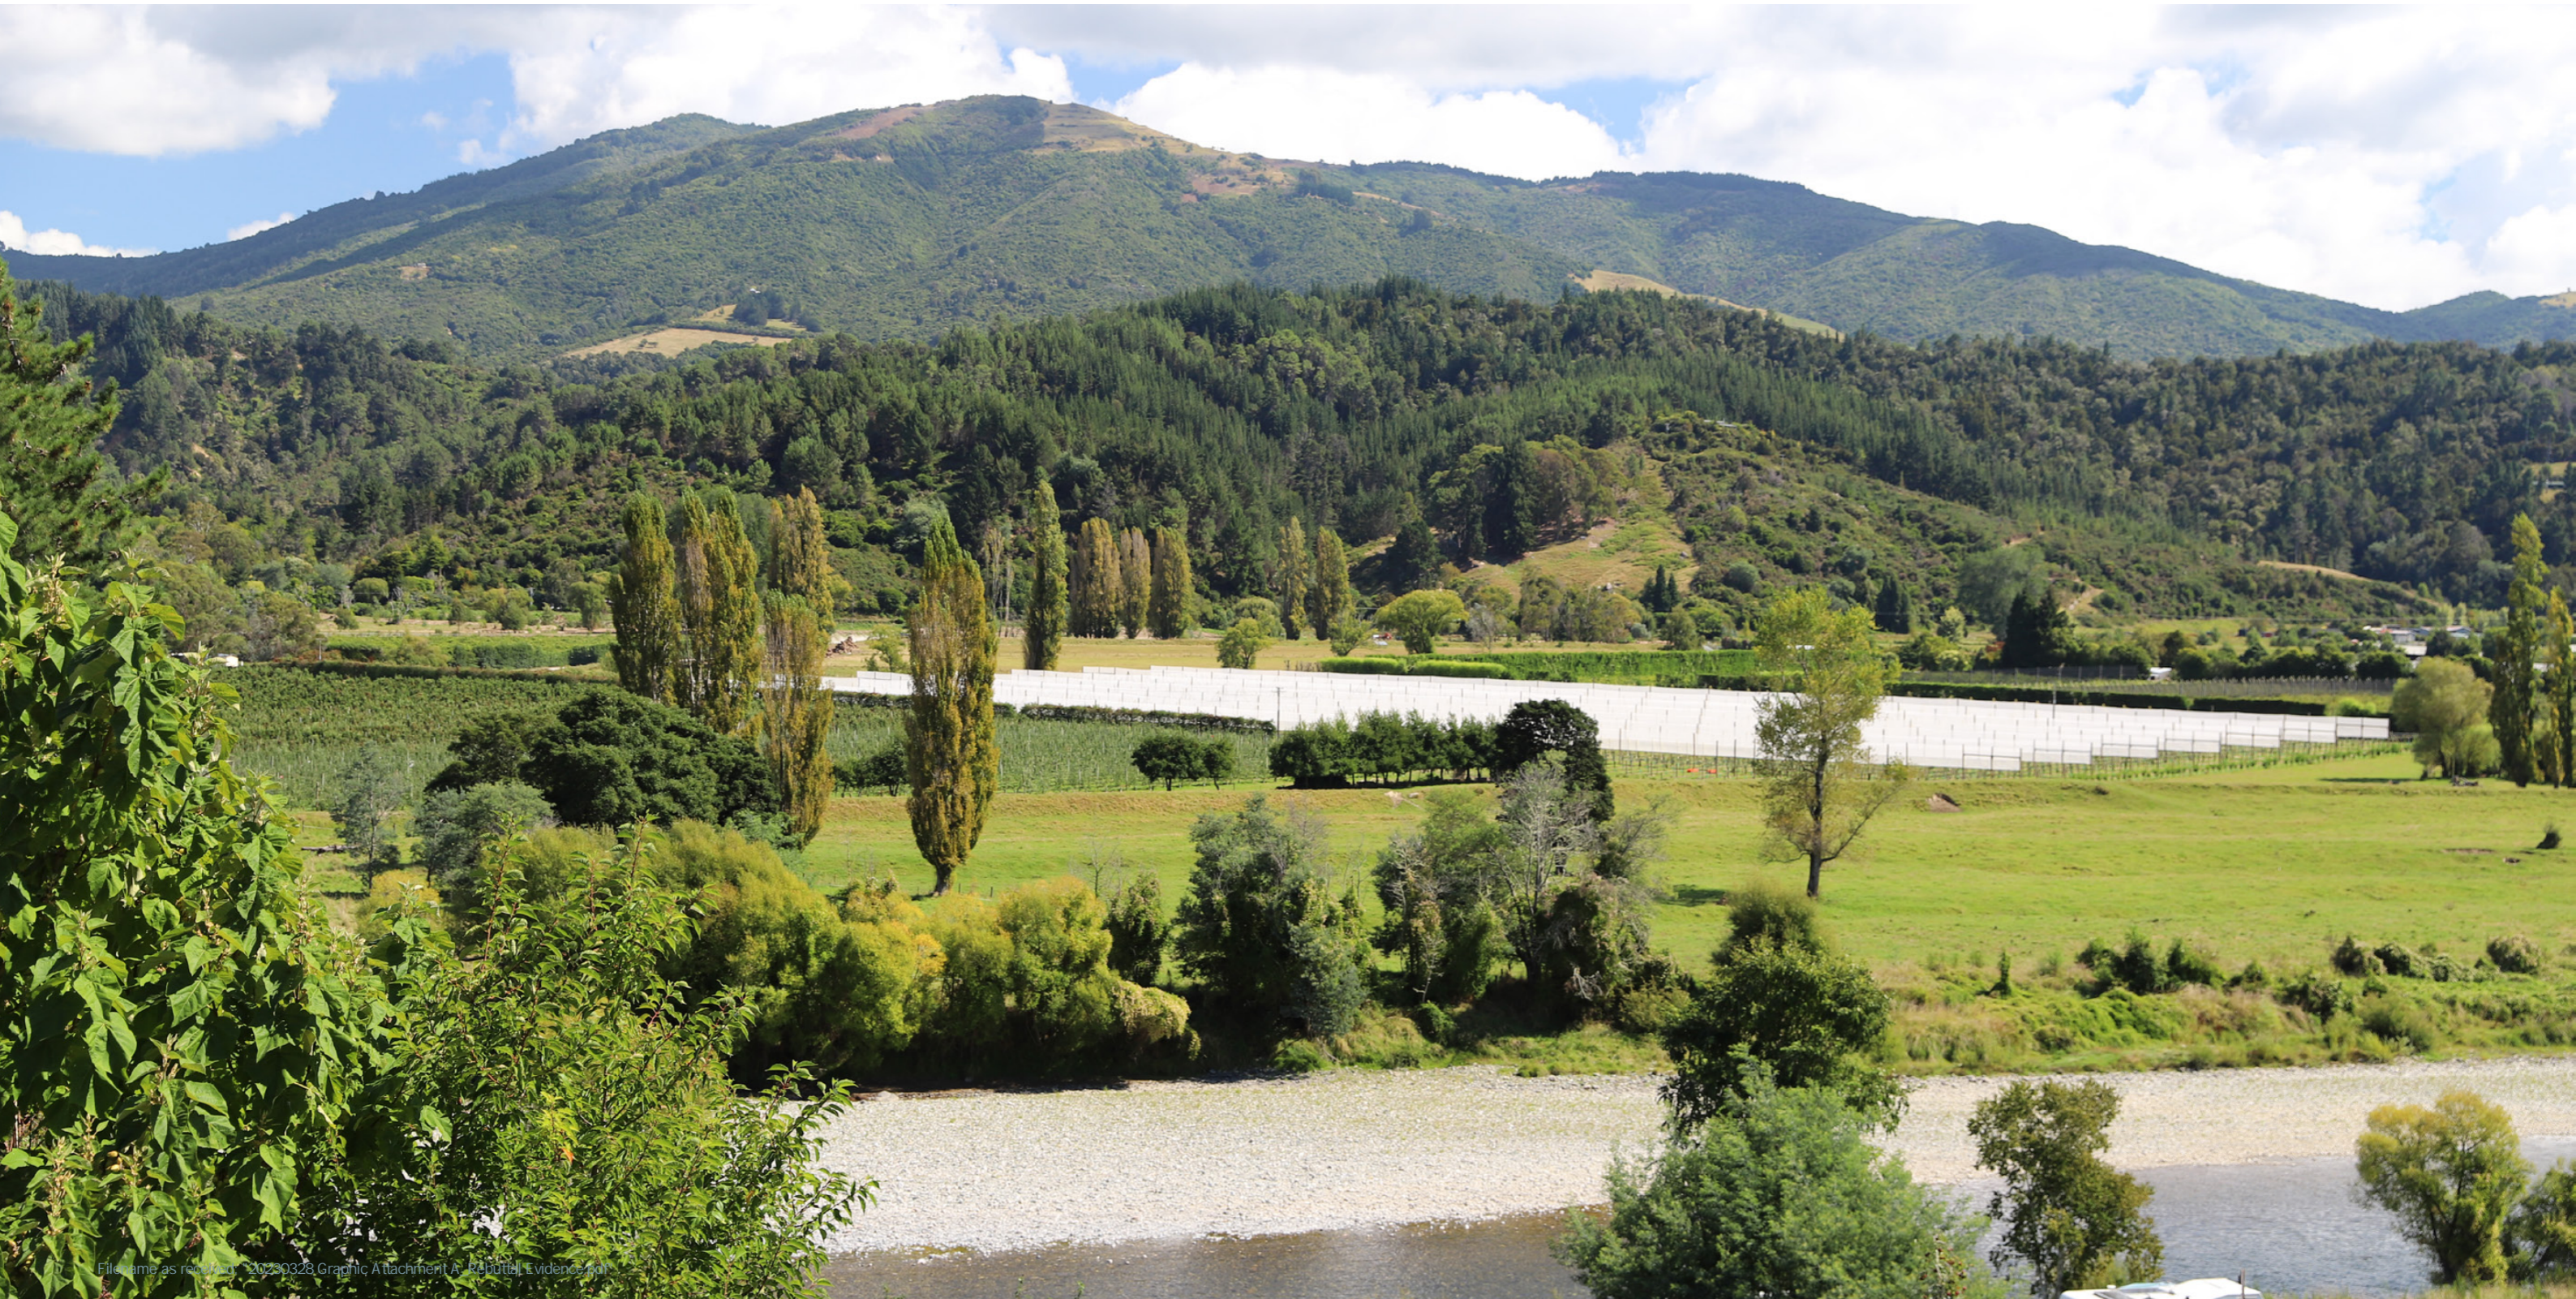
**COVER IMAGE:** View from driveway of 273 College Street looking north west (site to the south of photo not visible from viewpoint)

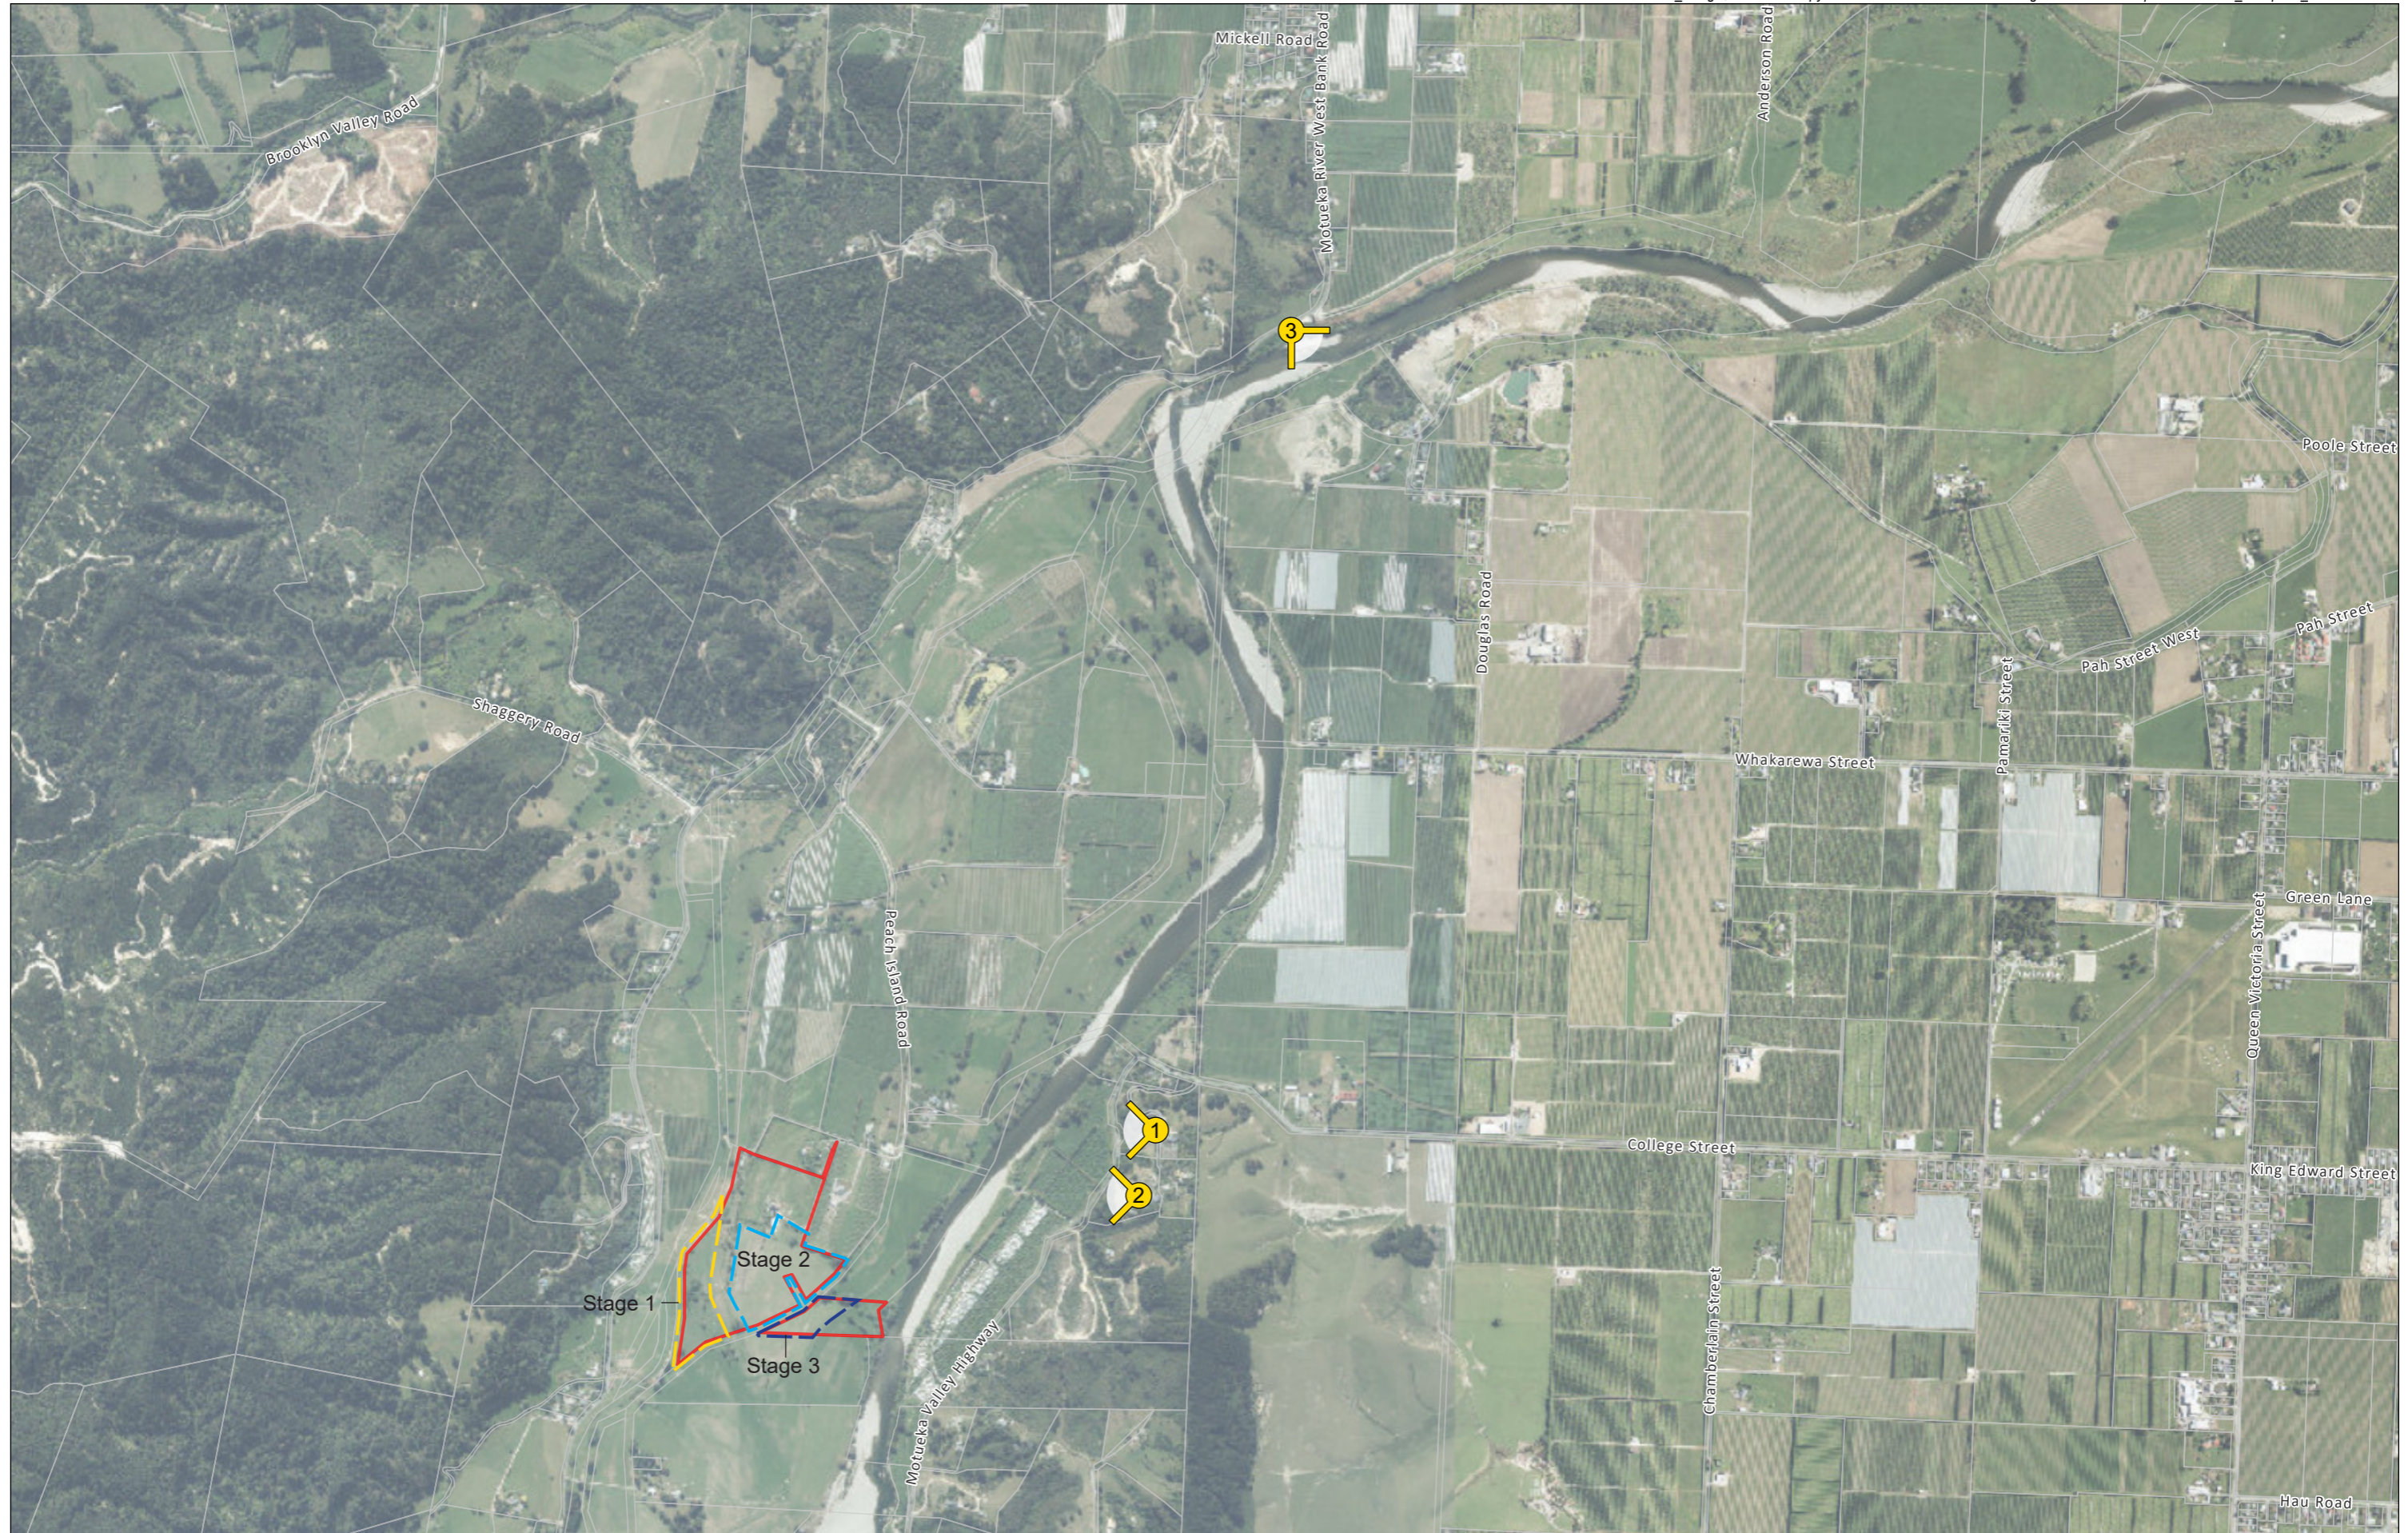
*Most of the developable part of the site obscured in summer by foreground vegetation. The site will be seen as a slither of land in the distant view. In winter the site will form a portion of the midground (southern) view, however overall the view will not change.*

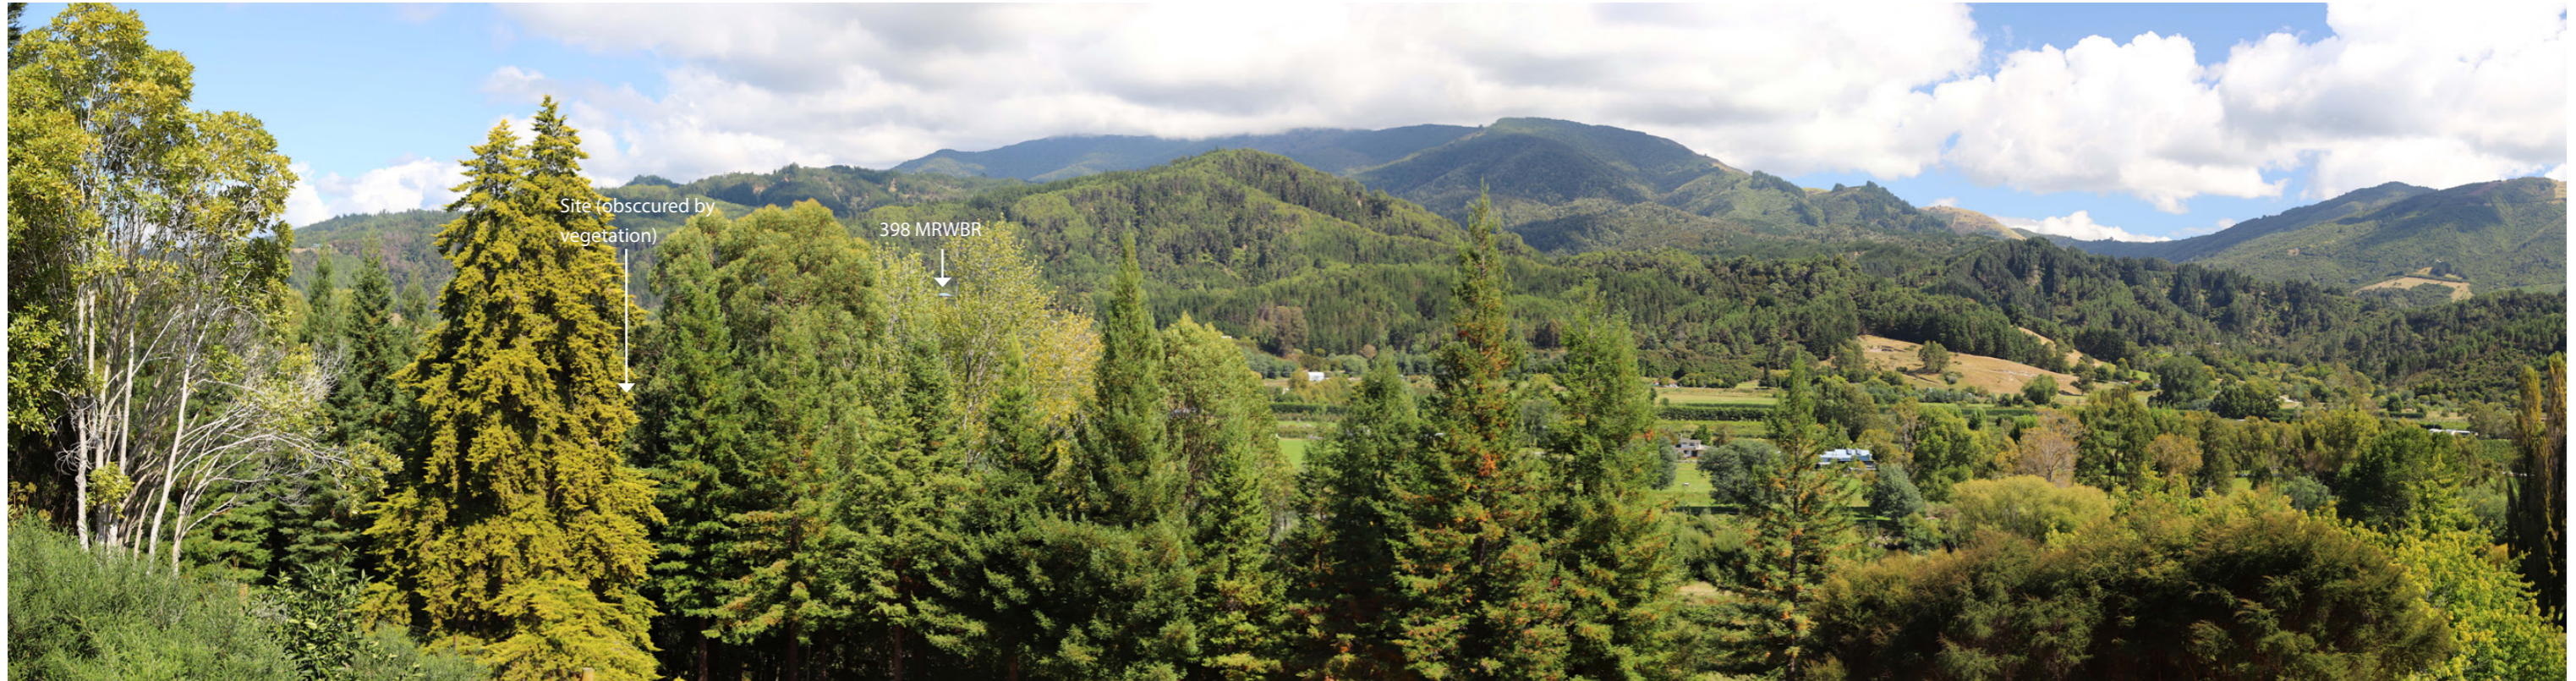
Existing View from 273 College Street. Foreground evergreen trees obscure view of site.

**Viewpoint 2:** From outside the second residence at 273 College Street

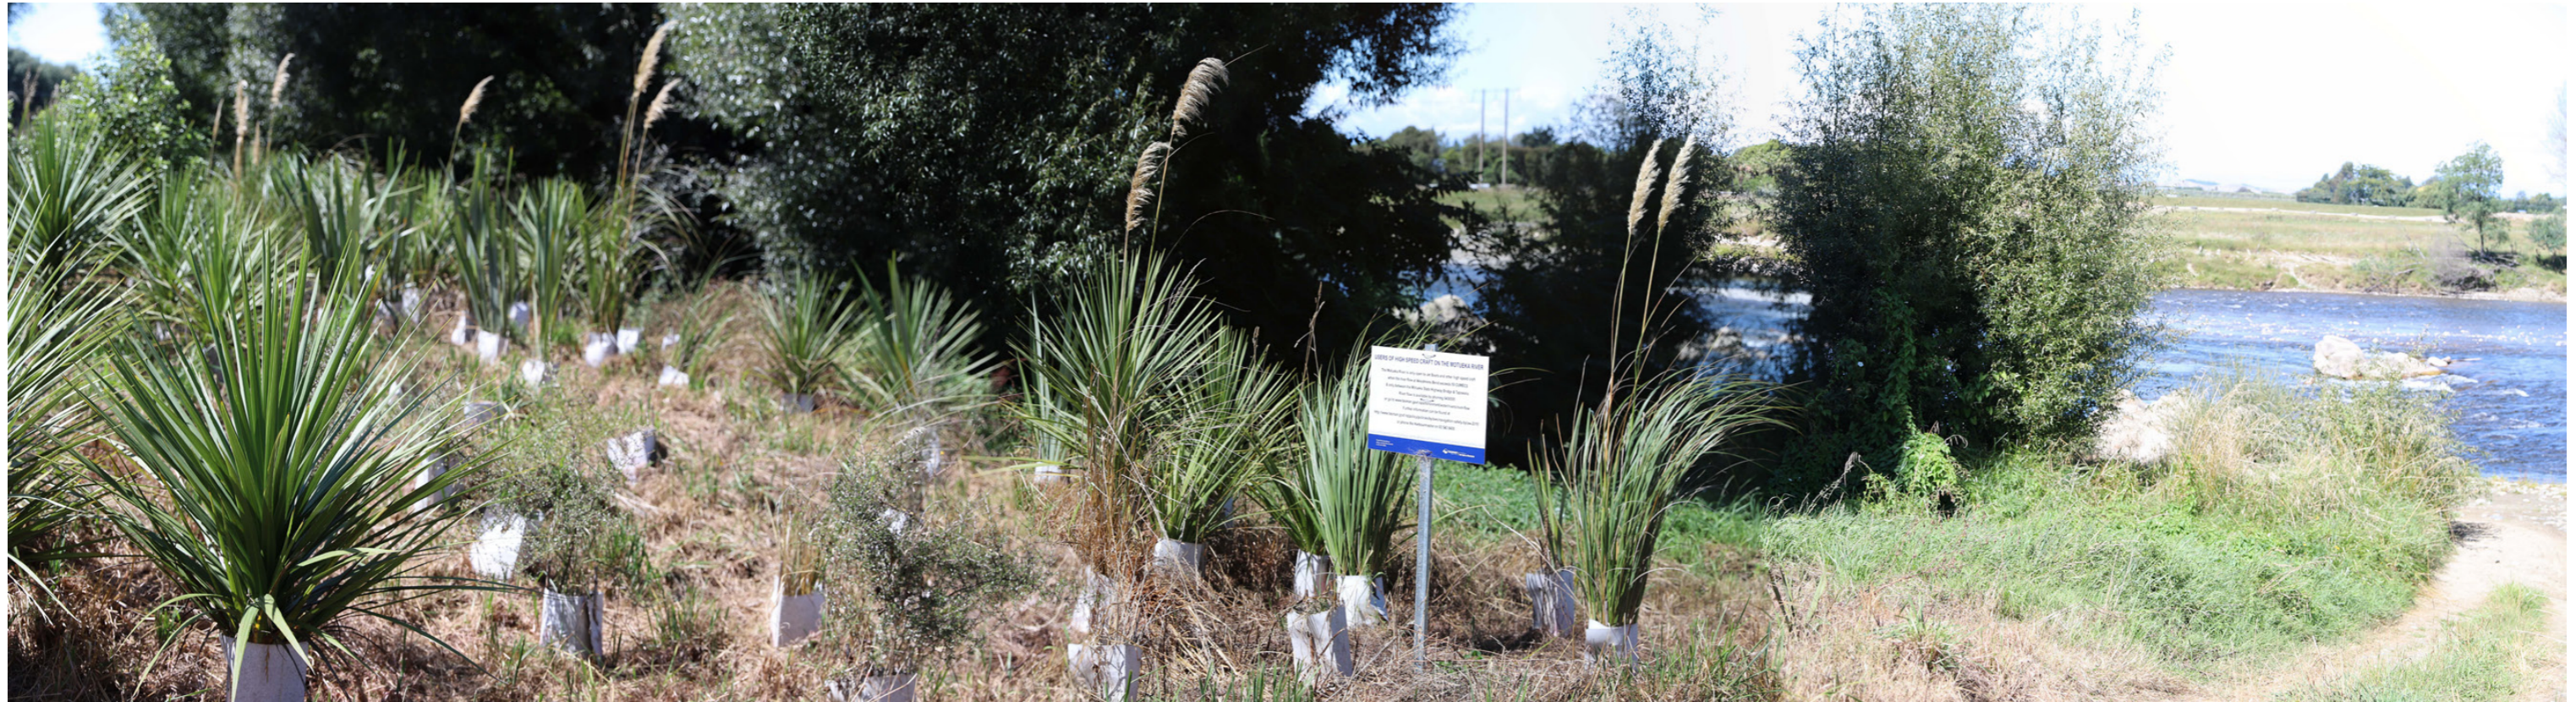
View showing planting adjacent to the Motueka River in Brookland, Species in the photograph include Cortaderia richardii (toe toe), Cabbage Tree (Ti Kouka), and Flax (harakeke).

**Viewpoint 3:** Riparian planting of similar species to that proposed in Stage 1 area (the secondary flood plain). Species in the photograph include *Cortaderia richardii* (toe toe), Cabbage Tree (Ti Kouka), and Flax (harakeke). This photograph shows planting next to the Motueka River south of Brooklyn settlement, and north east of Shaggery Stream tributary
