File No: 42454

9 September 2022

**GEOTECHNICAL ADVICE - DESKTOP STUDY AND SITE WALKOVER, 11 ARANUI ROAD,
MĀPUA 7005, LOT 2 DP 11502 AND LOT 2 DP 11106**

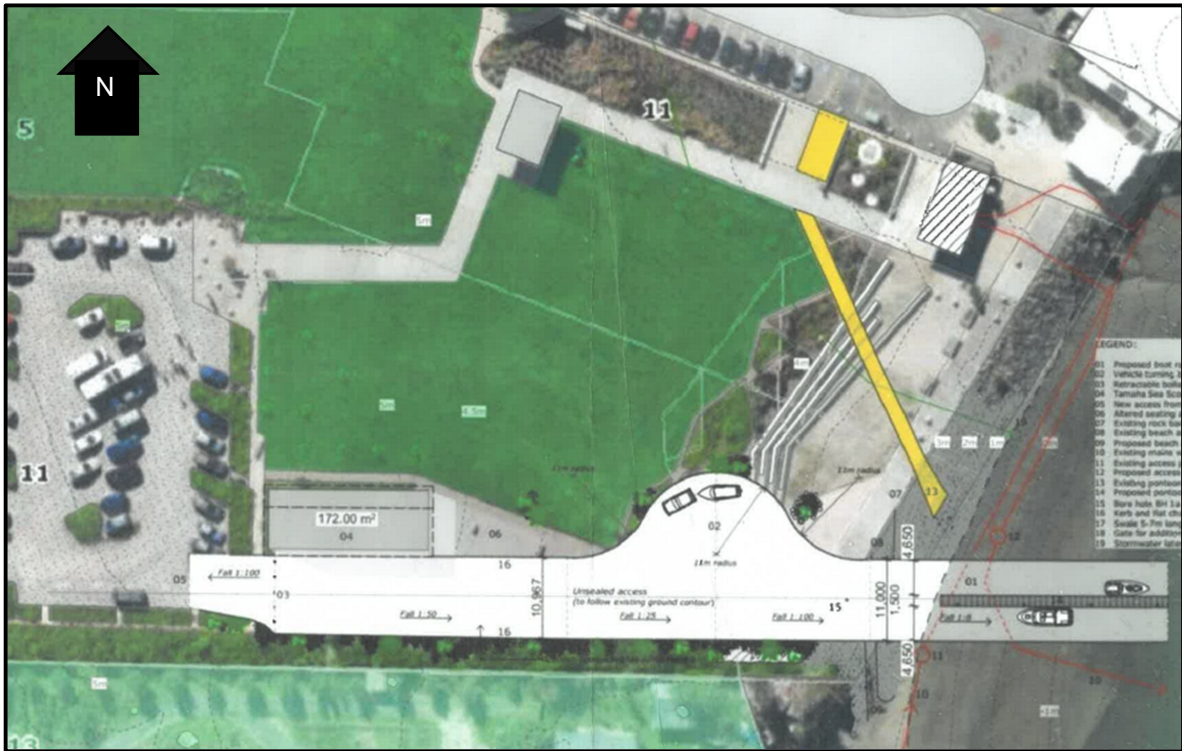
Figure 1: Draft Preliminary Concept design of the proposed boat ramp and associated access road and building provided by the Māpua Boat Ramp Community Trust. Not to scale.

The Māpua Boat Ramp Community Trust propose to construct a new boat ramp south of the existing Māpua wharf and restaurant complex involving an unsealed 11 m wide access road to an 11 m wide concrete boat ramp that will project into Waimea Inlet to the point of MLWS. The access road will incorporate a 180° U-turn facility to allow towing vehicles to back down the ramp to launch and retrieve craft.

The ramp will include an approximately 20 m long pontoon located adjacent and parallel to the boat ramp with a walkway bridge. The pontoon will facilitate the temporary berthing of boats and be operable from mid to low tide.

A building is also proposed to store boats and accessories for the Tamaha Sea Scouts. Toilet and kitchen facilities are also proposed to be included as part of that structure.

An excerpt of the draft preliminary concept design for the site is shown in Figure 1.

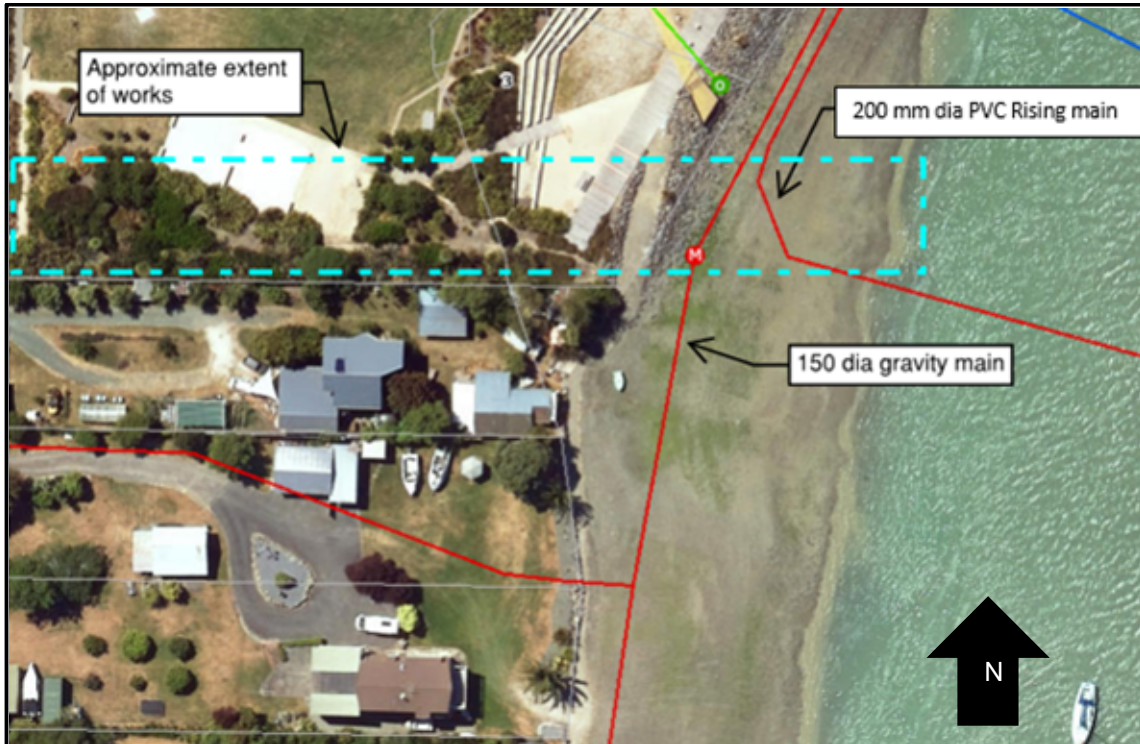
Tasman District Council (TDC) owned wastewater infrastructure passes through the area of planned works within the foreshore, as shown in Figure 2 below.

Figure 2: Location plan & existing wastewater infrastructure. Not to scale.

Hand-dug test trenches are proposed to accurately locate a 200mm diameter PVC Rising main within the area of proposed works.

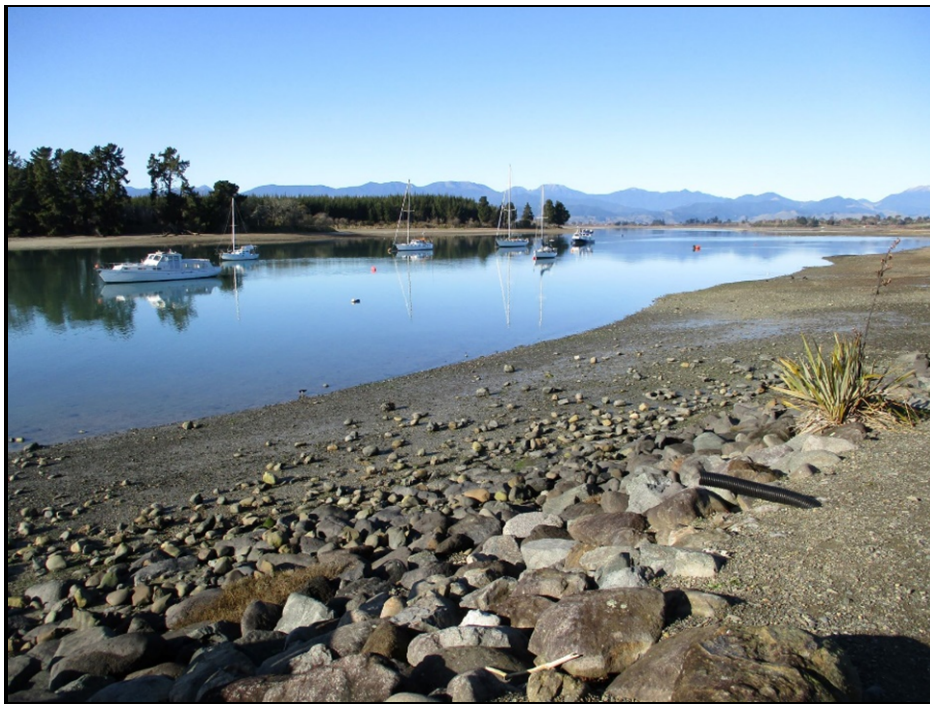
The site comprises a muddy-sandy beach with scattered boulders and shells. A sloping bank covered by boulders serves as erosion protection at the site (Figure 3). To the south, private properties extend to near the coastline and have a combination of concrete walls, rock and fenced boundaries with the beach. At the site, the area adjacent to the foreshore comprises a reserve area of flat land, a mix of graveled carpark and grassed land, a petanque court, paths and a wooden boardwalk, concrete seating and native bush areas (Figure 4). A fenced viewing platform is located in one area of the sea wall.

Figure 3: View looking south of the foreshore, in the approximate area of the planned boat ramp. Existing erosion protection in the foreground comprises large boulders tapering down to a muddy-sandy beach with loose gravel and boulders. The image was taken on 6 July 2022.

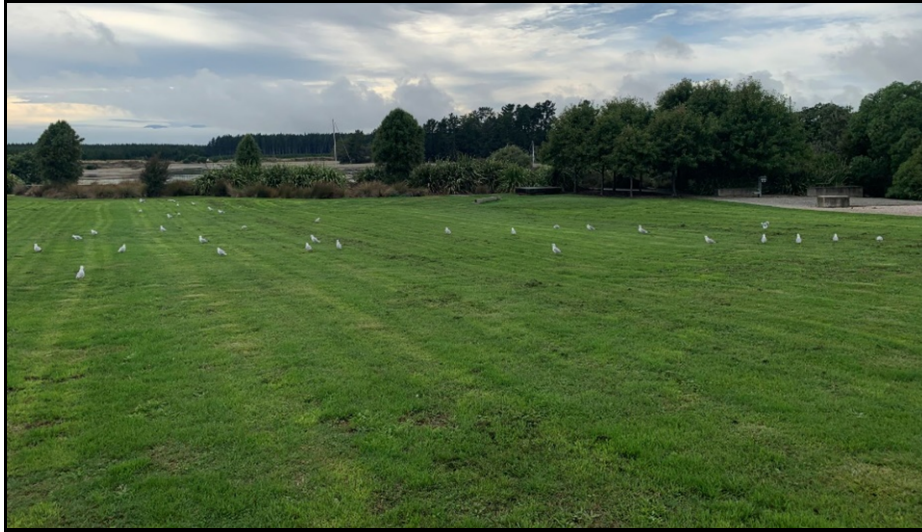
Figure 4: Open grassed area, paths, seating and native plantings in the reserve adjacent to the foreshore. View looking east. The image was taken on 14 February 2022.
