Technical Report

MOTUEKA / RIWAKA PLAINS GROUNDWATER QUALITY SURVEY 2019

October 2020

Tasman District Council File Ref: R99037

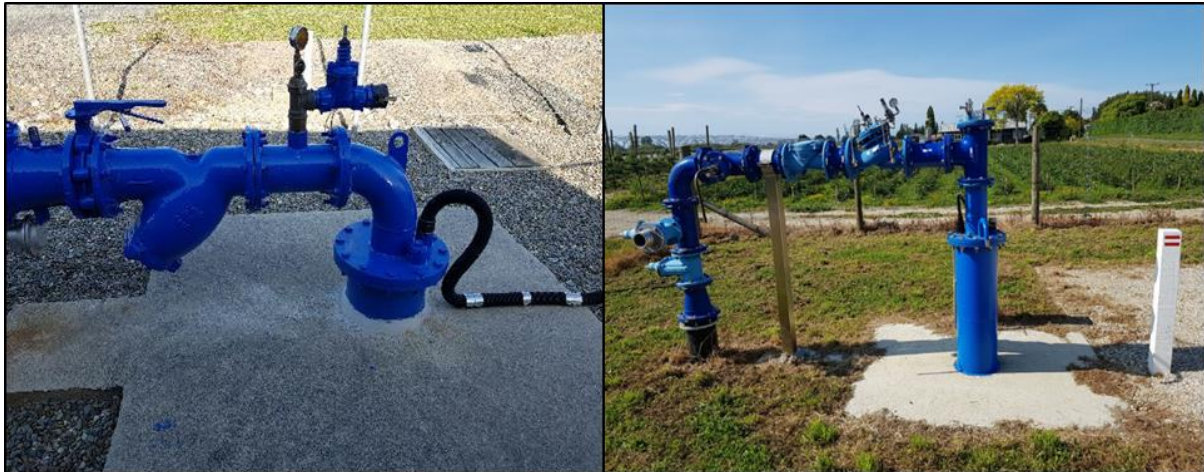
Council have three bore water supplies within the area including Motueka reticulated water supply (located near the Motueka Recreation Centre) and the Kaiteriteri/Riwaka reticulated water supply (located in Riwaka). These boreheads are in excellent condition and are raised above the ground. While it was not part of this project it is likely that the boreheads would meet the requirements in the DWSNZ (see Figure 11).

Figure 11: Examples of Council reticulated water supply bores from the 2019 Motueka / Riwaka Plains survey.

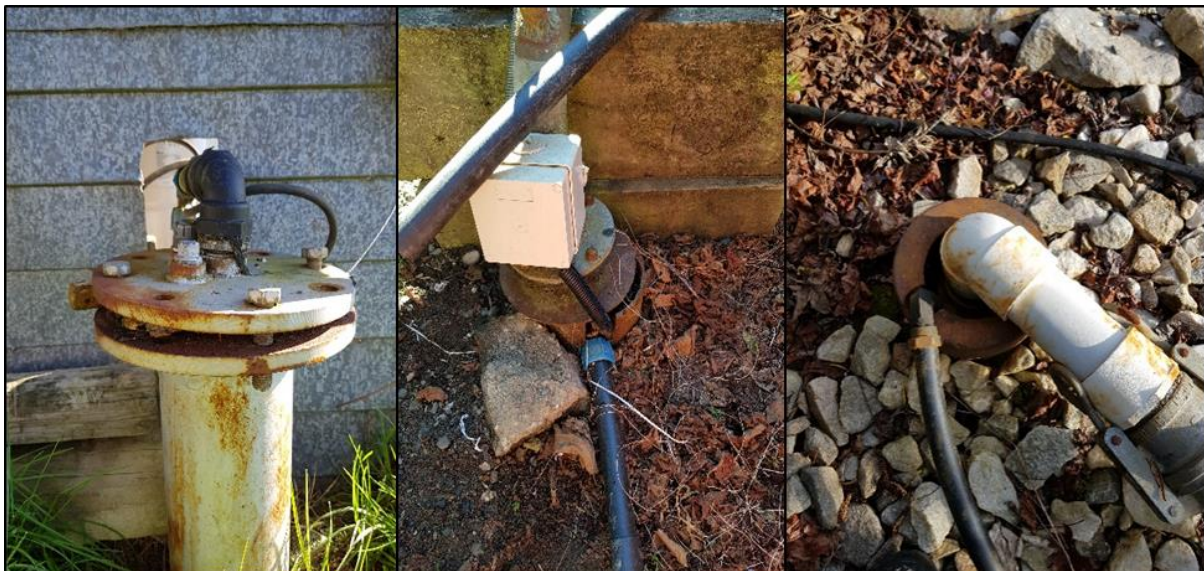
The community water supply (Council and private supplies), irrigation and large industry bores were generally steel pipe bore casings with a separate extraction pipe. Some of those private bores sighted had been modified or not appropriately sealed affecting the borehead security and potentially allowing access to birds and vermin along with dust and dirt. Most of these were not sealed at ground level. Examples of boreheads that have been modified or poorly sealed can be seen in Figures 12 and 13.

Figure 12: Examples of modified or poorly sealed boreheads from the 2019 Motueka / Riwaka Plains survey.

- Increase awareness of private bore owners on how to reduce their risk of bore contamination. Relevant information will be provided on the Council website and via the Newslines magazine.

- Increase awareness for bore drillers and non-Council water service agents (private and community) on the importance of borehead security and the need to improve this. Education/training for Council Environmental Health Officers by appropriate qualified Drinking Water Assessors to be provided to address borehead security.

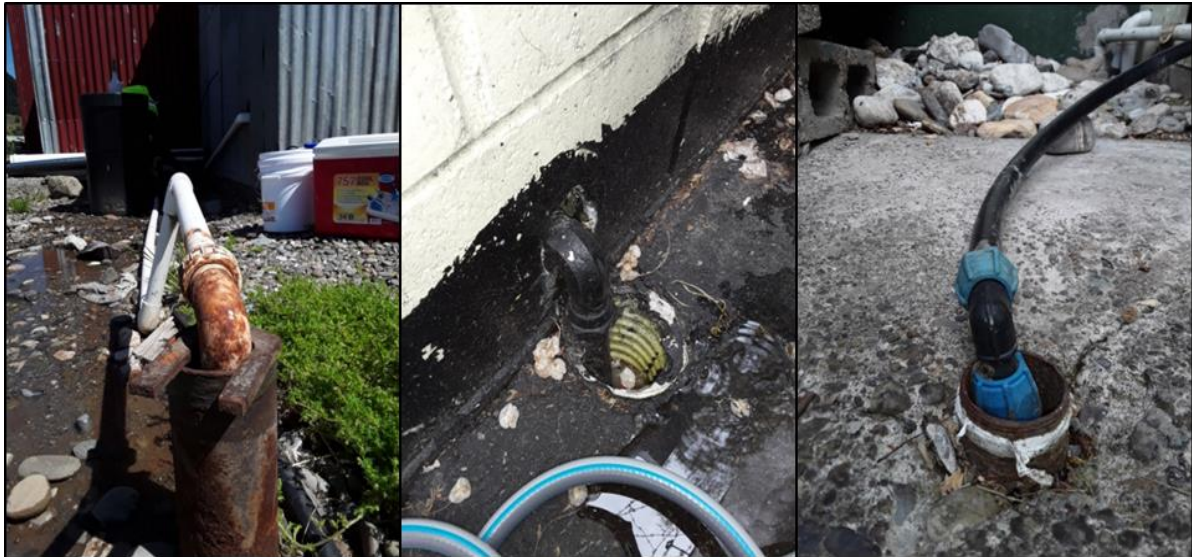
Figure 13: Examples of poor private boreheads / practices from the 2019 Motueka / Riwaka Plains survey.

- Well/boreheads next to rubbish storage, stormwater drains and in low-lying areas
- Chemical storage in the vicinity of well/boreheads
- Historic driven pipes not sealed at ground level or appropriately sealed
- Wells with unsealed well liners and inadequately fitting lids
- Lack of records on individual bore supplies due to them being a permitted activity

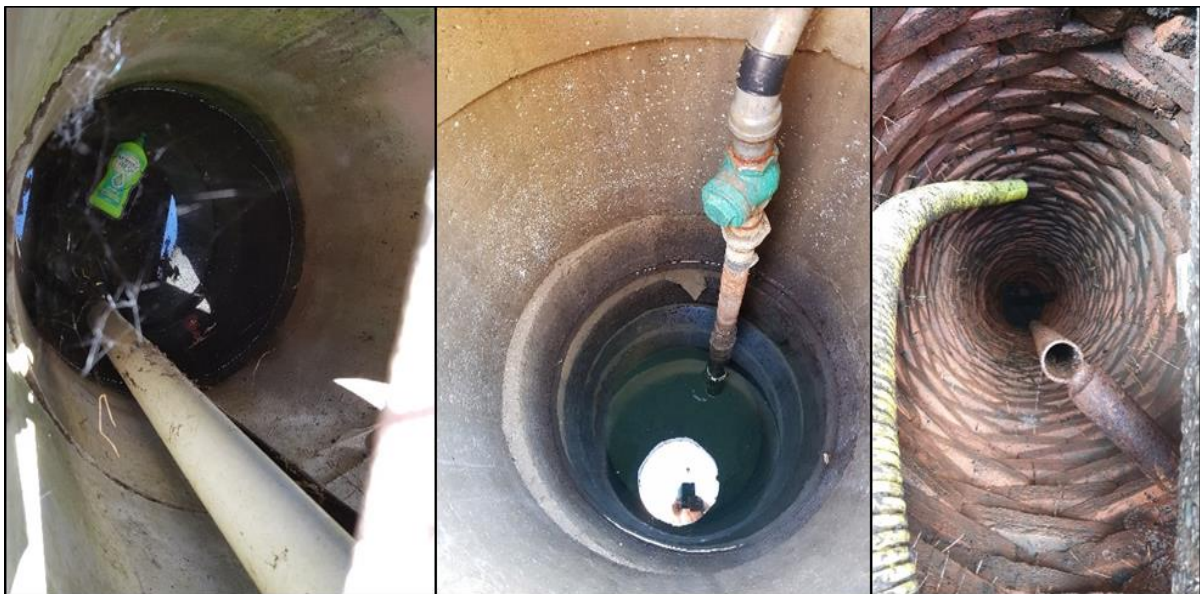
There were also a number of concrete lined wells seen throughout the area, some of which were in use. These were in areas where the groundwater level is higher (closer to ground level). These wells are more prone to contamination as they often can have gaps between the well liners and removable lids (see Figure 14).

Figure 14: Examples of wells from the 2019 Motueka / Riwaka Plains survey.

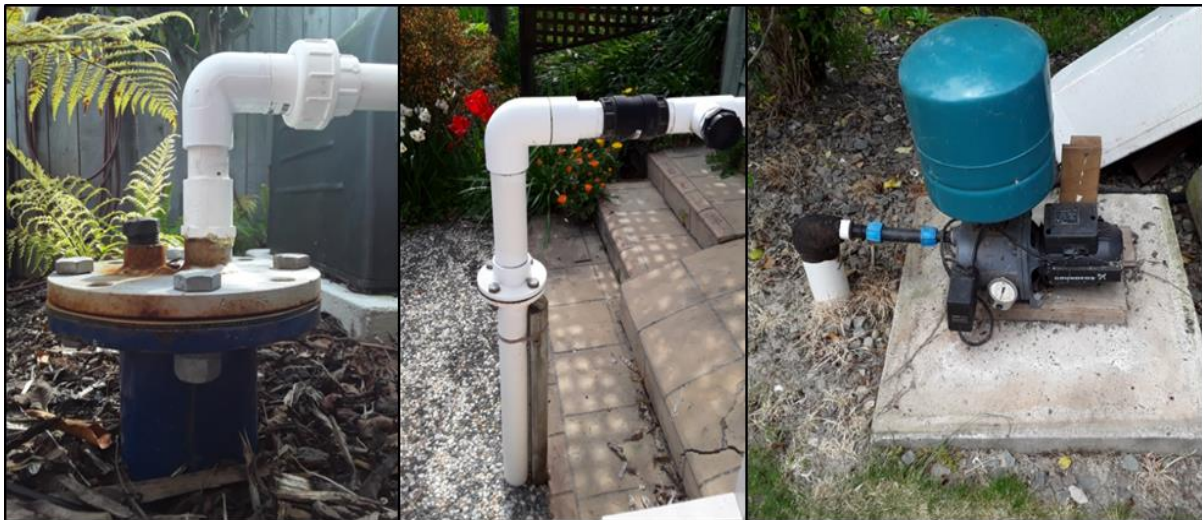
While some of the practices encountered could affect the groundwater, there were also some very good examples of private bores being well sited and protected (see Figure 15).

Figure 15: Examples of good private boreheads / practices from the 2019 Motueka / Riwaka Plains survey.
