River Water Quality in Tasman District

State of the Environment Report

River Water Quality in Tasman District 2015

A technical report presenting results of the Tasman District Council's 'State of the Environment' River Water Quality Monitoring Programme and additional data from the National River Water Quality Network. Indicators measured include: physical, chemical, and bacteriological characteristics of the water, macroinvertebrate indices and periphyton cover. The report highlights water quality condition and trends, from the Waimea, Motueka, Takaka, Aorere and Buller water management areas.

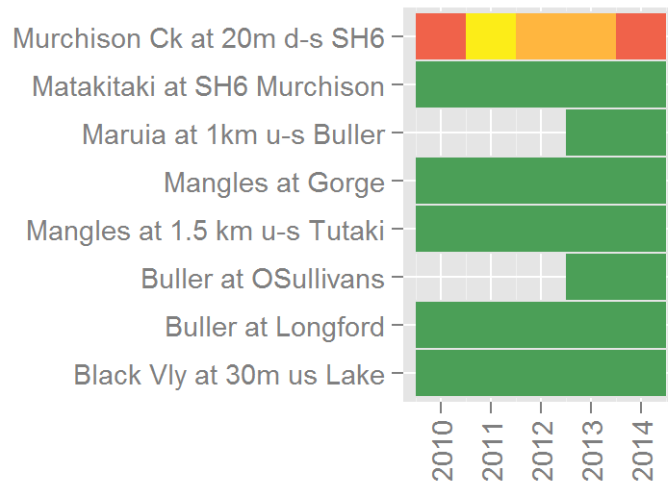
Figure 3. Tile plot of annual median *E. coli* values for sites in the Buller Water Management Area. Colours indicate attribute states A (green), B (yellow), C (orange) and D (red). Blanks indicate insufficient data (less than three records in a given year).

At all sites monitored in the Buller Water Management Area, except Murchison Creek, the annual median *E. coli* concentrations were in the A band (less than 260 *E. coli*/100 ml) (Figure 3).

The overall median for Murchison Creek at SH6 was 960 (2005-2015). The annual median *E. coli* concentration for this site was over double the National Bottom Line (1000 *E. coli*/100 ml) in 2010 (median value 2200 *E. coli*/100 ml). The annual median value for 2014 was right on the National Bottom Line (median value 1000 *E. coli*/100 ml). These results make this site the worst performing, in terms of *E. coli* concentrations, in the Tasman District.

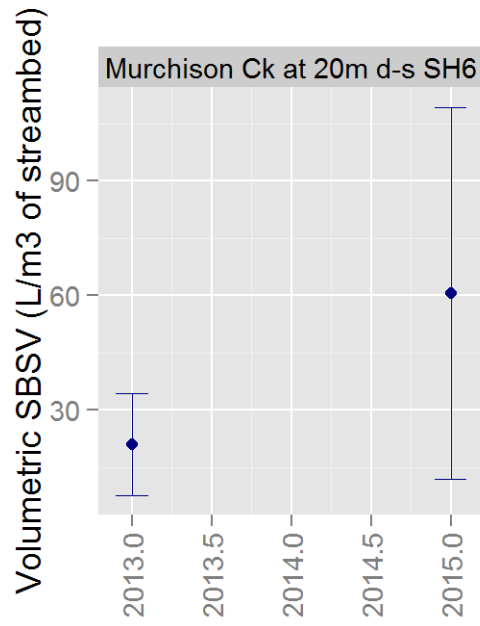
Figure 8. Mean volumetric suspendable benthic sediment volume (SBSV) from 2013 to 2015 (sampled during summer). The error bars show 95% confidence intervals.

Murchison Ck at 20 m d-s SH6 was the only site in the Buller Water Management Area for which there were records of volumetric SBSV (Figure 8). At this site, there was no difference in mean volumetric SBSV between 2013 and 2015.

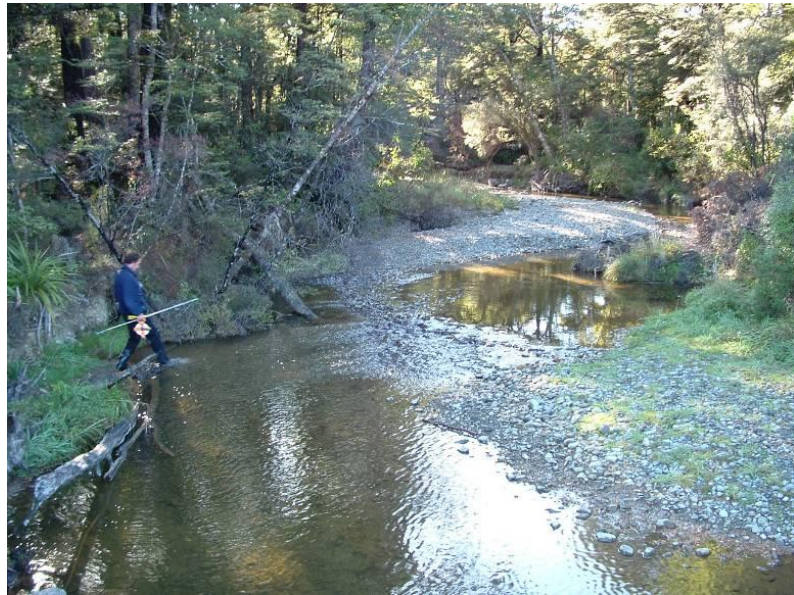
Above: Black Valley Stream, looking upstream from Kerr Bay Rd (May 2008)

Black Valley stream has generally had **very good water quality** since the late 1990's when the St Arnaud sewage treatment scheme was installed. Median is 15 *E.coli*/100 ml, which is equivalent to a pristine forested stream.

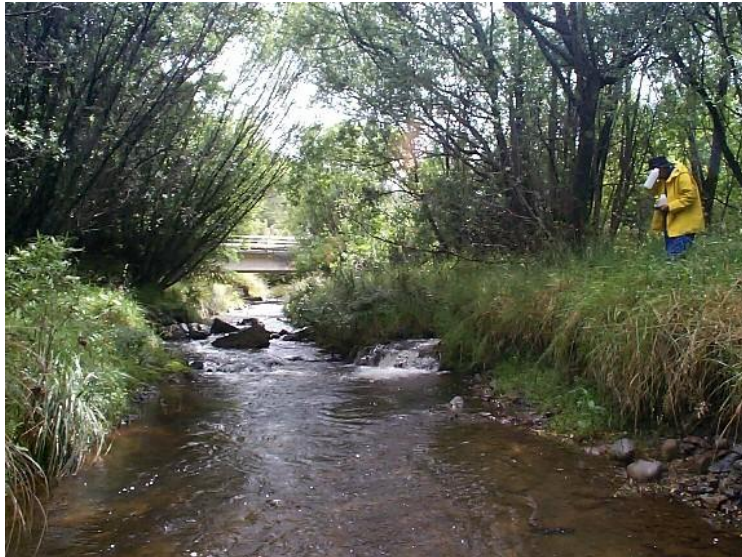
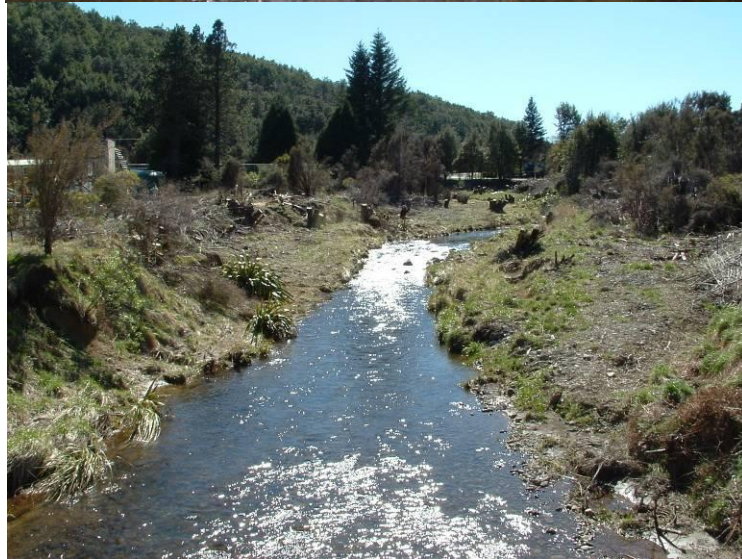
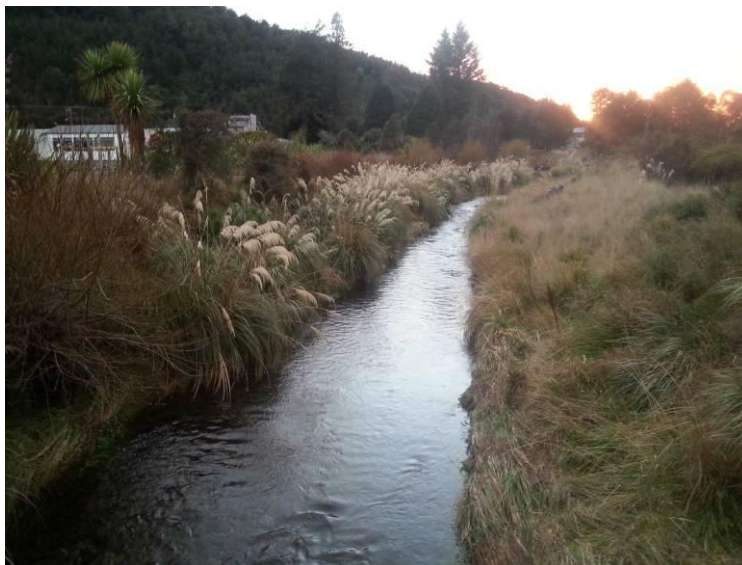
**Willow clearance and riparian plant replacement with natives on Black Valley Stream downstream SH63.
From top: November 2002, October 2012, May 2015.**

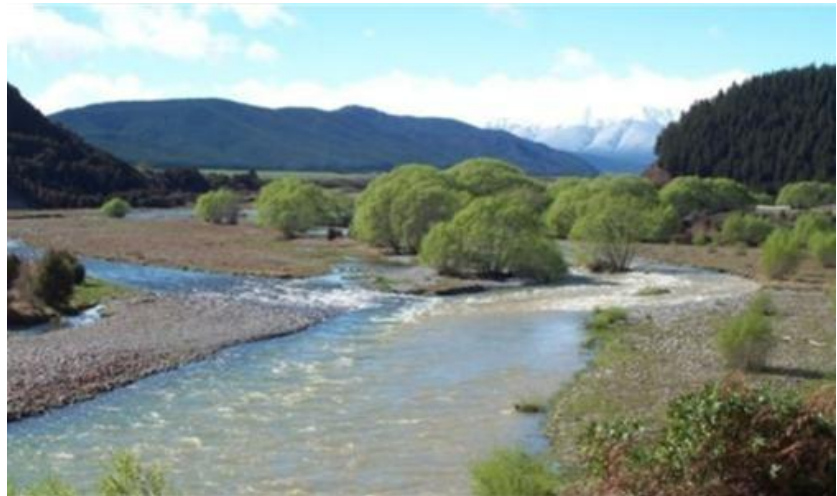
Buller River near Harleys Rock, downstream Howard River (September 2007). Clear water from the Buller River can be seen on the left of the photo (true right), and turbid water from the Howard River is coming in on the right of the photo (true left).

Heavy fine sediment load to the Howard River, and then on down the Buller River, occurred for several years from 2006. Farmers in the Howard Valley (Basher, G. *pers. comm.*) explained that the sediment was coming from the true right branch of the Howard River about 6-8 km upstream of Howard Head Station, after a heavy downpour in 2006. While the stream mostly cleared within a week, the river became very discoloured after 20-30 mm of rain, and this lasts for 2-3 days with the effect slowly diminishing over the 5-6 years afterwards.

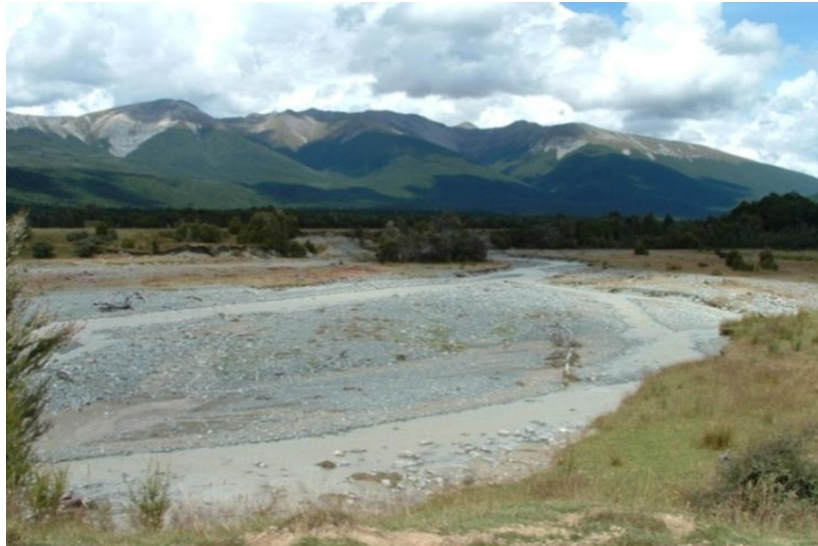
Howard River at Howard Head Station (February 2008), looking south to the Angelus Range where the source of the sediment is located.

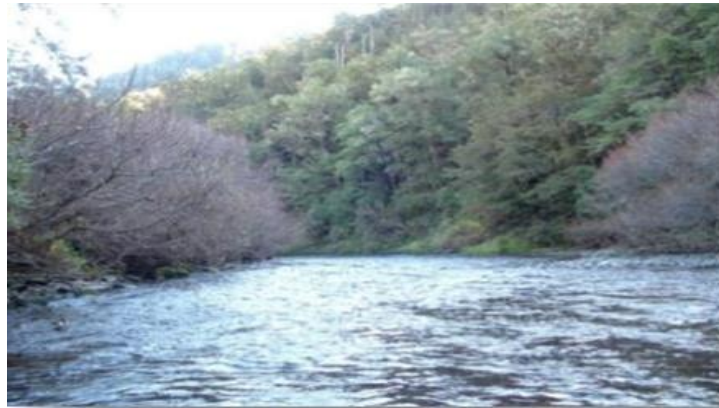
Above: Mangles Rv at Gorge (May 2008).

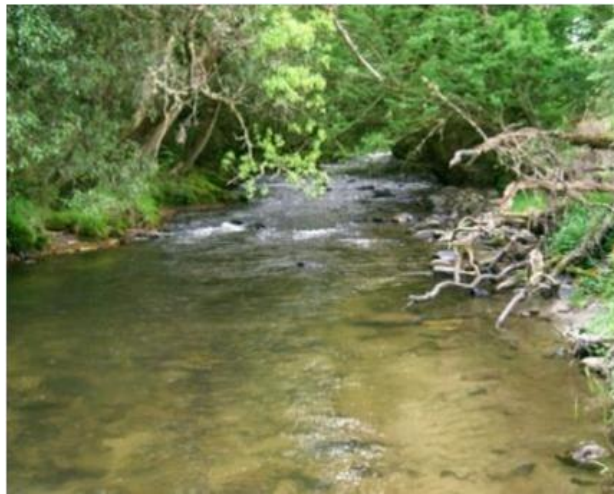
Mangles Rv u-s Tutaki Rv (April 2005)

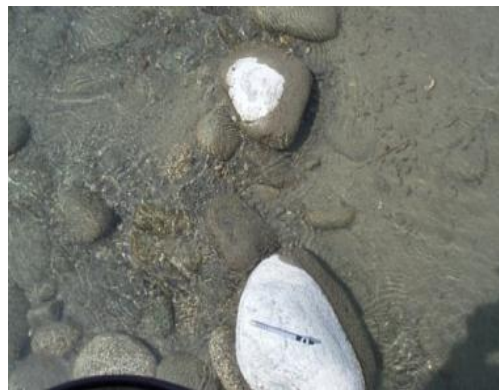
Fine sediment deposits, common at this site.

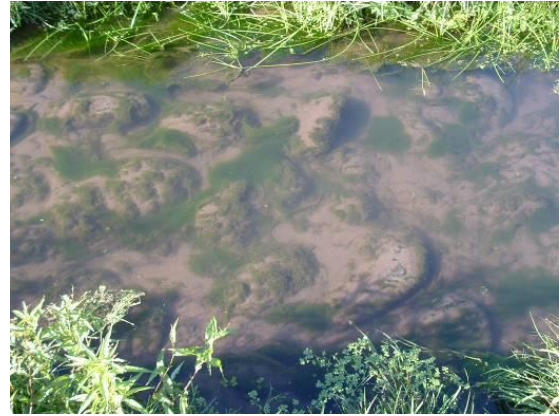
Above: Murchison (Ned's) Creek showing the thick fine sediment deposits and filamentous green algae (April 2012)

Fine sediment volume has averaged 60L/m³ of the bed volume, which is considerable. The main sources of fine sediment are from discharges from transport operations (a truck wash facility discharging into the creek ceased in 2008), slips in the hill country to the south east of the township in 2011-12 (this loading of sediment reduced to almost nil by mid 2014, even at high flows) and farming activities (particularly stock trampling the banks). Its spring-fed nature, with relatively stable flows, also means that sediment in the creek is not readily flushed.

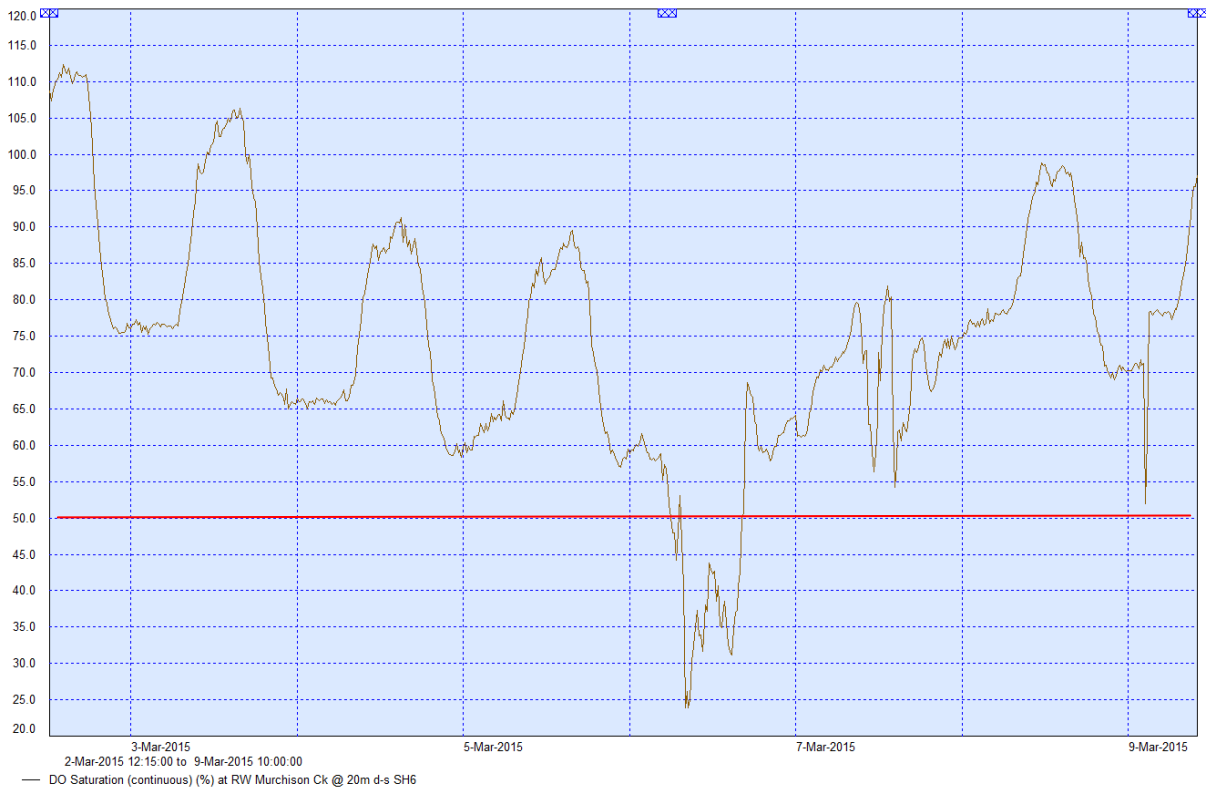
Figure 14. Dissolved oxygen % saturation at Murchison Creek 20 m downstream of SH6 from 2-9 March 2015. The national proposed bottom line for the daily 1-day minimum is shown by the red line.

Dissolved oxygen levels were measured in March 2015. Daily minima were found to be generally over 60% (Figure 14). The spiky and erratic dissolved oxygen plot shown below is probably due to rain in the middle of the monitoring period (6 March), and possibly stock in the stream. This pattern is more closely reflected in the dissolved oxygen profile for the true right branch upstream of Fairfax (Figure 16) rather than the true left branch at the Kiwi Park Motels (Figure 15).

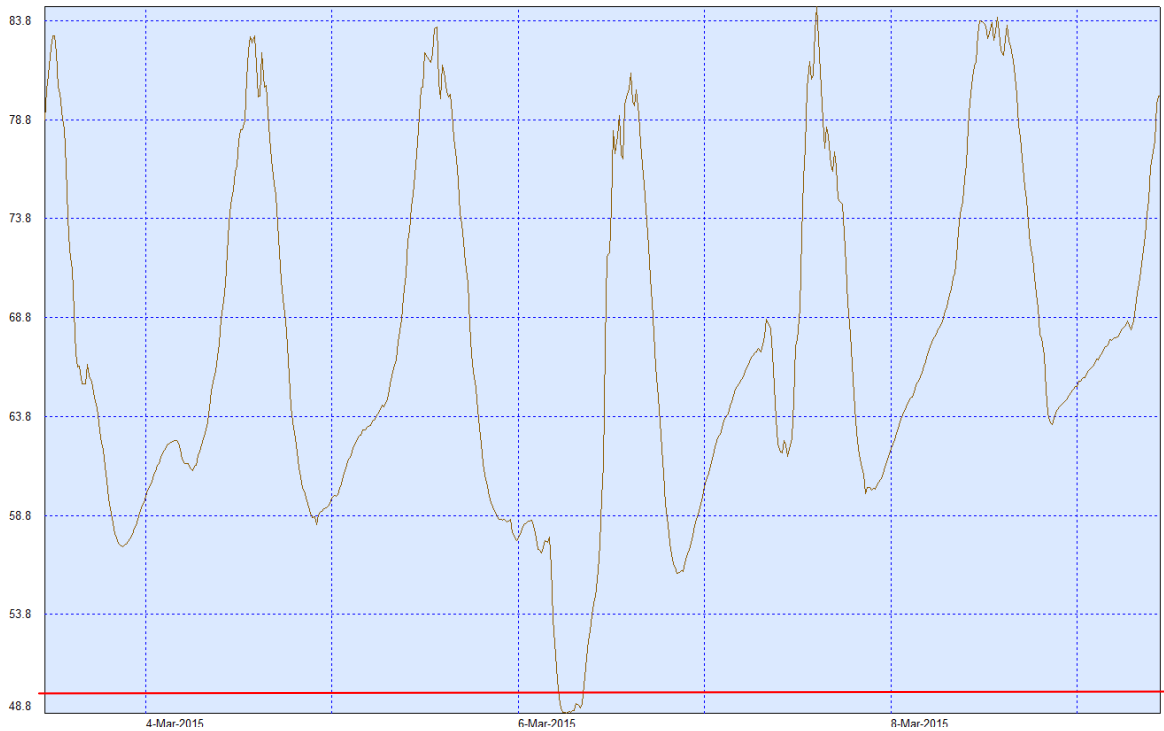
Figure 15. Dissolved oxygen % saturation at Murchison Creek upstream Kiwi Park Motel from 2-9 March 2015. The national proposed bottom line for the daily 1-day minimum is shown by the red line.

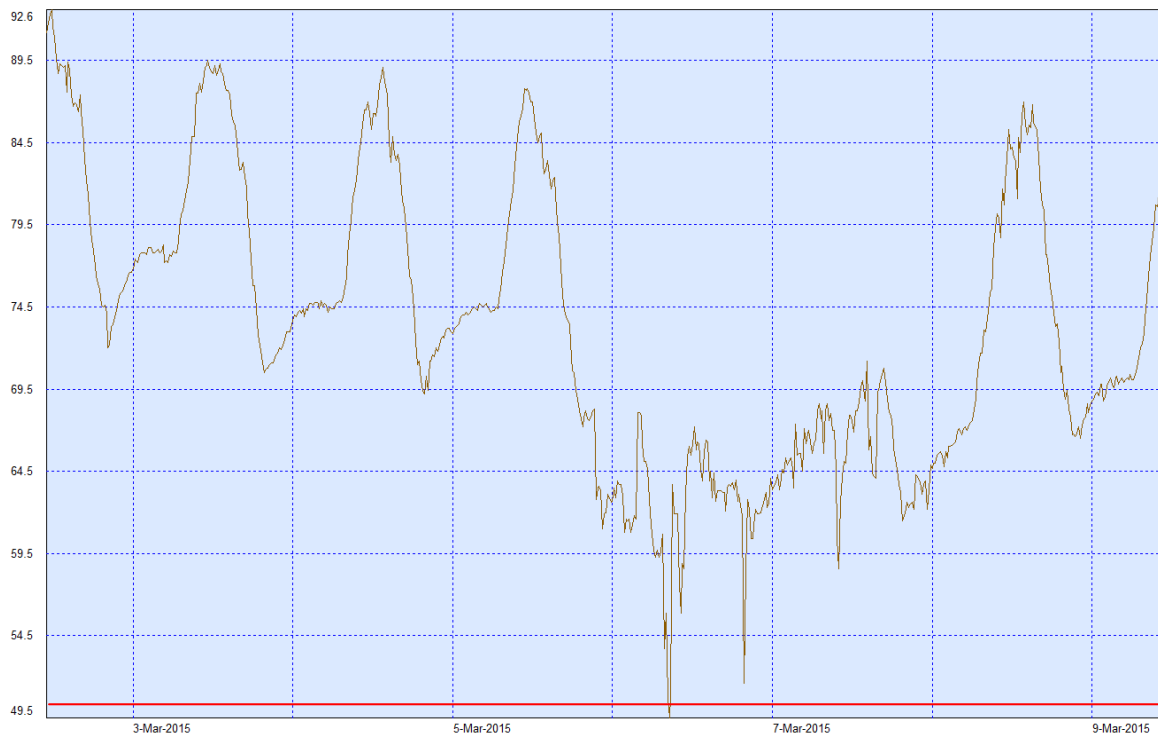
Figure 16. Dissolved oxygen % saturation at Murchison Creek upstream Fairfax St from 2-9 March 2015. The national proposed bottom line for the daily 1-day minimum is shown by the red line.

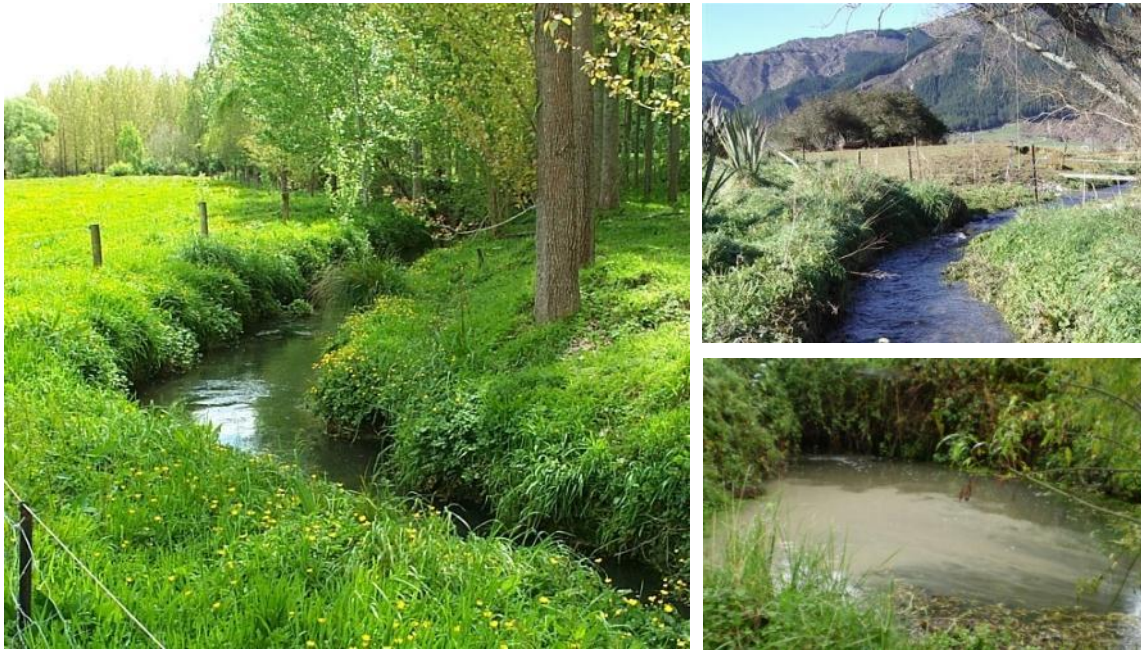
Left and bottom-right: Murchison Ck at SH6 (October 2008 and April 2007 (sediment discharge event)). Top right: Murchison Ck upstream Fairfax St (July 2007).

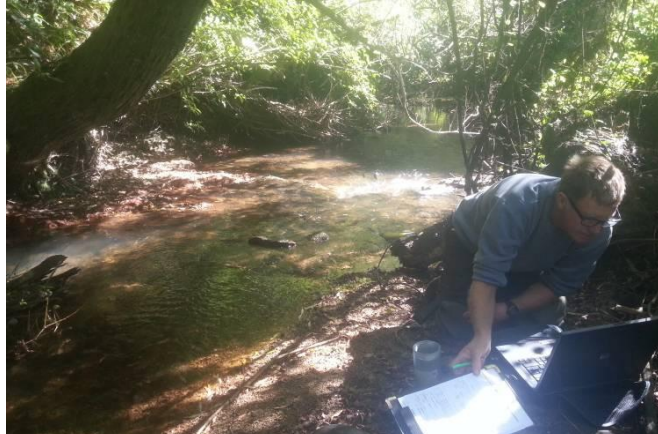
Above: Doughboy Creek 200 m upstream Buller River (March 2014)

Resuspendable solids (Shuffle method) indicate moderate-high levels of fine sediment in the bed. Conductivity is consistently high ranging from 240-250 $\mu\text{S}/\text{cm}$ indicating a strong groundwater influence or other discharges from the catchment. Heavy trampling and soil loss from banks of this stream were evident in winter 2013. Better stock exclusion is required along this stream.

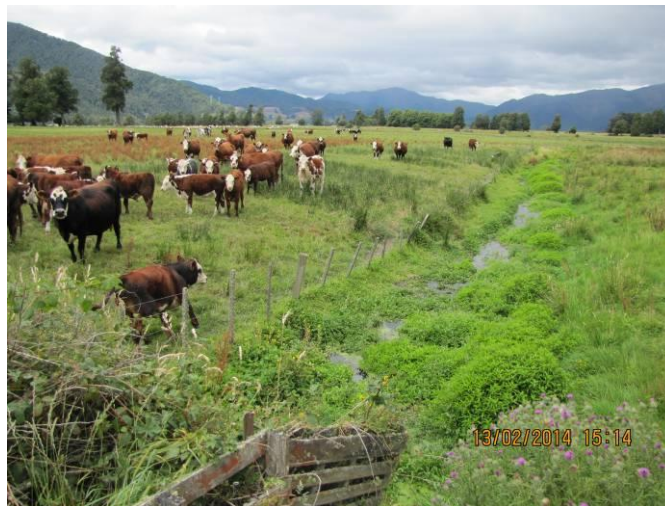
View upstream of Hinehaka Road (February 2014), note the lack of adequate riparian fencing.

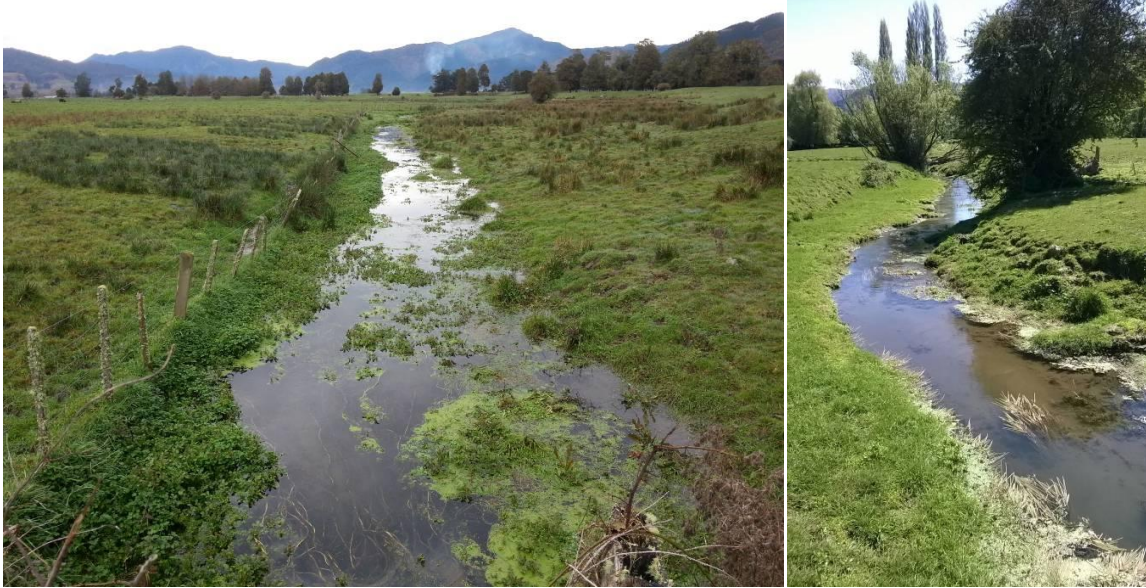
Left: View upstream of Hinehaka Road (July 2014). Right: view downstream (October 2014)
