Technical Report

WAIMEA GROUNDWATER QUALITY SURVEY 2021

June 2023

A technical report presenting results of the Tasman District Council's groundwater quality synoptic survey undertaken in the Waimea Plains. The report draws on various monitoring data collected by Tasman District Council, including that collected for the Institute of Geological and Nuclear Sciences Ltd as part of the National Groundwater Monitoring Programme and the Institute of Environmental Science and Research as part of the national survey of pesticides, glyphosate and emerging organic contaminants.

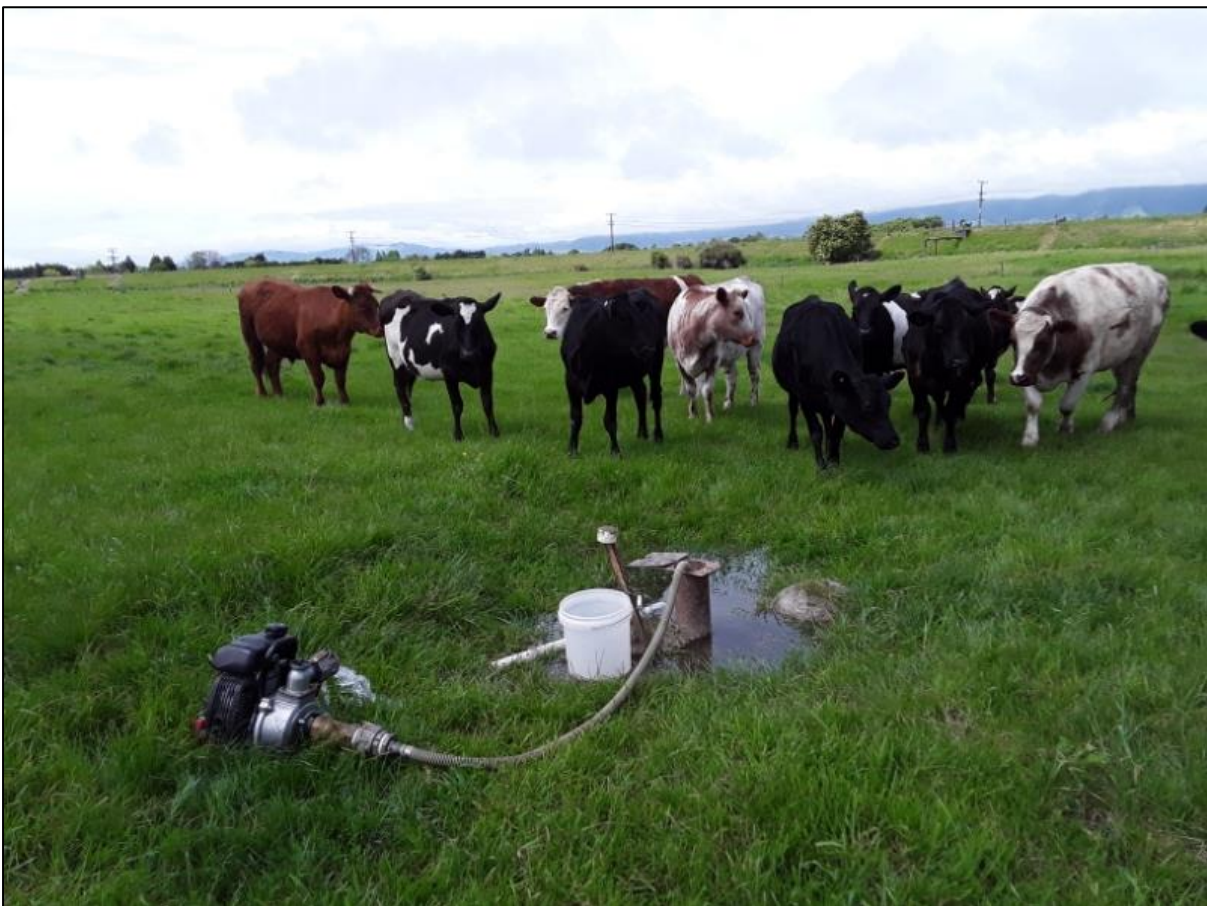
Figure 5: Bore located in paddock with no fencing to prevent stock from accessing the bore. Though the riser is above the ground surface, the bore itself is located in a low-lying area where water tends to pool with no concrete pad to prevent soakage. Contamination is likely to soak into the ground near the bore or have floodwaters flow directly down the bore.

Wells and driven bores are sourced by shallow groundwater close to the ground surface above it and it is common for these to breach the MAV for the bacteriological pathogen indicator *E.coli*. Most the bores/wells with bacteriological exceedances did not meet the safe water take requirements (Section 2.4 from the Drinking Water Acceptable Solution for Spring and Bore Water Supplies ([Taumata Arowai, 2022b](#))) and the bore construction requirements (Chapter 16, Clause 16.12 under the Tasman Resource Management Plan ([Tasman District Council, 2022b](#))). Contamination can include seepage from stagnant water near the bore/well, localised seepage along the edges of the bore/well, animal faecal contamination, septic tank seepage and runoff/seepage following rainfall into the bore/well.

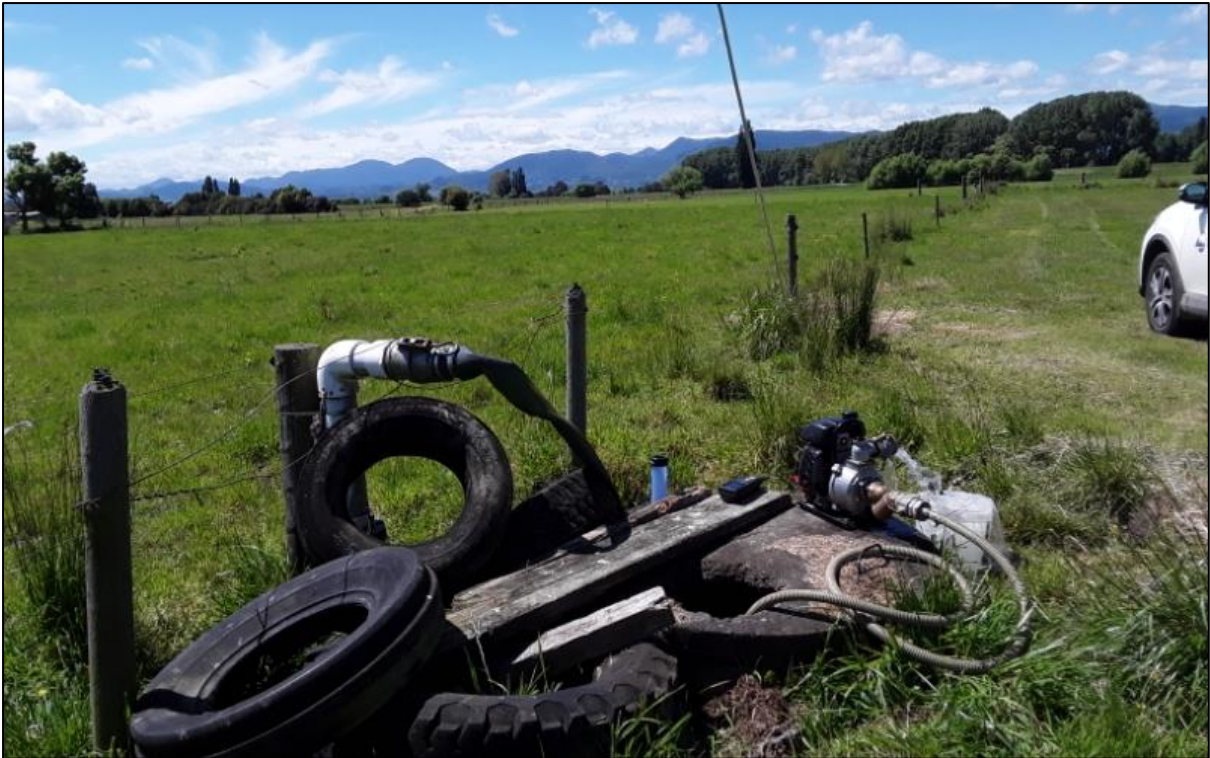
Figure 6: Well with no adequate well head protection. Contamination can easily enter into the groundwater by falling directly into the well.

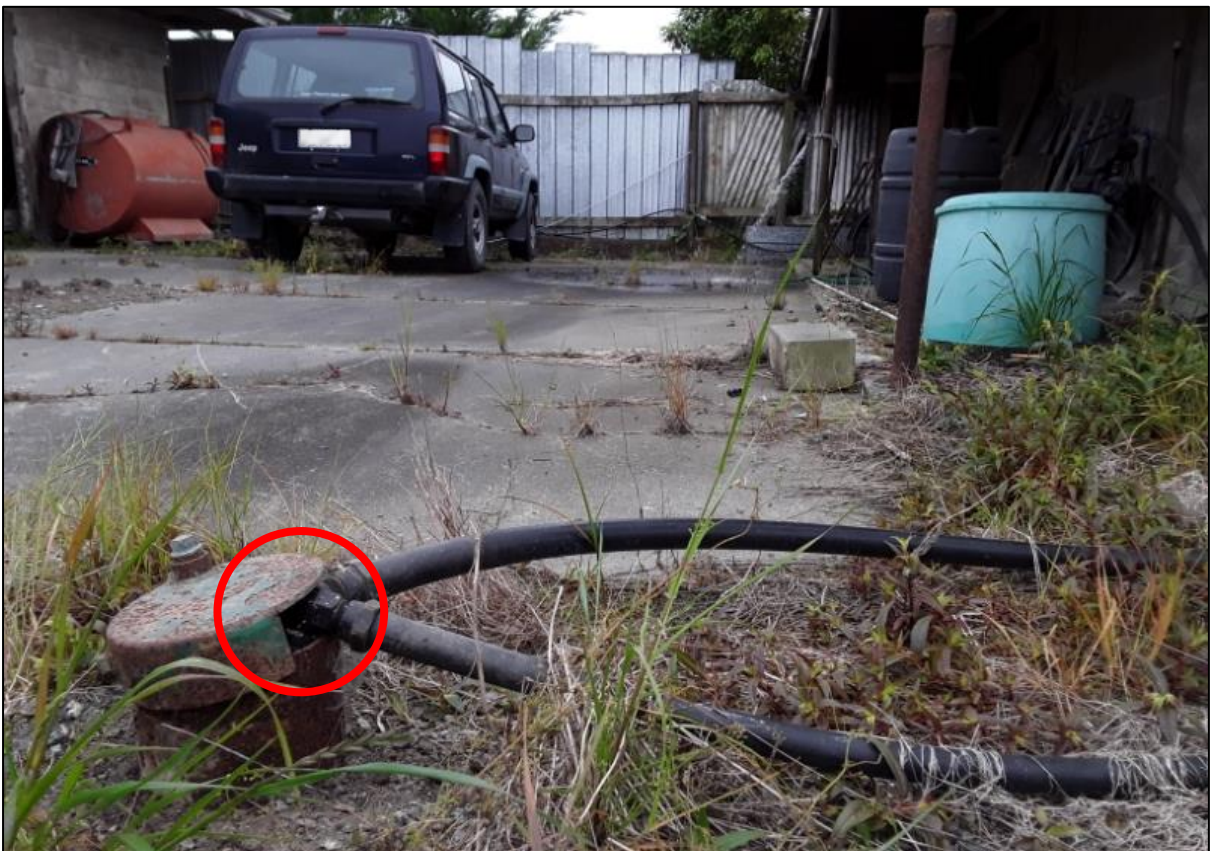
Figure 7: Bore located in low lying area without adequate bore head protection. Contamination can easily enter into the groundwater from the bore.

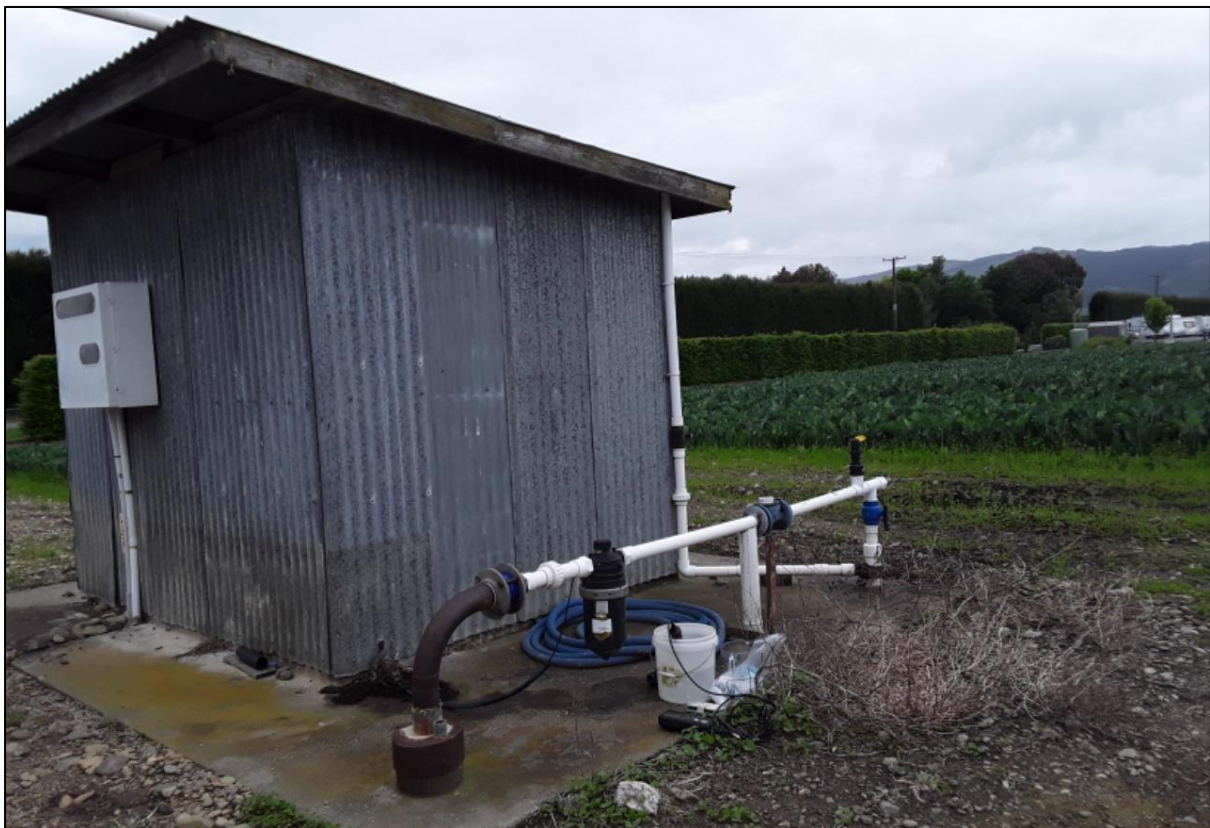
Figure 8: Bore with a sealed bore head located above the ground to prevent stormwater runoff entering the bore. Backflow prevention device installed to prevent contaminated water flowing back into the aquifer. Concrete pad to deflect stormwater and prevent direct soakage into the bore.

Drilled bores access deeper groundwater (typically in the Waimea Plains this is bores accessing the UCA and LCA or deeper AGUA/HU sites). Most of the groundwater from the bores had no detections of *E.coli* at the time of sampling, with the majority having good bore head protection and were appropriately sited away from potential contamination sources. Drilled bores can also access semi-confined and confined aquifers, which have a confining layer which prevents contamination from seeping directly from the ground surface above the bore. However, semi-confined and confined groundwater are still susceptible to contamination in areas which recharge those aquifers. The deeper the groundwater is abstracted from the aquifer, the more natural filtration and die-off of pathogens occurs. Figure 8 shows an example of bore located in the Waimea Plains that is appropriately sited, with good bore head protection.

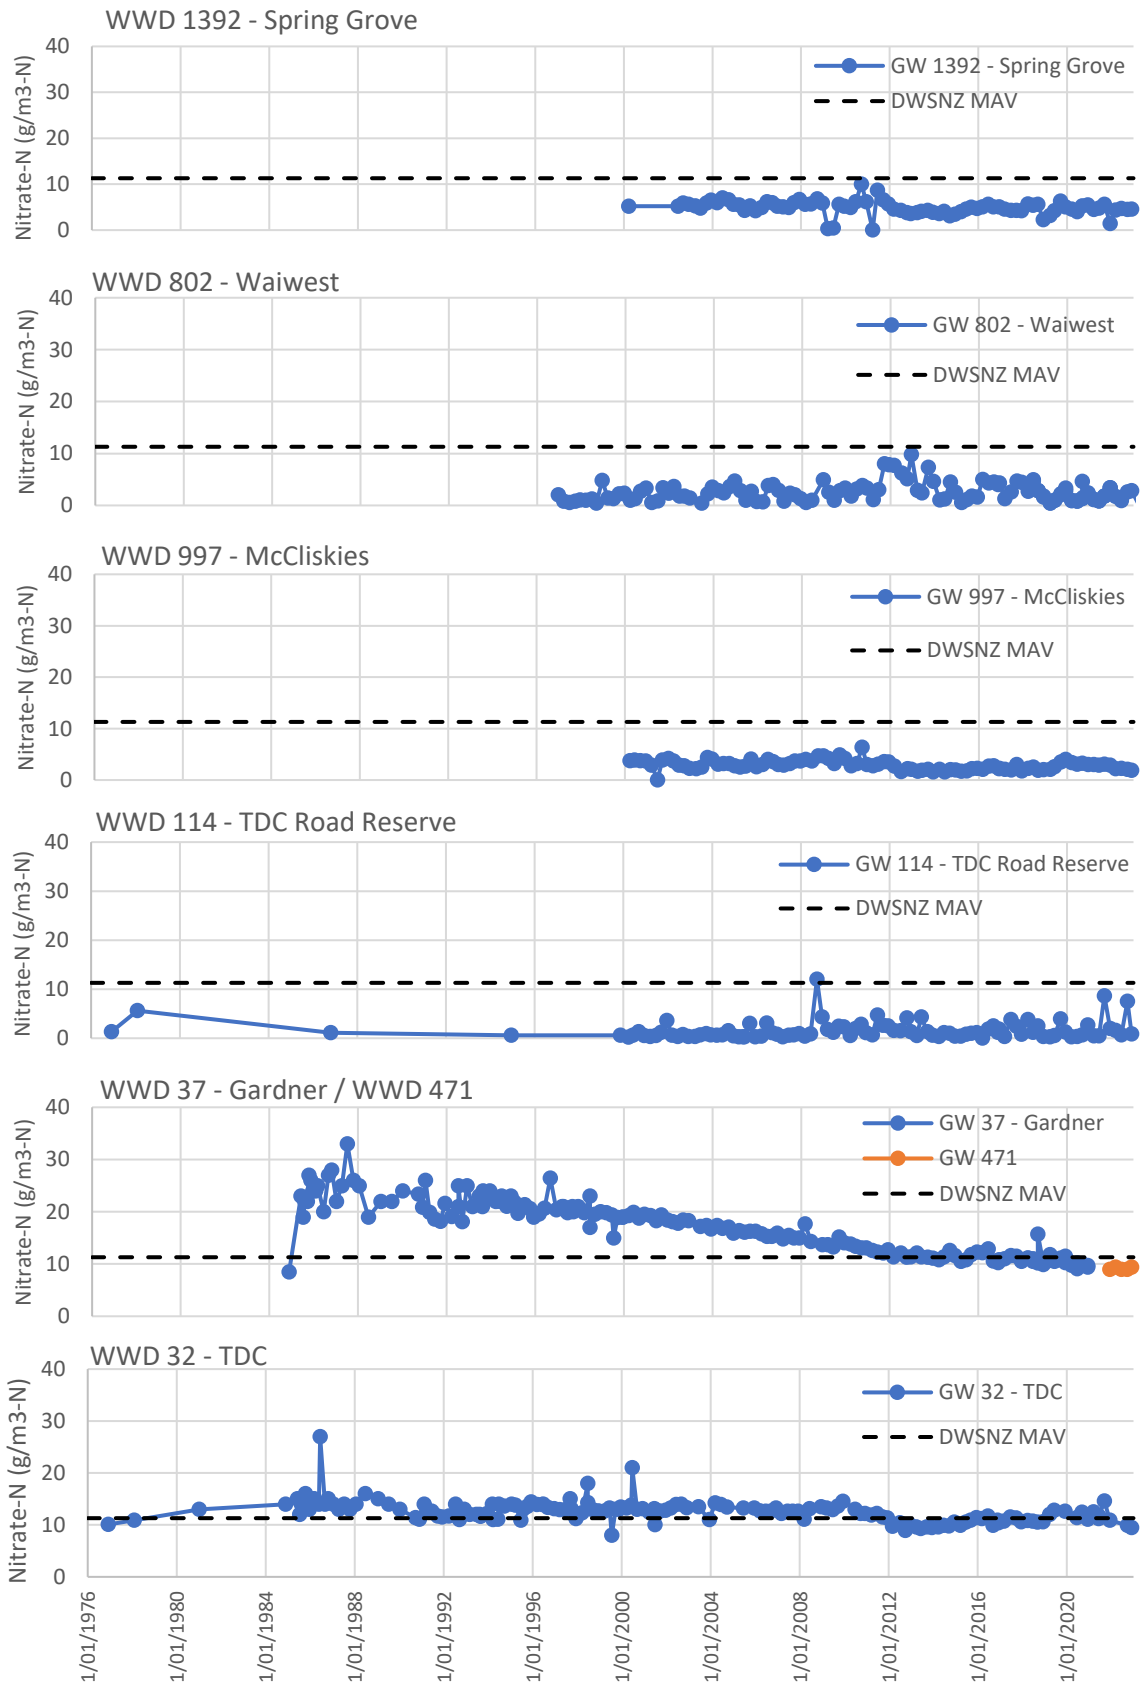
Figure 11: Measured groundwater nitrate-N concentrations over time in the Waimea Plains State of the Environment bores.

The three SoE bores from the AGUA all show low to medium nitrate-N concentrations (below the MAV). There appears to be no significant seasonal variation. From trend analysis, Spring Grove and McCliskies show a decreasing trend, with Waiwest showing an increasing trend. For all three SoE AGUA sites there is little variation from the mean throughout the years, suggesting that despite a strong trend (increasing or decreasing) resulting from the trend analysis, the actual movement of the trend from the mean is small. The average nitrate-N concentration for these bores are as follows:

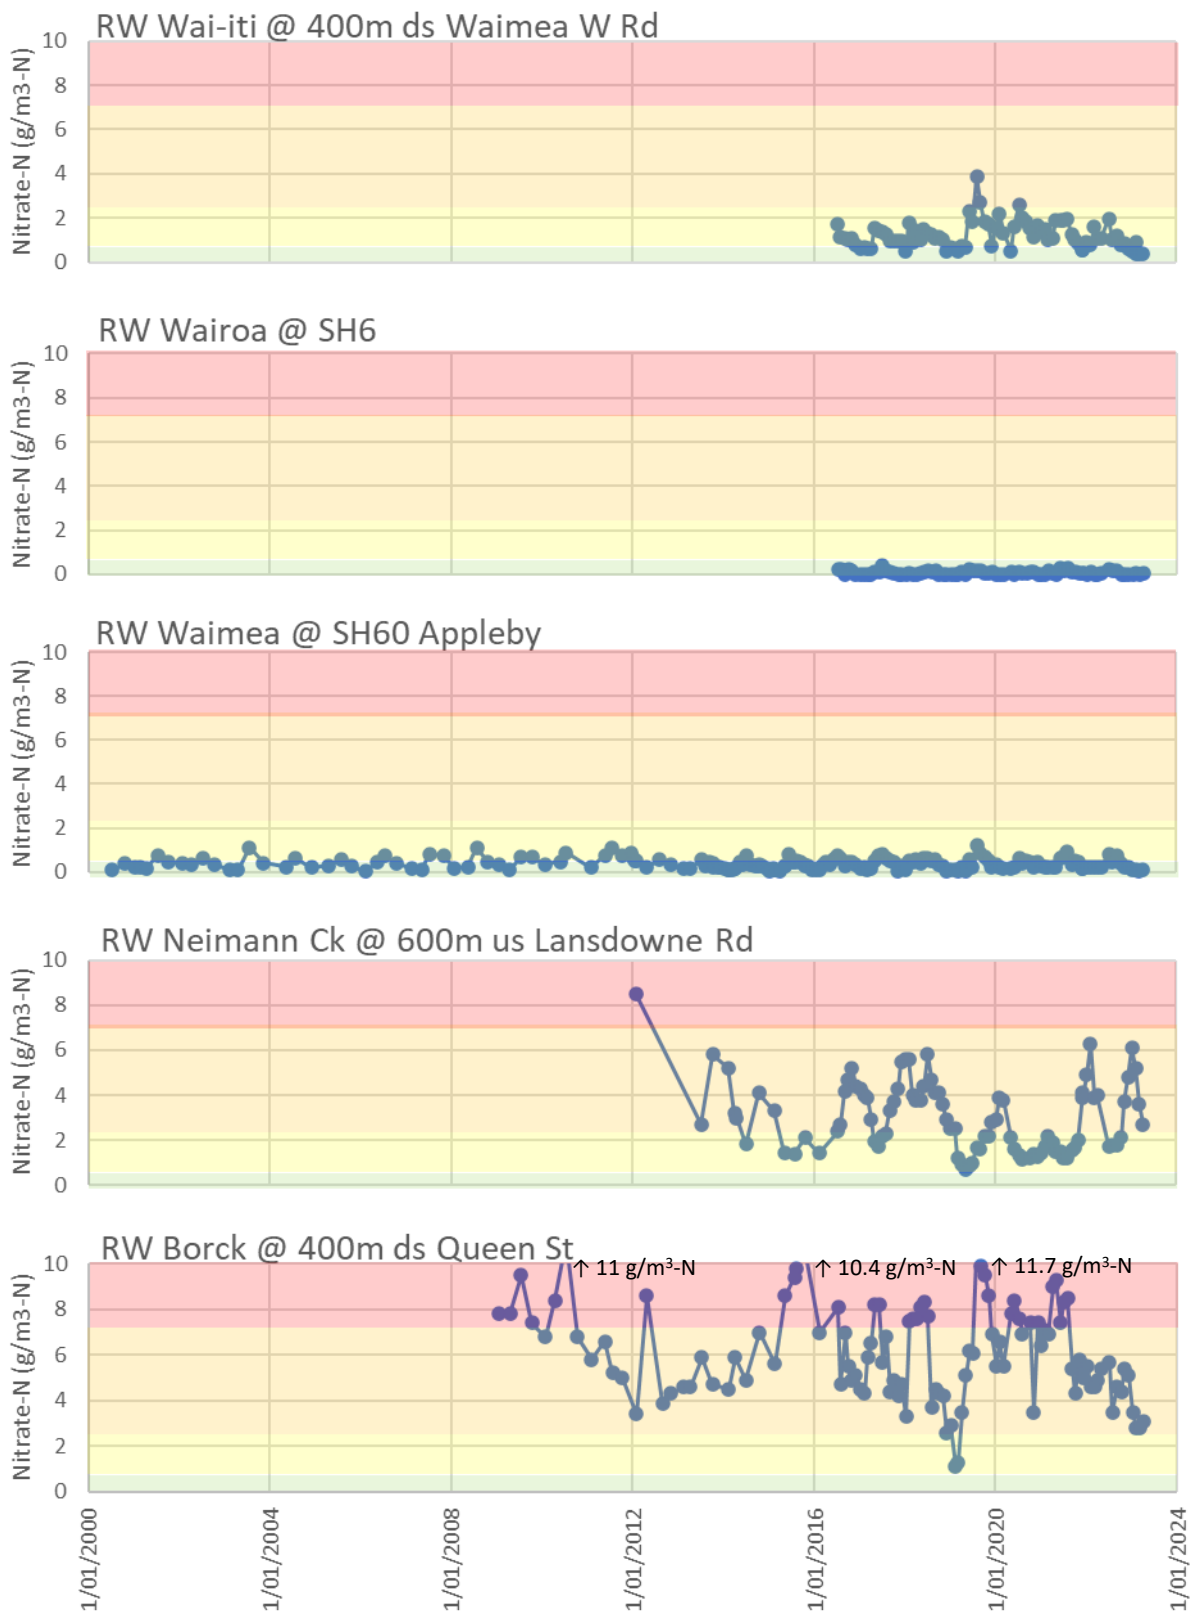
Figure 15: Measured surface water nitrate-N concentrations over time in the Waimea Plains State of the Environment surface water sites.

Water in the spring fed creeks is hard, which means that the impact of nitrate toxicity experienced by the ecosystems in the spring fed creeks is lessened (Hickey, 2015) but the current levels still exceed the NPSFM ecosystem criteria. The spring-fed streams have high nitrate concentrations as the source water is from groundwater in the Waimea Plains. With the long residence time in the groundwater system, these sites are unlikely to recover anytime soon. If action was taken immediately to reduce nitrate inputs into the springs, it could still take up to 15 to 20 years before nitrate concentrations reduce to acceptable levels (James and McCallum, 2023).
