Appendix A: Stage 3 design drawings (Bound separately)

Lee Valley Dam - Initial Peer Review Feedback on Stage 1 Design Report

Peer Review of Lee Valley Dam Design

Appendix D: Draft Emergency Action Plan (EAP)

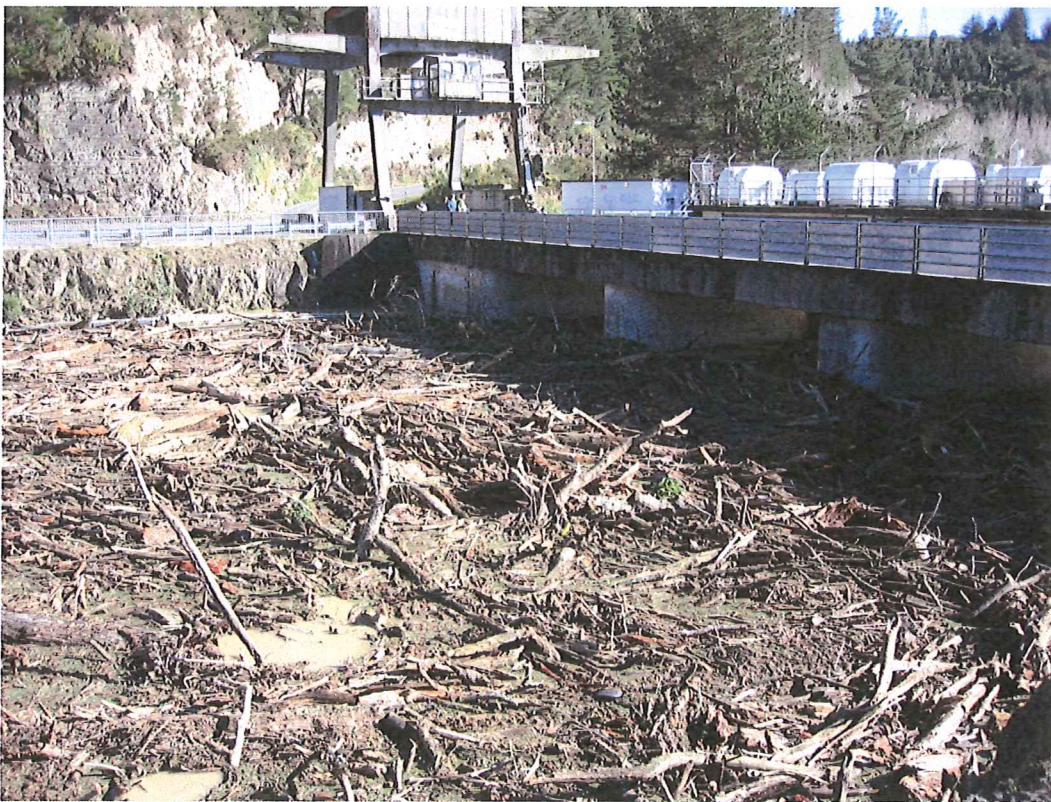
Photo 1 - Matahina

By way of example, Photos 1 and 2 show debris rafts on two New Zealand schemes, Matahina and Patea. Advice from operators of schemes with similar debris issues is that extracting the debris can be time consuming, difficult and hazardous if boats are required.

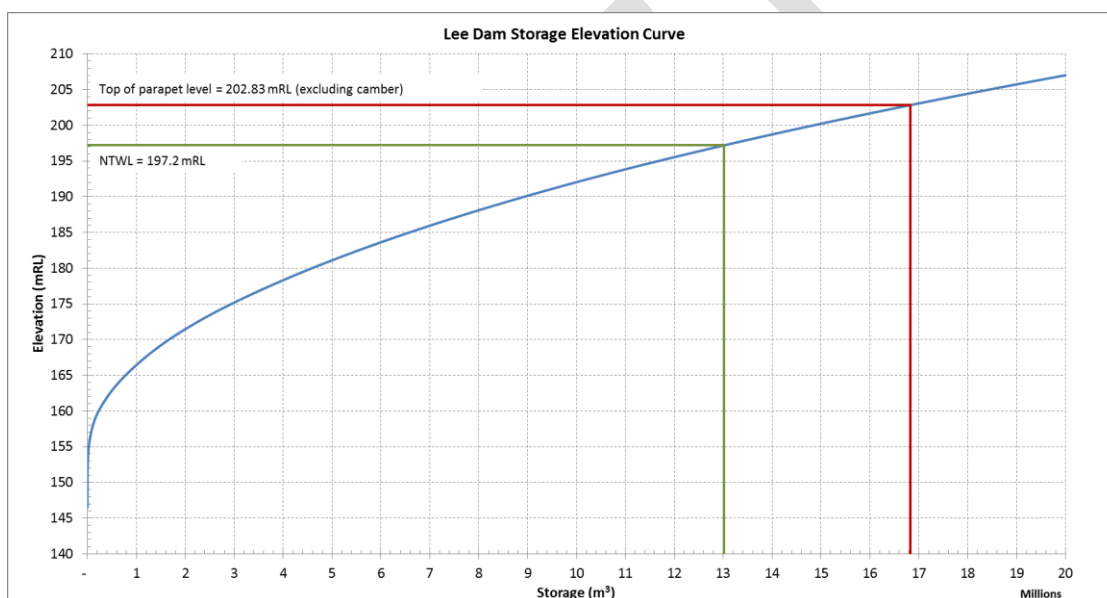
Figure 6 1 Storage elevation curve for the Lee Valley Dam indicating NTWL and top of parapet wall

At the Normal Top Water Level (NTWL) of 197.2 mRL the reservoir has a storage capacity of approximately 13 million m³. Further details on the Reservoir can be found in the Stage 3 Design Report (T&T, 2012).

Figure 6-1 presents the reservoir water storage versus water elevation relationship for the dam.

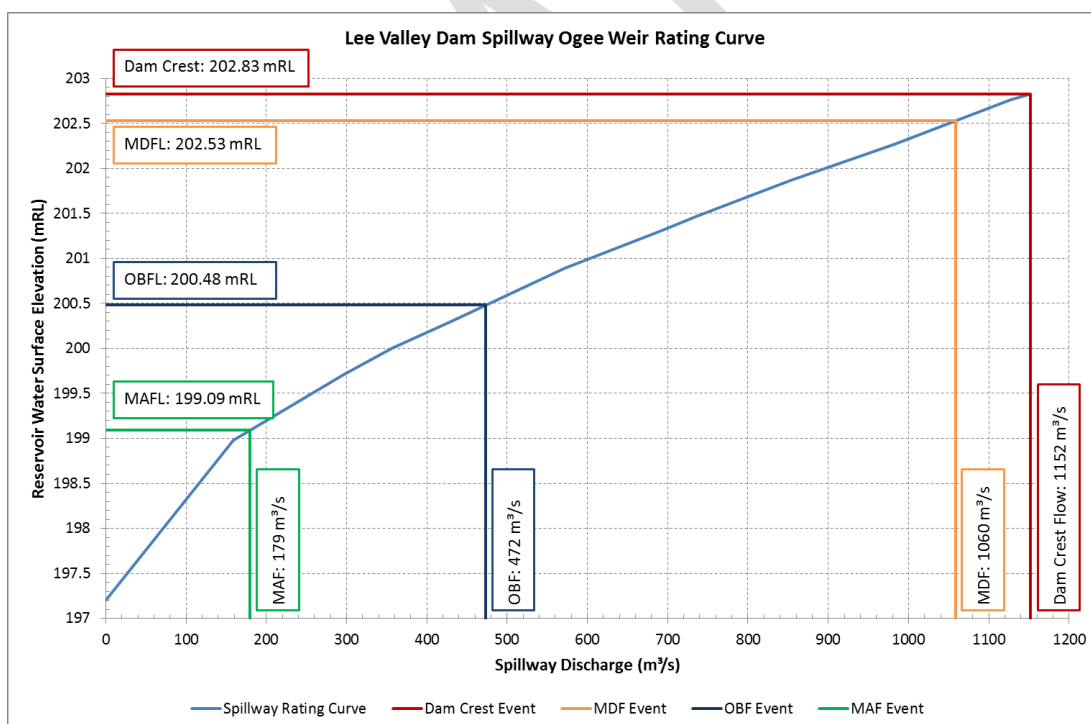
Figure 6 2 Ogee weir design rating curve

Figure 6-2 shows the design rating curve (flow rate versus reservoir level) for the spillway ogee weir.

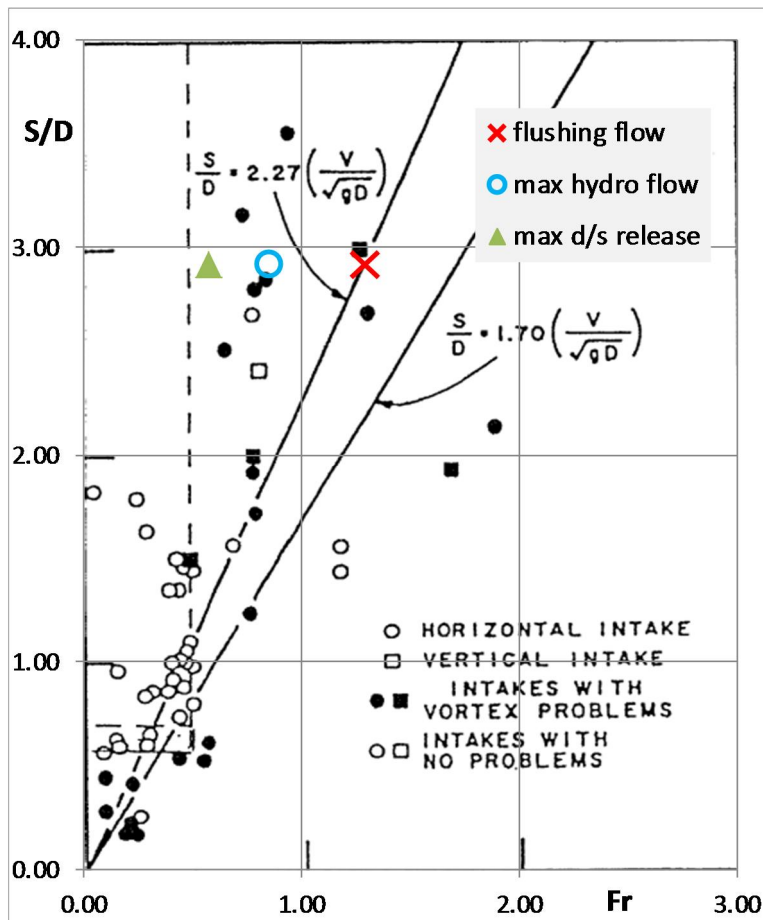
Figure 1. Submergence depth (S) of intakes to minimise the occurrence of vortices

It is likely that lowering the elevation of the intake will lower the risk of vortex formation, however it is noted from Figure 1 that there is no safe submergence. Furthermore lowering the elevation will lead to a deeper dive and deeper extraction of water, which may not be desirable for the environmental advisor.
