<p><b>Tonkin &amp; Taylor</b> Environmental &amp; Engineering Consultants D Auckland D Hamilton D Nelson D Wellington D Whangarei</p>	<p><b>TASMAN DISTRICT COUNCIL</b> GEOTECHNICAL PRE-FEASIBILITY ASSESSMENT Lee River Valley, Tasman Geotechnical Section – Site 2</p>
	<p>FIG. No. Figure 4</p>
<p>PROJECT No. 22032.002</p>	<p>REV. 0</p>

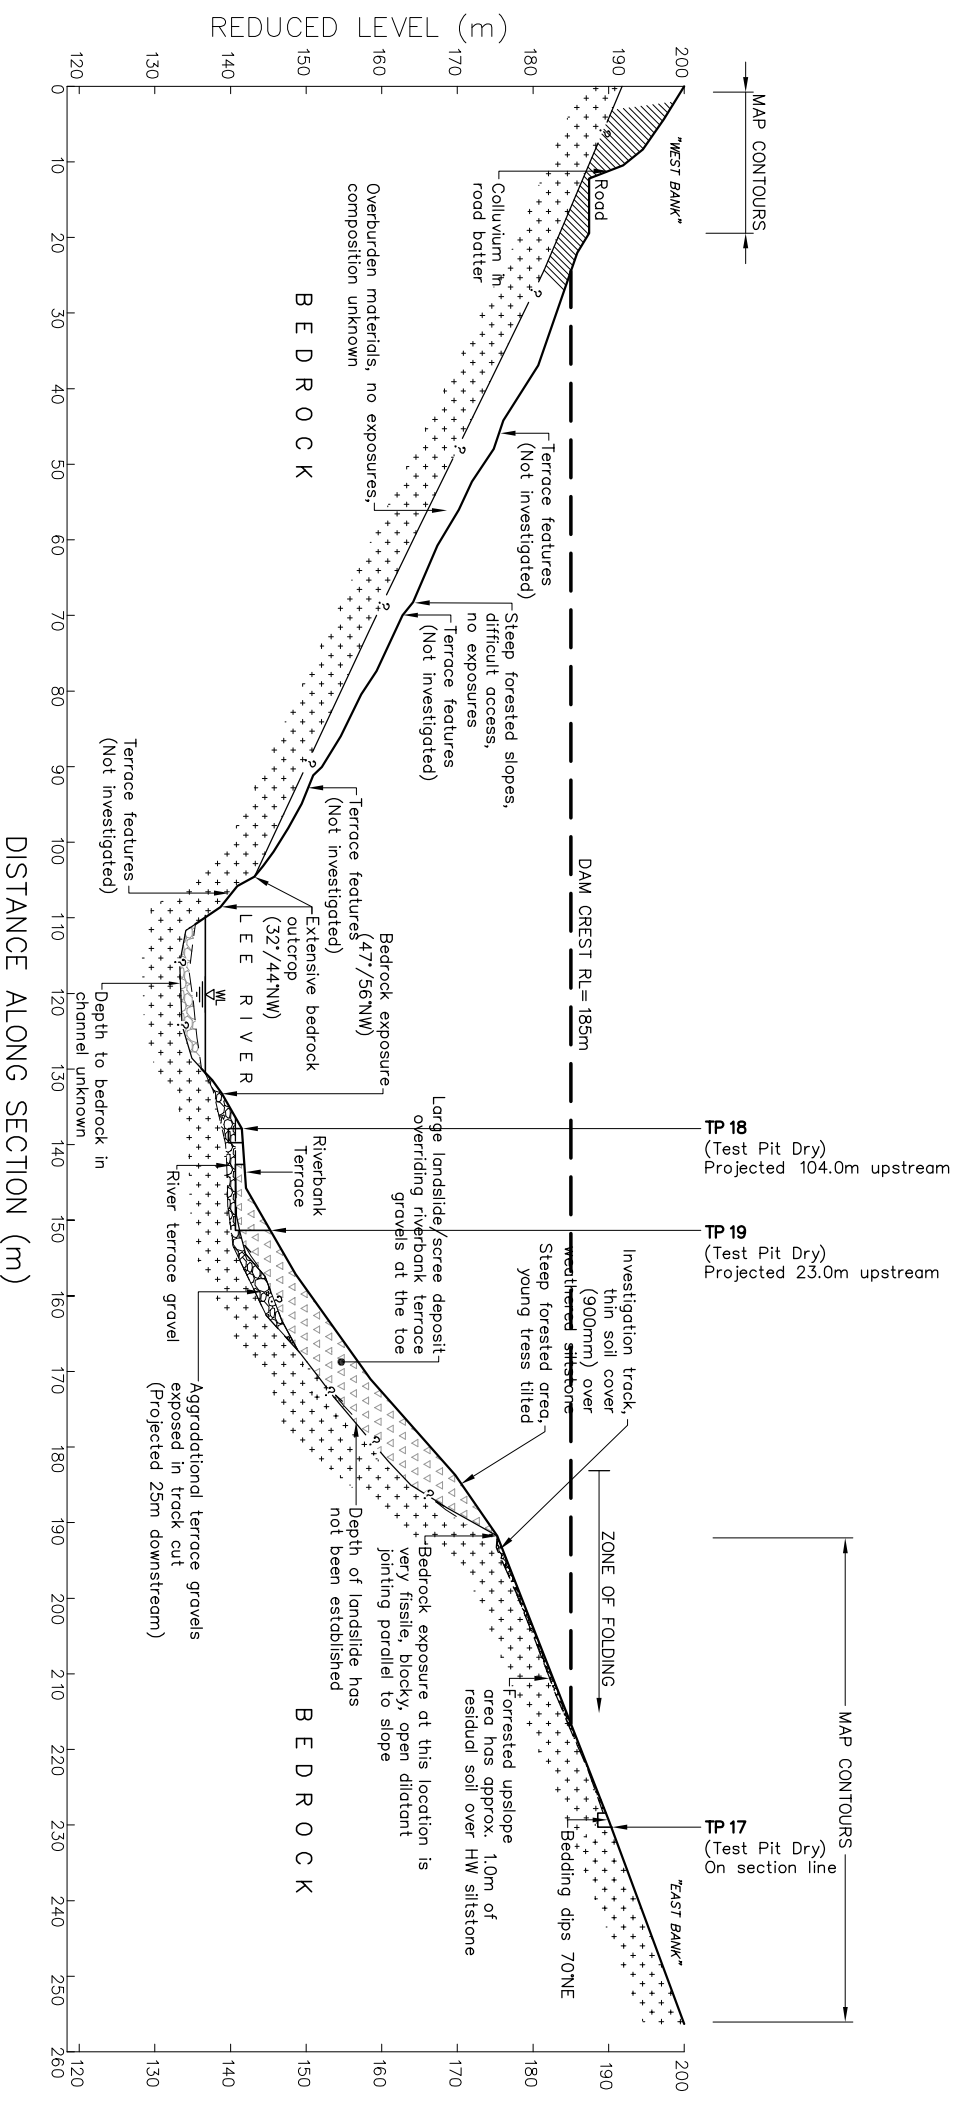
- NOTES:**
1. The debris slide covers the whole of the concave slope, but not along the track itself. Material is bedrock derived.
  2. Ground conditions are accurate at investigation locations & are inferred between test locations & may vary from the profile shown
  3. Western & Eastern parts of section are offset by approx. 40m due to imperceptible gorge
  4. Ground Profile obtained from a combination of T&T Abney Survey & topographic contours on upper slopes (NZMS 1:50 000 series)
